Shake-Table Studies of Repaired Reinforced Concrete Bridge Columns Using Carbon Fiber-Reinforced Polymer Fabrics

by Ashkan Vosooghi and M. Saiid Saiidi

ACI Structural Journal, V. 110, No. 1, January-February 2013.

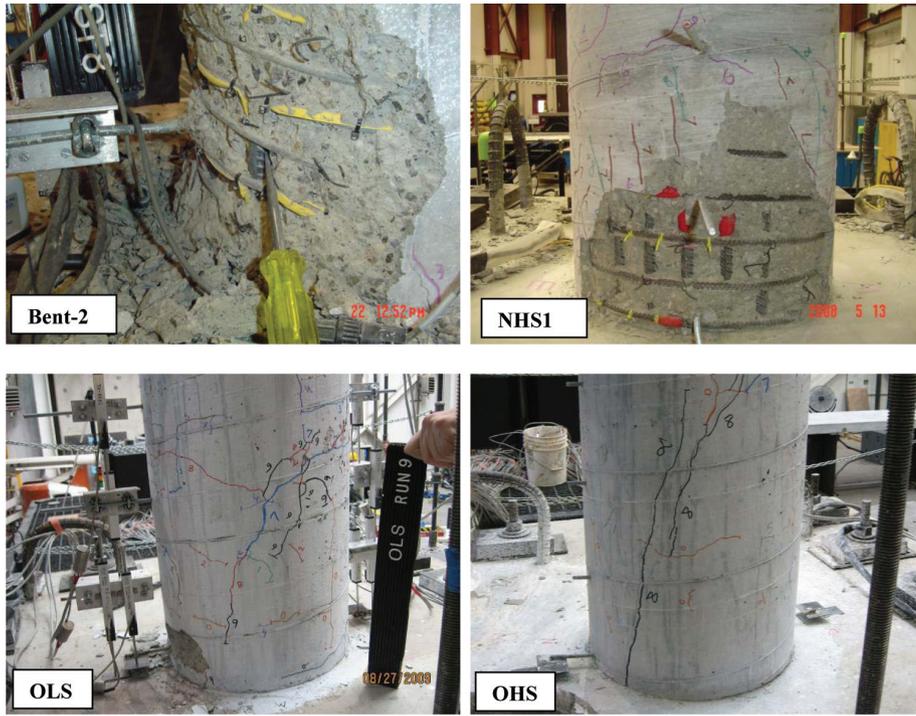
The models were tested to reach the highest repairable damage state. The standard columns reached DS-5. At this damage state, many spirals and longitudinal bars are visible, some of the longitudinal bars begin to buckle, and the edge of the concrete core is damaged (Fig. 2). Due to severely inadequate transverse steel and longitudinal bar lap splice, the substandard columns did not undergo significant plastic deformations. Testing of Columns OLS and OHS was stopped at DS-3 and DS-2, respectively (Fig. 2), to avoid complete failure of the columns. Shear cracks covering a large area of OLS and OHS were formed during the last run. Considering the very low amount of transverse steel in these columns, it was felt that additional motions would lead to total failure of the columns, thus preventing repair.

Fig. 2—Apparent damage after original shake-table tests.

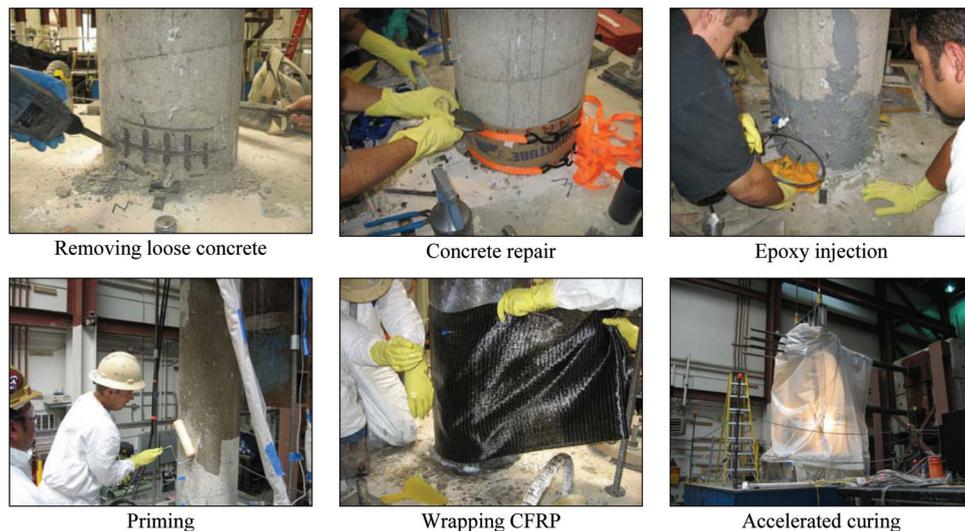
Fig. 4—Rapid repair procedure.

The loose concrete was removed by an impact hammer with a chisel head (Fig. 4). The area was cleaned using compressed air to remove dust and the remaining concrete particles after chipping the concrete. No loose concrete was observed in the original substandard columns after the tests. Therefore, this step was not exercised for these columns.

To provide integrity and stiffness for the damaged columns, the cracks were injected with epoxy at a pressure of 40 to 50 psi (0.28 to 0.34 MPa). To inject the epoxy, several ports were attached on all the visible cracks and the crack surfaces were sealed with a removable sealer. Epoxy was injected into a given crack through one port and injection was continued until bleeding from another port occurred. The epoxy injection process is shown in Fig. 4.

After the concrete was repaired and epoxy was injected, the column surface was smoothed slightly by a grinder to remove any surface roughness and any injected material residues from the column surface. A layer of epoxy was applied to prime the column surfaces (Fig. 4). Subsequently, a thickened epoxy was applied directly on the columns to smooth out imperfections. After preparing the surface, the epoxy was applied to CFRP layers using a paint roller and the sheets were wrapped around the columns manually (Fig. 4).

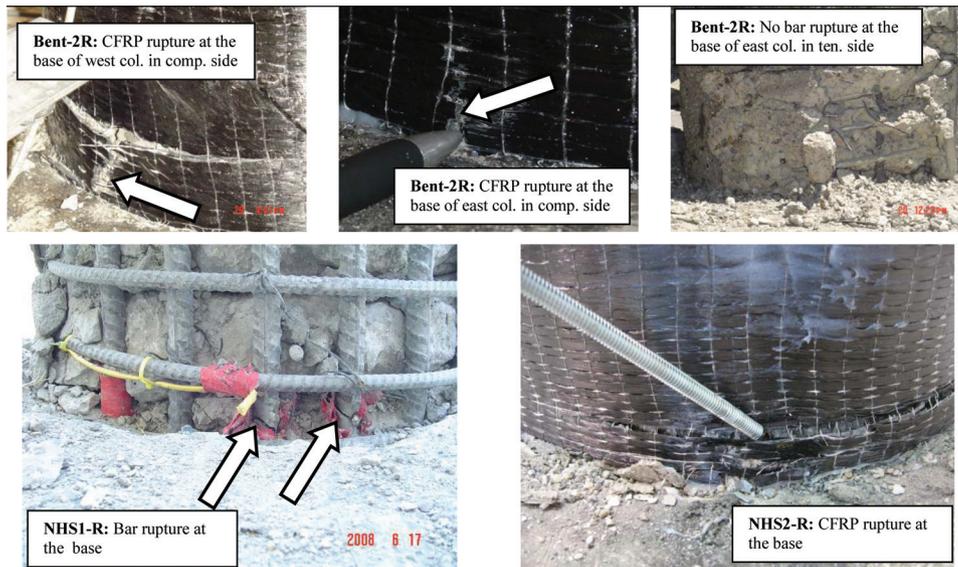
In Bent-2R, no damage was observed during the shake-table runs until the drift ratio of 9.0%. At this drift ratio, the first CFRP rupture occurred in the column under compressive force due to the overturning moment (west column). This rupture was extended during subsequent runs. The second CFRP rupture was observed in the east column during the last run at a 13.1% drift ratio. The ruptured jackets in both columns are shown in Fig. 5. After the shake-table test, the CFRP jacket and some concrete were removed from the plastic hinge regions and no ruptured bar was observed (Fig. 5).

Fig. 5—Repaired columns after shake-table test.

In NHS1-R, no damage was observed during the test. During the last run, a sound of steel rupture was heard. After removal of the jacket and some concrete, two broken longitudinal bars were found at the column base (Fig. 5). Removal of the jacket and concrete at the column top did not reveal any ruptured bars.

In NHS2-R, no damage was observed during the test until a drift ratio of 9.94%. The jacket ruptured over an approximately 0.25 in. (6 mm) area at the column base at this drift ratio. This rupture was extended during the subsequent run, which was the last one (Fig. 5). The maximum measured drift ratio was 13.3% during this run. During the last run, the CFRP rupture was accompanied by a sound of steel rupture. After removal of the jacket and some concrete, two broken longitudinal bars were found at the column base. No bar fractures were noted at the top plastic hinge after removal of the jacket and concrete in NHS2-R.

No damage was observed in OLS-R and OHS-R during the tests. During the last run, the sound of steel rupture was heard. After removal of the jacket and some concrete, a broken longitudinal bar was found in the primary tension side of each column base. Removal of the jacket and concrete at the top of OHS-R did not reveal any ruptured bars.
