Safety inspections and seismic behavior of embankment dams during the 2011 off the Pacific Coast of Tohoku earthquake

Dam and Appurtenant Structures Research Team, Hydraulic Engineering Research Group, Public Works Research Institute, Japan

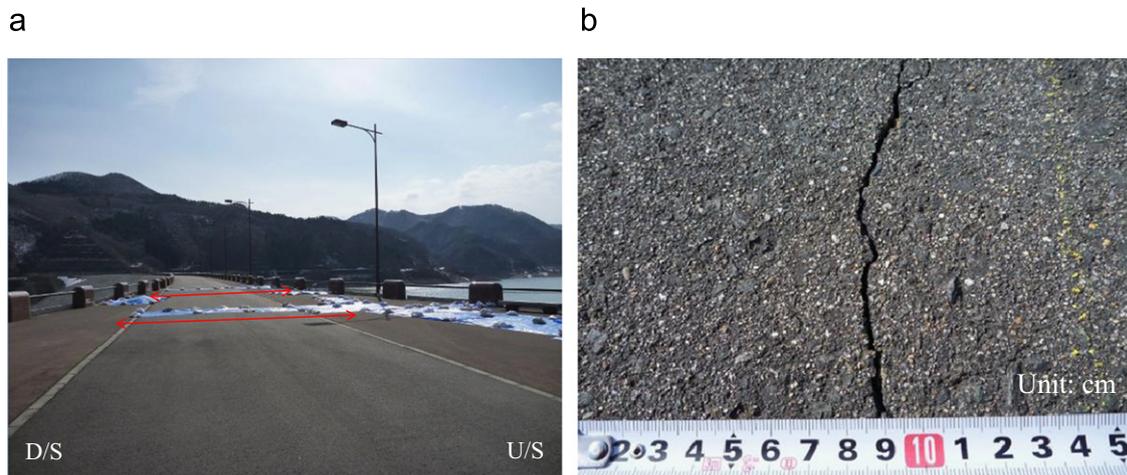
Photo 1. Cracking at the crest of Surikamigawa Dam. (a) Overview of the crest and (b) Close-up of a crack.

- Cracking of the pavement on the dam crest near both abutments, primarily in the stream direction (Photo 1).
- Settlement of the dam body of approximately 170 mm at the crest near the maximum cross section.
- Increase in total leakage from approx. 70 L/min to 100 L/min.

- The settlement caused by the earthquake was much smaller than the height of freeboard, and was not differential...
- The follow-up careful monitoring revealed that the increment of leakage was temporary.
- The cracks generated in the asphalt pavement on the dam crest were narrow in width.
- No damage was found on the upstream or downstream surfaces of the dam body.

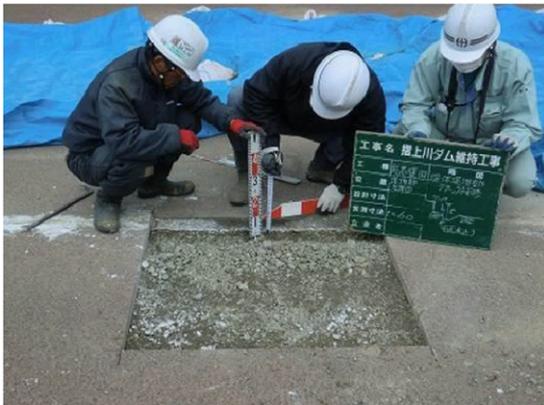
Photo 2. Crack depth analysis at Surikamigawa dam.

However, to thoroughly ensure the safety of the dam, the depth of the cracks was investigated by the manager, as shown in Photo 2, with careful attention given to changes in the monitoring data. A close-up of a cross section around the dam crest is shown in Fig. 5. The investigation results confirmed that the cracks in the crest pavement terminated at 300 mm in depth within the protective layer just under the pavement, and did not reach the core zone.

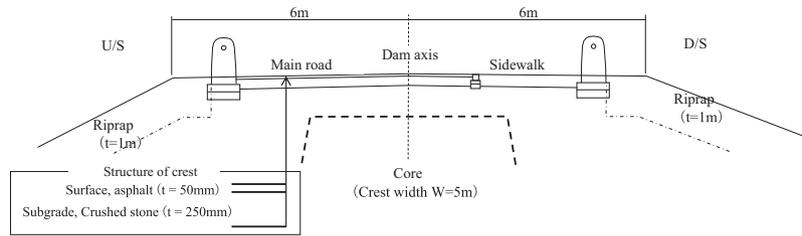
Fig. 5. Cross section around the crest of the Surikamigawa Dam.

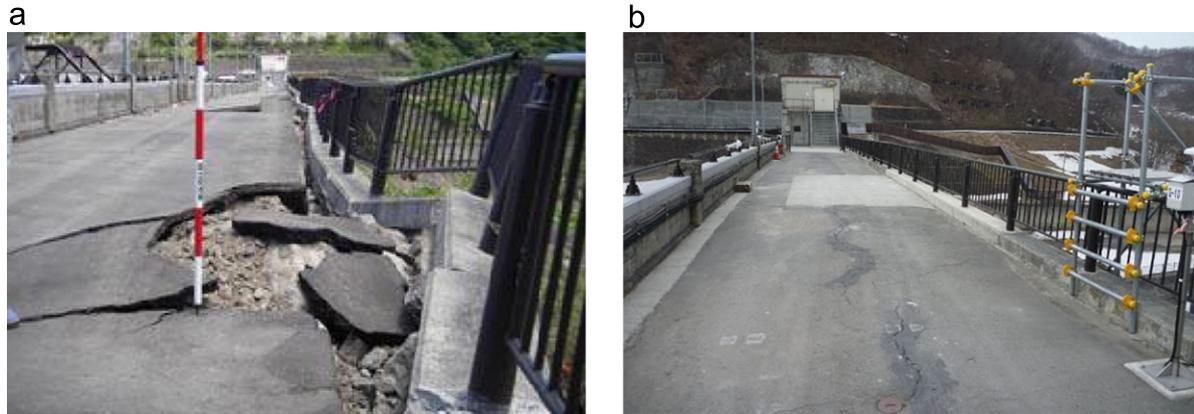
Nairiku (Inland) Earthquake of 2008, which occurred near this dam. The 2008 earthquake caused rippling and cracking of the crest pavement and openings at the boundary between the crest pavement and railings (Photo 3(a)) (Yamaguchi et al., 2008), while damage due to the earthquake of 2011 (Photo 3(b)) was extremely minor.

Photo 3. Crest of the Ishibuchi Dam. (a) After the 2008 earthquake (Yamaguchi et al., 2008) and (b) After the 2011 earthquake.

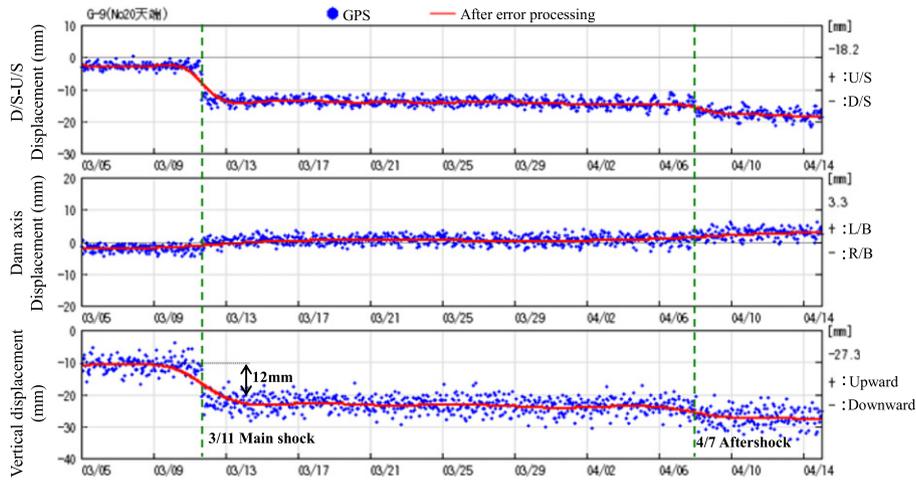
deformation at the measurement point at the center of the dam crest, namely No. G-9 indicated in Fig. 6(a). The results revealed that the main shock of the 2011 earthquake on March 11 caused 12 mm of settlement at the crest, and the largest aftershock, which occurred on April 7, resulted in a bit more settlement. Considering the GPS measurement data and the fact that no damage occurred at the concrete facing along the upstream slope, it was concluded that there was no threat to the safety of the dam.

Fig. 7. Earthquake-induced settlement of the Ishibuchi Dam measured using GPS monitoring system.

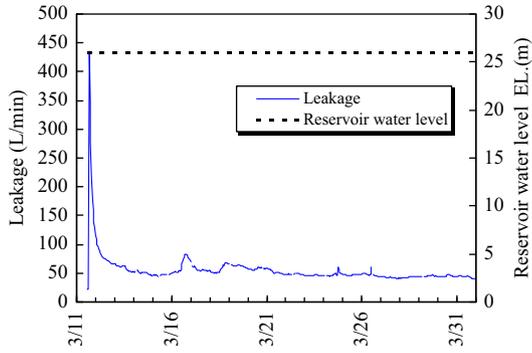
Careful monitoring of measurement data with particular focus on the amount of leakage was continued. The results showed that the amount of total leakage rapidly decreased after the earthquake and remained stable at below 50 L/min, although it has increased just after rainfall within the range of past records. No other problems that threaten the safety of the dam have been found.

Fig. 9. Time series of total amount of leakage at Kejonuma Dam.

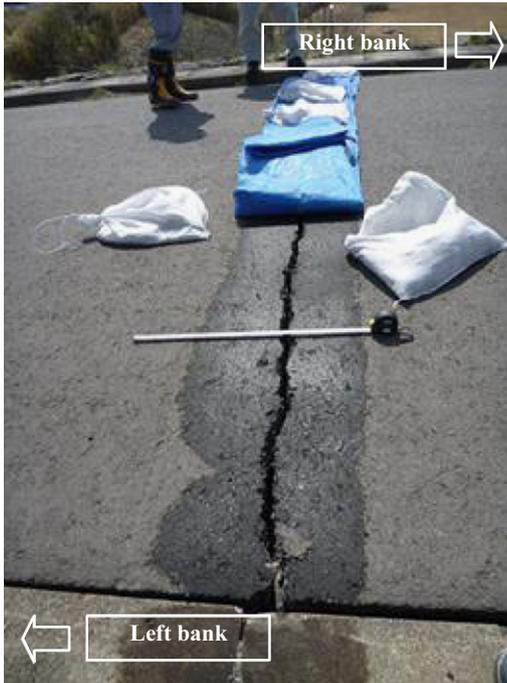
- (a) Several small cracks in the stream direction on the dam crest including cracks of 25–30 mm in maximum width at the left bank side, as shown in Photo 4.
- (b) A slight opening between the pavement and curb on the dam crest.
- (c) A rapid but temporary increase in the total amount of leakage from 20 L/min to 430 L/min.
- (d) A maximum settlement of 139 mm (much smaller than the height of freeboard) and deformation of 58 mm in the downstream direction at the center of dam crest.

Photo 4. Cracking in the stream direction on the crest of Kejonuma Dam.

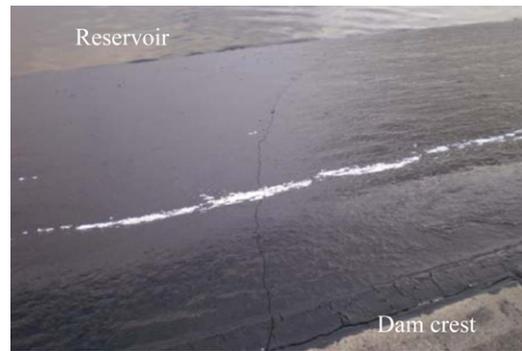
- (a) Two relatively long cracks in the asphalt facing forming the impervious membrane (Photo 5).
- (b) Maximum earthquake-induced settlement of the dam body of approx. 90 mm at the dam crest around the maximum cross section.
- (c) Temporary increase in leakage of 19 L/min–91 L/min.

Photo 5. Cracking of the asphalt facing of the Minamikawa Saddle Dam.

As a result of investigation by the manager, the extent of cracks in the asphalt facing was identified. Remedial work consisting of partial reconstruction of the damaged facing is now being planned.
