## Cyclic Response of Reinforced Concrete Moment Resisting Beams Repaired with Epoxy Injection

Engr. Muhammad Rashid<sup>1</sup>, Dr. Naveed Ahmad<sup>2,\*</sup>

### ABSTRACT

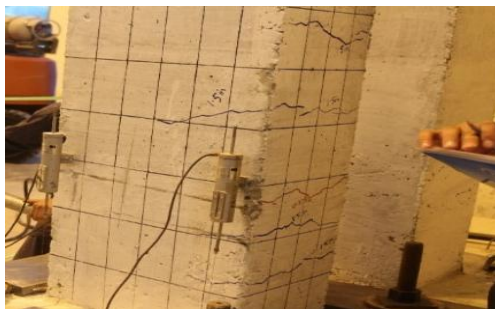
Figure 5: Specimen Damage Patterns

The specimen was loaded with an initial displacement of 0.375 in. Full depth flexural crack formed at the northern face of the beam at a distance of 18 in. from the face of the block, whereas a flexural crack at a distance of about 16 in. formed on the southern face. Cracking was not observed on the eastern and western faces at this displacement demand. At displacement amplitude of 0.75 in., no new cracks formed on any face of the beam. With further increase in displacement demand to 1.5 in., new flexural cracks formed at 8 in., 13in. 26 in. and 34 in. from the support on the southern face. A flexure crack formed at northern face at a distance of 27 in., whereas slight diagonal cracking occurred on the western face. A wide distribution of cracks took place during the displacement cycles of 2.5 in., with cracks on the northern and southern faces as high as 54 in. Full depth inclined cracks were observed on the eastern and western faces of the beam which increased in number at displacement demand of 3.5in. Minimal new cracks were observed further till the conclusion of test at 5.5 in.

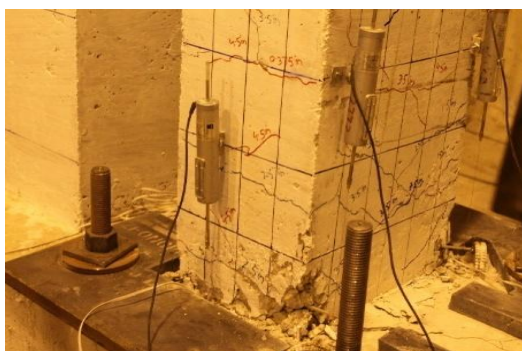
Spalling of the concrete cover started on the northern and southern faces at a displacement of 4.5 in., which escalated at final the displacement cycles of 5.5 in exposing the reinforcing bars on the southern face. The specimen could not be displaced further because the maximum stroke of the hydraulic jack was 6 in. The hysteretic response was marked by a strong pinching due to the slip of longitudinal bars. No strength drop was observed in the hysteretic response due to the fact that the specimen was not tested till failure as shown in Fig. 6.

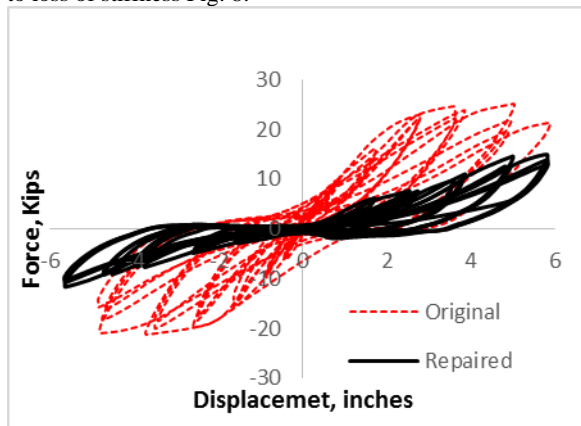
Figure 8: Comparison of Original & Repaired Response of Specimen

The response of the repaired specimen was unsatisfactory. The beam showed a considerable drop in the strength and a severe pinched hysteretic response due to loss of stiffness Fig. 8.

The reason behind this performance is the fixed end rotation at the interface between the beam and the anchorage block. The interface opening was injected with epoxy but based on the results it can be said that the merely filling the interface opening with epoxy will not restore the original stiffness of the beams which will render the beam unable to achieve its original strength. The efficiency of the epoxy injection in treating the cracks could not be studied due to the fact that the beams did not sustain the original loads, which caused those cracks.

- i. The epoxy injection repair technique should be coupled also with other technique(s) e.g. reinforcement jacketing, fibre reinforced polymer sheets, etc., that can increase the stiffness and strength of the beam.
