6th International Conference on Applied Human Factors and Ergonomics (AHFE 2015) and the
Affiliated Conferences, AHFE 2015

The causes of work place accidents and their relation to construction equipment design

Within this context, this paper aims to analyze a workplace accident in civil construction work, in the area of solid waste recycling (the collection, transport and crushing of demolished material), in order to identify the causes of the accident and propose solutions for the design of construction equipment.

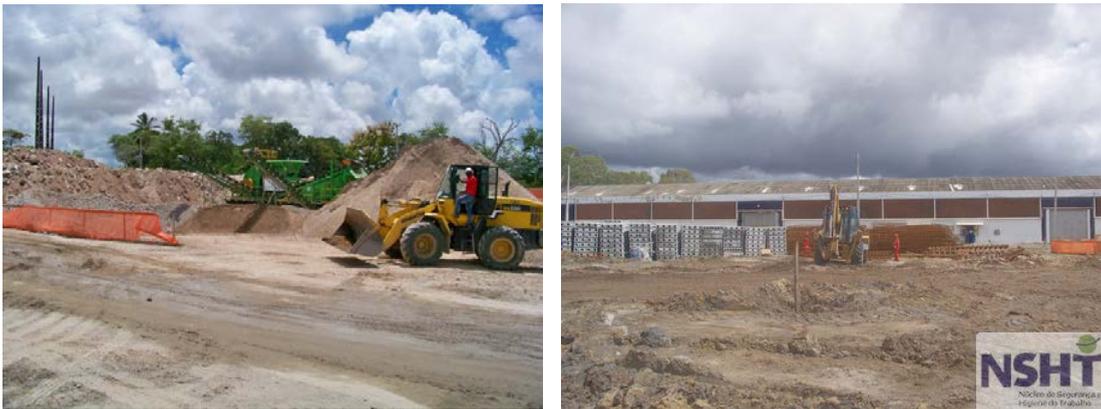
Fig. 1 shows the area for the recycling of solid waste, specifically the area of crushing demolished material, as well as part of the old factory sheds before demolition. Fig. 2 and 3 illustrate activities related to the manual and mechanized excavation; use of continuous flight augers CFA; leveling of cuttings, use of jackhammers; and the concreting of blocks for capping the piles with the use of a pumped concrete mixer truck.

Fig. 1. (a) area for the recycling of solid waste; (b) sheds of the old factory before demolition.

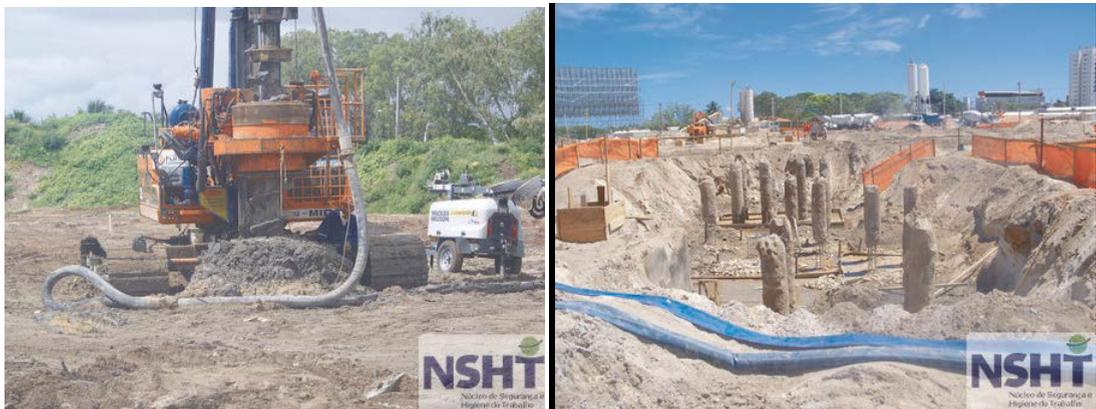
Fig. 2. (a) continuous flight augers; (b) erecting piles.

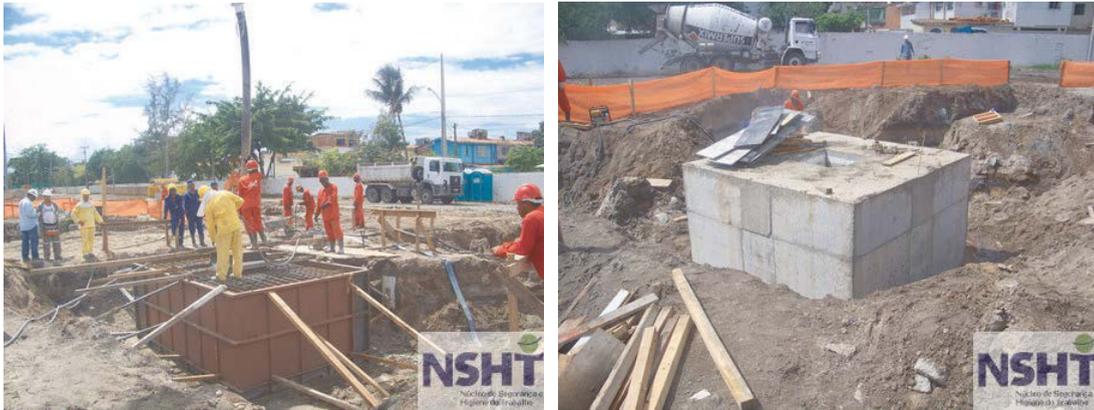
Fig. 3. (a) concrete blocks for crowning the piles; (b) concreted crowning block to connect the stakes to the pillar.

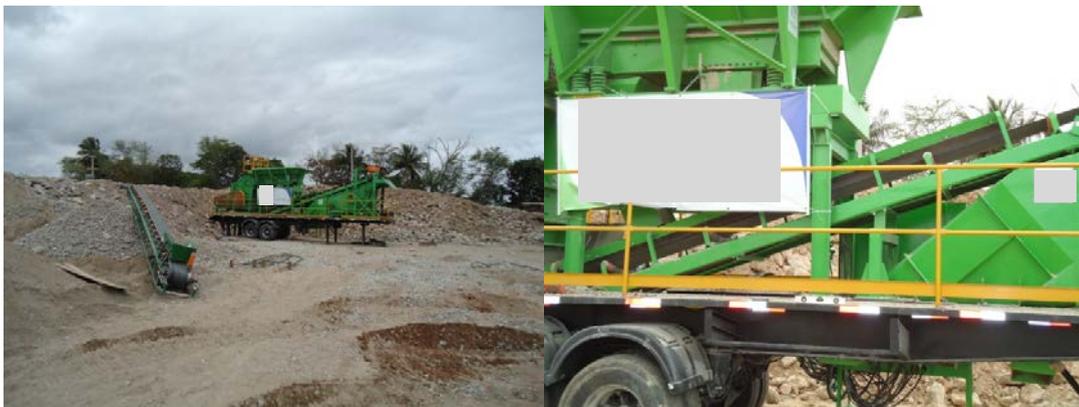
The accident occurred in an area of a subcontracted third party, for the collection, transport and crushing of the material demolished at the site in Recife, Brazil, during the foundation stage of construction. This third party worked on undertaking the demolition and recycling services of the demolished material in the construction work under study. It was using the mobile crushing equipment ICON UMB1010 - VR, to remove debris and for crushing the demolished materials (Fig.4). The equipment consists of two parts. The top is for the buckets, motors and crushers used for the collection, transportation and crushing of the material. Whereas the bottom consists of a platform, which transports and fixes the unit.

Fig. 4. mobile equipment for removal and crushing.

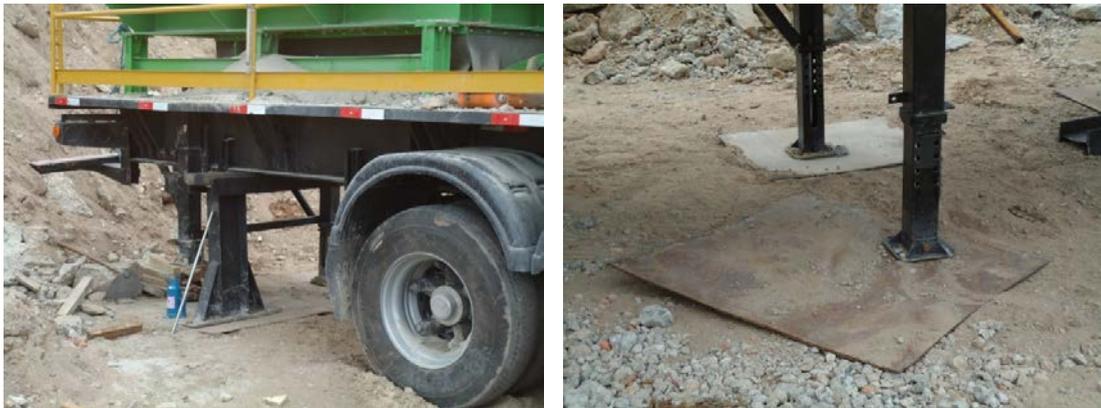
Despite the supporting metal parts for fixing the unit having a hydraulic system, the connected equipment causes strong and intense vibration, causing wear on the supporting metal parts. As reported by the commercial manager of the third-party company, to solve the problem, the company's operational team used three metal trestles to support the truck, giving it greater stability and preventing the rapid wear of the original pieces of support equipment (Fig.5).

Fig. 5. metal parts for fixing the mobile equipment.

The use of trestles to support and fix the mobile unit was also suggested by the manufacturer of the equipment, in order to extend the life of the chassis suspension, improve equipment operational safety and minimize vibration. The manufacturer stated that construction trestles consisted of beams in "I" formation, in 250 x 120 mm steel, supported on steel plates with sufficient height so that the tires become suspended above the ground.

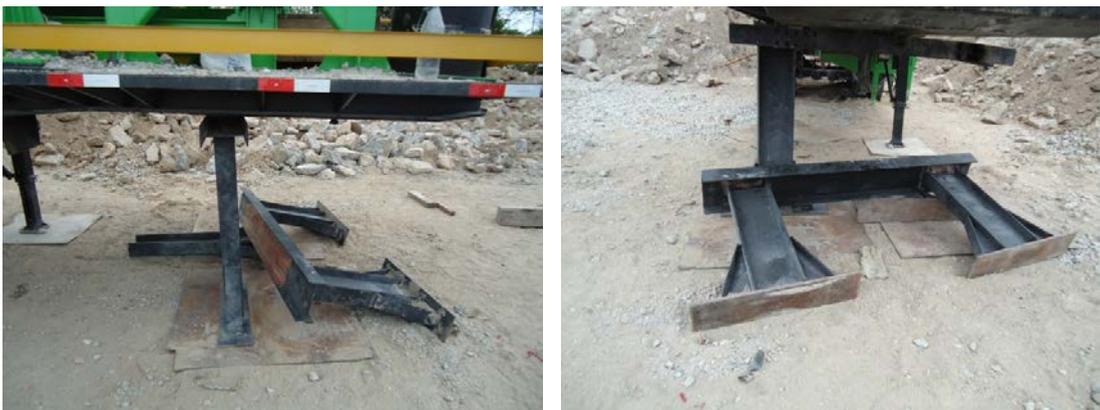
of the trestles had a broken support, as can be seen in Fig.6. In this case, the commercial manager of the outsourced company reported that this support would have been soldered at the location.

The employees were adjusting the trestle with the broken support for subsequent welding, when the victim, crouching and pressing one foot on one of the trestles, lost his balance and fell backwards. When he fell, in order to keep his balance and prevent his fall, 'pulled' at the other metal trestle, which was loose and very close (Fig.6). This, weighing about 300 kg, fell on top of him, crushing his face.

- a failure in the operation of the mobile crushing equipment when it is operated with excessive vibrations. The equipment must be stable;
- inadequate guidelines on the part of the manufacturer regarding the use of the trestle. The trestle is only an accessory, or simply, a piece of support equipment;
- a failure in the design of the trestle, which was unstable. The trestle should have all four supports on the ground;
- the trestle had a broken support;
- inappropriate Operating Procedure;
- a lack of training on the part of the management team.

Fig. 6. (a) improvised support for the truck; (b) the metal piece that fell on the employee.

- designing rigid supports for the unit;
- designing trestles as part of the equipment, which would mean not having to improvise and the not having to handle the trestles;
- development of specific operating procedures for this activity;
- teaching / strengthening the skills of the management team. Despite giving technical training on environmental and operational issues of crushing waste, the management team of the outsourced company demonstrated a deficiency in technical knowledge of health and safety at work.
