Experimental investigation on stiffened steel plate shear walls with two rectangular openings

Saeid Sabouri-Ghomi, Salaheddin Mamazizi*

Department of Civil Engineering, K.N. Toosi University of Technology, Tehran, Iran

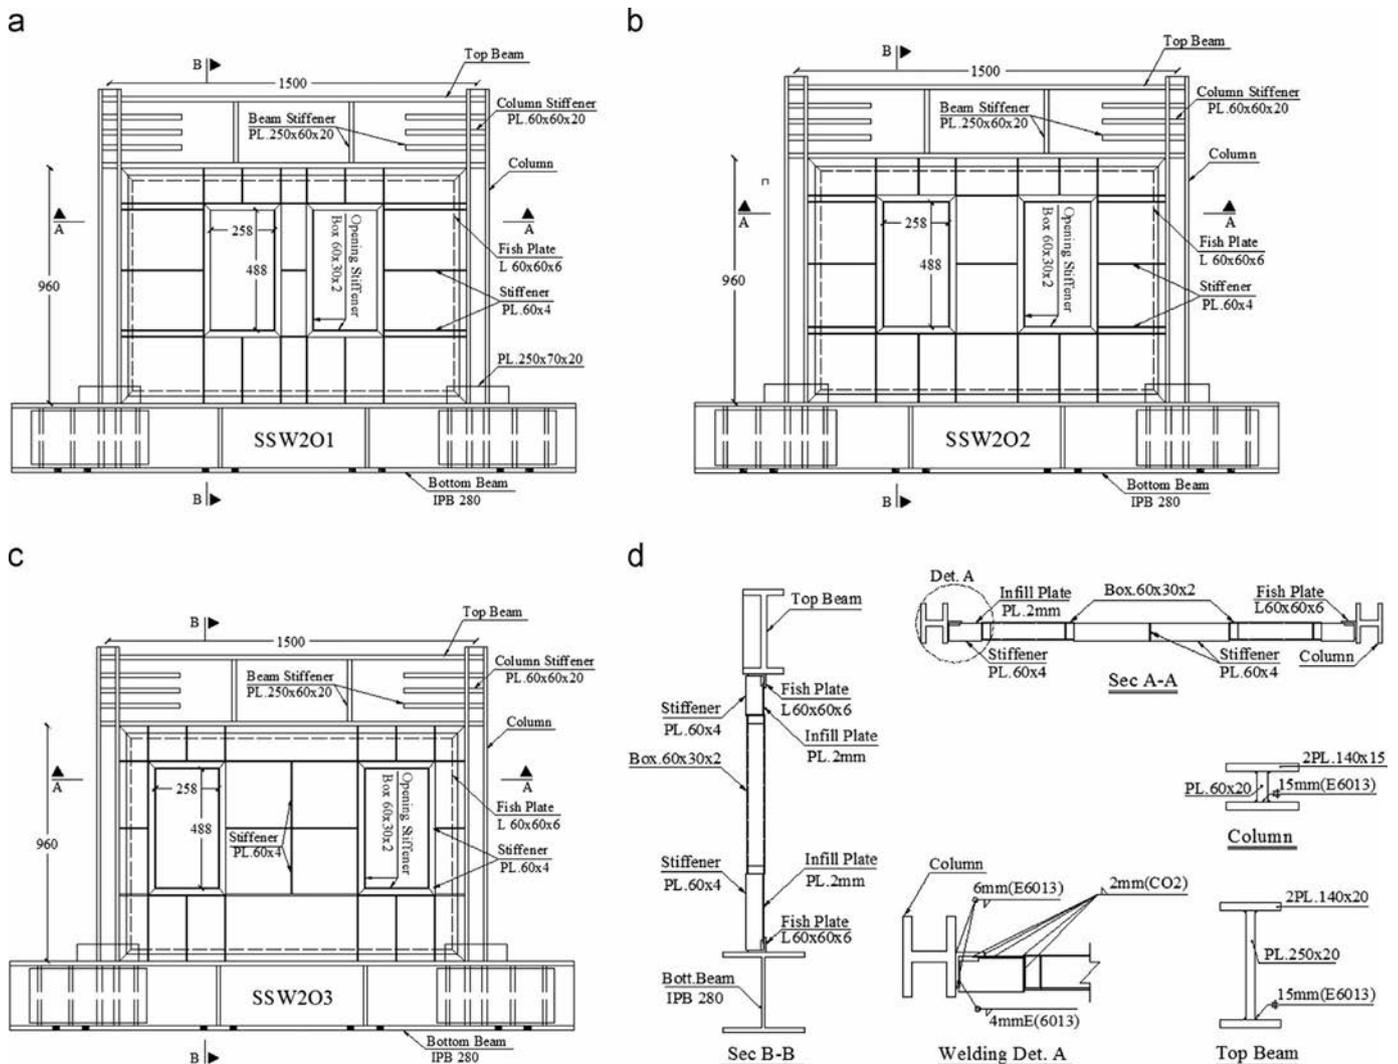
Fig. 1. Specifications and details of perforated specimens. (a) SSW201, (b) SSW202, (c) SSW203 and (d) vertical and horizontal cross sections and welding details.

In this paper three one-third scaled one-bay single-story stiffened SPSWs with two symmetrical stiffened rectangular openings under cyclic loading were examined and experimental results of a same specimen without any openings were used. The perforated specimens were coded as SSW201, SSW202 and SSW203 as shown in Fig. 1. The other SPSW specimen was called DS-SPSW-0% which its infill plate specifications and frame geometry were similar to other specimens except it was without openings as shown in Fig. 2. Stiffeners were installed on the infill steel plate divided it to some sub panels. Sub panel that was

Angle of 60 × 60 × 6 mm was used as fish-plate. For accurate welding between the steel plate and the angle, one side of the angle was milled to 50 mm. The infill plate was lapped over the fish-plate and was welded continuously on the fish-plate. Stiffeners with dimensions of 60 × 4 mm were installed on the one side of the infill steel plate. The philosophy of using the stiffeners on the infill steel plate was to transfer the shear buckling to the sub panels and to increase the shear buckling strength. The required stiffeners on the infill steel plate were optimally designed in terms of layout and the moment of inertia. In addition to the results of eigenvalue buckling finite element method, the following conditions were taken into account for the design of stiffeners:

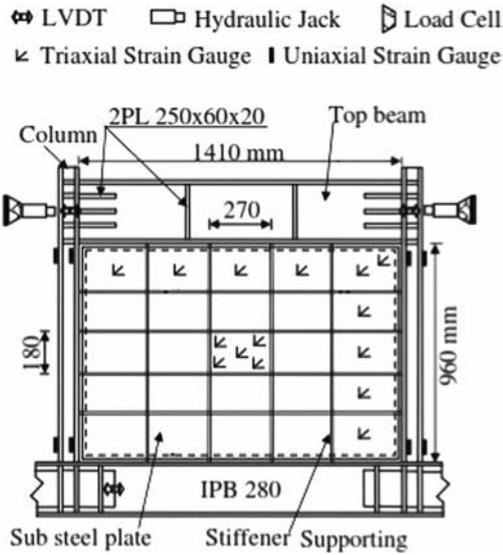
Fig. 2. Specification of DS-SPSW-0% specimen.

in Ref. [12] were used for the comparison of structural parameters. This specimen was similar to perforated specimens in terms of infill plate specifications and frame geometry.

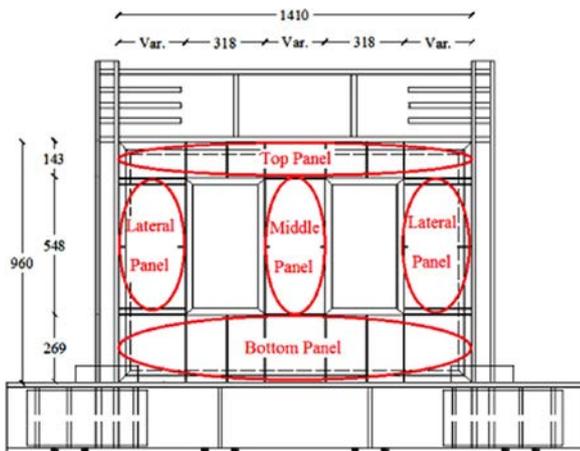
Fig. 3. Typical location of middle, lateral, top and bottom panels and dimensions of panels.

located between two openings was called middle panel and the sub panels that were located between opening and column were called lateral panels as shown in Fig. 3. This figure also shows the locations of top and bottom panels. The considered variable in these specimens was the interval between openings, which led to different aspect ratios for middle and lateral panels.

According to the loading capacity of laboratory actuator, the specimens were designed and fabricated based on PFI (plate-frame interaction) method [20,21]. Fig. 4 shows the fabricated perforated specimens before test. The infill steel plate thickness was taken 2 mm. The distance between the centerlines of columns was 1500 mm and their height was 1250 mm. The inner height and width of the surrounding frame were equal to 960 mm and 1410 mm respectively. The frame was consisted of top beam and two columns, which were built up of plates by welding. The dimensions of the column flange and web were 140 × 15 mm and 60 × 20 mm, respectively and the dimensions of top beam flange and web were 140 × 20 mm and 250 × 20 mm. The internal height and width of the openings was equal to 488 mm and 258 mm, respectively. Fig. 1 shows the specification of specimens, arrangements of different stiffeners, horizontal and vertical cross sections of specimens, dimensions of the columns and top beam, and details of connections and welding. Dimensions of openings and their distance from the bottom and top beams were designed based on architectural considerations. Table 1 shows the width of middle, lateral, top, and bottom panels. The height of panels was similar in all specimens as shown in Fig. 3.

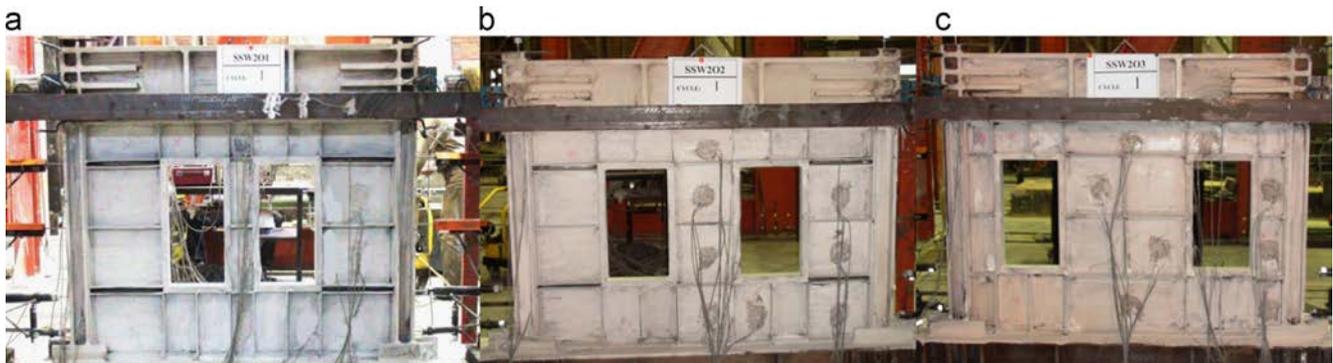
Fig. 4. Experimental specimens before conducting the test. (a) SSW201, (b) SSW202, and (c) SSW203.

were designed and installed at the top level on the both sides of the specimen, as shown in Fig. 4.

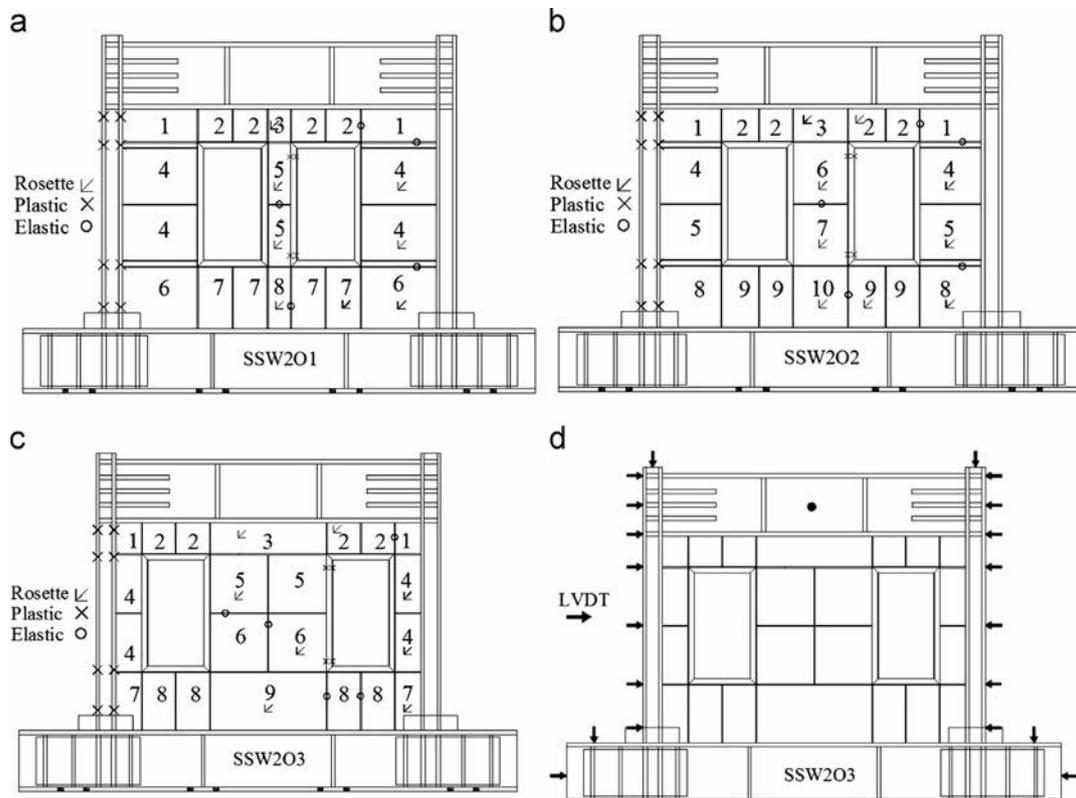
Fig. 5. Code of sub panels and arrangement of instrumentation on perforated specimens. (a) SSW201, (b) SSW202, (c) SSW203, and (d) Arrangement of LVDTs for all specimens.

elastic and plastic strain gauge, and load cells were the same for all three specimens. Nevertheless, the locations of rosette strain gauges in specimens were changed with regard to variation of openings location and panel's dimension. Fig. 5 presents the location of these instruments.

The details and descriptions of specimens are described from cycle 6 in the following sections. In the first five cycles loading, installed strain gauges did not show certain yielding on the plate. To present the required description the sub panels of specimens have been numbered as shown in Fig. 5.

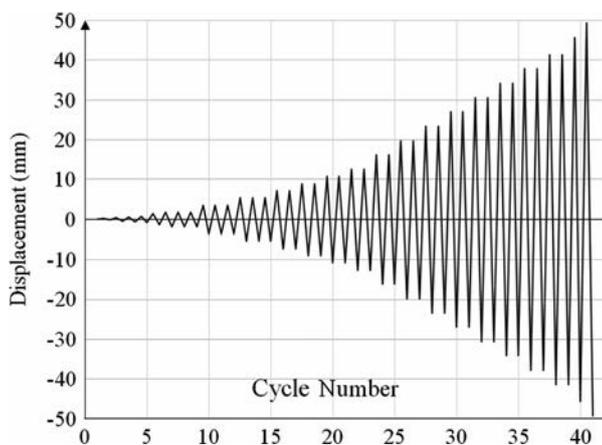
Fig. 6. Lateral loading history according to ATC24.

The cyclic quasi-static loading was applied horizontally to the center of the top beam, according to ATC-24 protocol [24]. Before testing, the yielding shear displacement on the infill steel plate was predicted by PFI theoretical method and the numerical method. Later, during the tests, specimens yielded at almost the predicted value, which validated the prediction. Elastic cycles should be performed with force control. According to the protocol, at least three of the elastic cycles should be carried out using force amplitude and in the inelastic region test should be performed under deformation control [24]. No vertical load was applied to the specimens and the test could be stopped when the lateral load dropped below 80% of the maximum load. Fig. 6 shows loading history consists of stepwise increasing deformation cycles, and numbers of cycles were used in each loading step. Five cycles were applied to be performed before the yield point of the specimen.

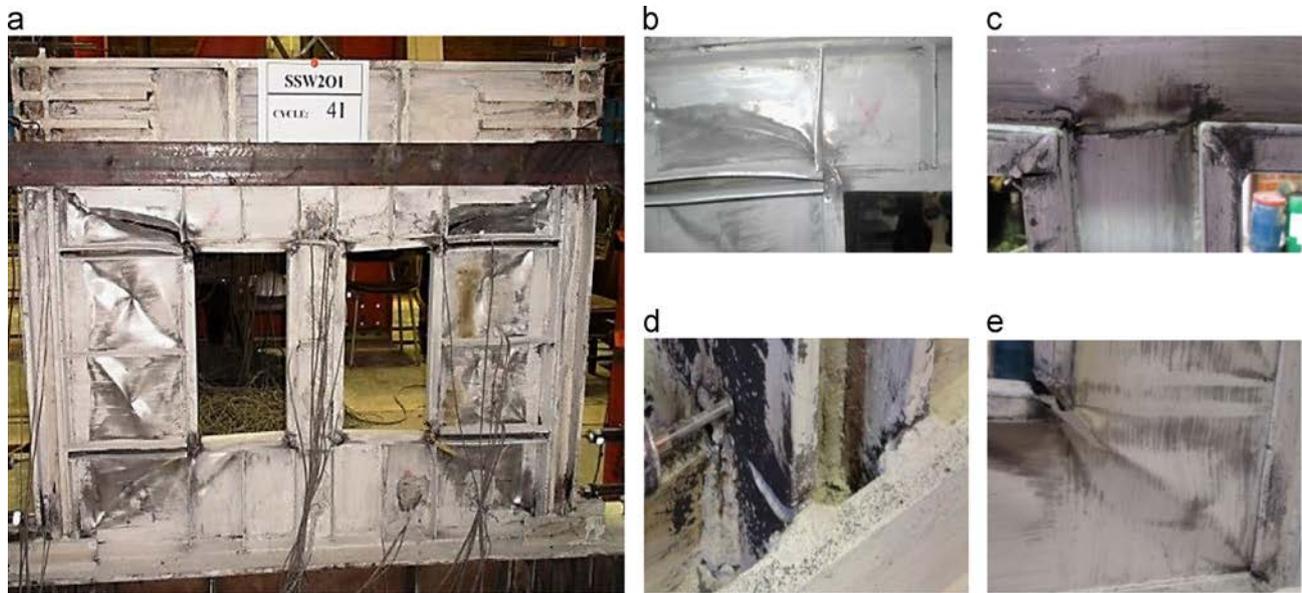
Fig. 7. Details of SSW201 specimen during test. (a) deformation of specimen at cycle 4, (b) plate buckling in subpanel 1, horizontal and vertical stiffeners, (c) plastic hinges at top of middle panel, (d) failure in exterior column flange at base, and (e) tearing infill plate in subpanel 6 and separation in boxes and angles connections.

In cycle 30, buckling and deformation was initiated in the stiffeners attached to boxes connections (Fig. 7b). In cycle 31, cracking was appeared in the connection of column base. In cycle 34, interior column flange yielded at the top and base in 7.9 mm displacement. In cycle 35, rupture of the infill plate was propagated toward the columns from the boxes connections along the prior created buckling waves in sub panels 1 and 6 so that separation of the angles connection contributed it. The rupture of the infill plate at sub panels 1 was more than sub panels 6 because of separation of the angles connection at the top is more than the same connection at the bottom. In cycle 40 at sub panel 1, the infill plate started to separate from attached angle to the top beam. In addition, failure was begun in the fish-plate in the connections of the column base (Fig. 7e). In cycle 41, the infill plate of sub panel 1 was completely ruptured, and in 47.5 mm displacement, the interior column flange yielded at points corresponding to top and bottom edges of the openings.

Eventually, the test was terminated in cycle 41, with failure occurred in the columns base in 50.3 mm (5.2% drift) displacement and strength of 521 kN (Fig. 7d). The view of the specimen after termination of the test was shown in Fig. 7a.

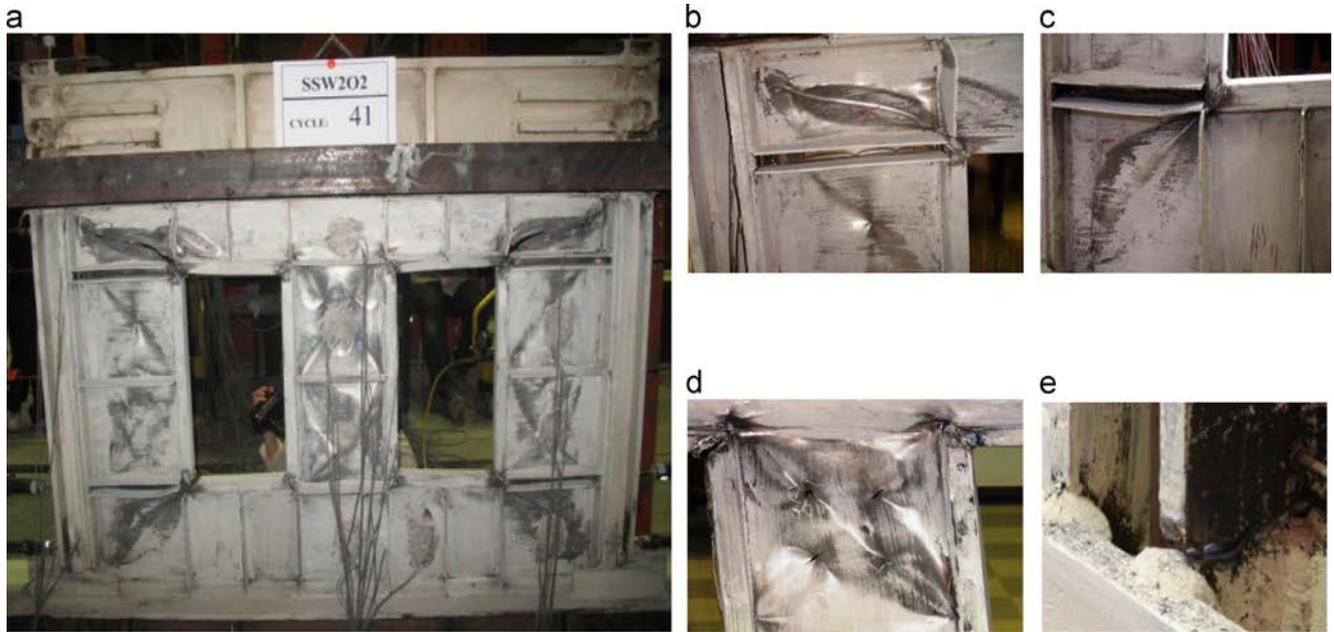
Fig. 8. Details of SSW202 specimen during test. (a) deformation of specimen at cycle 41, (b) plate buckling in subpanels 1,2,4 and vertical stiffeners, (c) plate buckling in subpanels 1,2,3 and vertical stiffener, (d) plate buckling and tearing in subpanel 6, and (e) failure in exterior flange at base column.

In cycle 22, exterior and interior column flange yielded at the top point in 10.9 mm displacement. Also in 12.8 mm displacement, exterior column flange yielded at the points corresponding to top opening edge. During cycle 23, the buckling wave was initiated in adjacent to the connection between two boxes in sub panel 1 and 8. The buckling wave was fully developed toward the angles connection, and it was caused the boxes connection begin to separate (Fig. 8c).

During cycle 25, failure was commenced in top corner of angles connection. In cycle 26, tearing was observed in middle of sub panel 7 and due to propagation of buckling wave in sub panel 1, rupturing was begun in the sub panel 2 (Fig. 8b). In this cycle, yielding of the infill plate was developed at the top and bottom edges of sub panels 6 and 7 adjacent to the boxes connection (Fig. 8d), and vertical stiffeners attached to the boxes connection buckled in sub panel 1 (Fig. 8b).

buckling happened in one of the two horizontal stiffeners attached to the bottom box (Fig. 8c). In cycle 34, the bottom angles connection was cracked, and interior column flange yielded at the top and bottom points corresponding to edges of the opening in 31.6 mm displacement. In cycles 35 and 37, failure occurred at the base columns (Fig. 8e).

In cycle 38, separation of the angles connection on the one hand, and separating of the boxes connection on the other hand, was led to rupture of the infill plate in sub panel 1 along the buckling wave. However, in sub panel 6, rupturing of the infill plate was continued from the boxes connection. Finally, the test was terminated in cycle 42 with the shear strength of 545 kN in 61.5 mm (6.3% drift) displacement. Fig. 8a shows the deformed SSW202 specimen after termination of test.

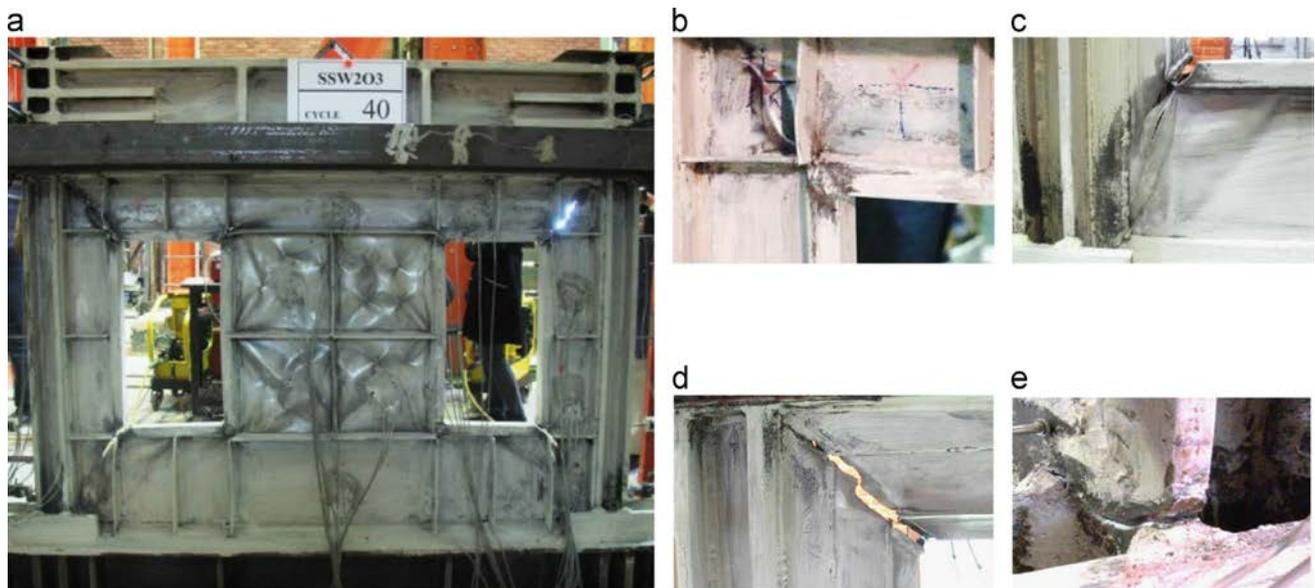
Fig. 9. Details of SSW203 specimen during test. (a) deformation of specimen at cycle 40, (b) plate buckling in subpanels 1 and vertical stiffener, (c) plate tearing in subpanel 7 and separation in boxes connections, (d) plate tearing in subpanel 1 and separation in boxes and angles connections, and (e) failure in exterior flange at base column.

During cycle 20, rupturing occurred in the angles connection in sub panel 1, also the boxes connection was cracked. In this cycle, sub panel 8 yielded in 10.8 mm displacement. In cycle 22, exterior column flange yielded at the point corresponding to bottom edge of opening. In next cycle, the infill plate was ruptured adjacent to the boxes connection in sub panel 5. In cycle 24, in 14.2 mm displacement, both of interior and exterior column flanges yielded at the points corresponding to top edge of opening. In cycle 25, the infill plate was locally ruptured in sub panels 5 and 6. In this cycle, top vertical stiffener attached to the boxes connection buckled adjacent to the column (Fig. 9b). In cycle 28, in

The specimen reached to ultimate shear strength of 624 kN in 27 mm (2.8% drift) displacement in cycle 30. In this cycle, boxes connection was completely separated in one of the openings (Fig. 9e). During cycle 33, one of the exterior column flanges failed at the base (Fig. 9c). In cycle 36, in 34 mm displacement, the interior column flange yielded at the base. In cycle 37, the column flange was completely ruptured at the base welding point, as the result the shear strength of specimen was significantly reduced.

In cycle 39, due to increase horizontal displacement, the infill plate in sub panel 1, was completely ruptured along the buckling wave adjacent to the angles connection (Fig. 9d). However, in sub panel 7, the rupture was stopped adjacent to the angle attached to the column (Fig. 9e). Finally, the test was terminated in cycle 40, in

45.8 mm (4.8% drift) displacement with the strength of 573 kN. Fig.9-a shows the deformed SSW203 specimen after termination of test.

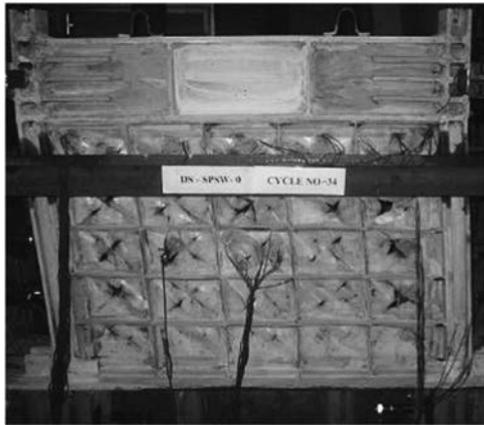
Fig. 10. Deformation of DS-SPSW-0% specimen at 6.44% drift.

specimen, the first steel plate tearing occurred as a very small tear in the middle of the one sub steel plates at 21.6 mm the story shear displacement (2.25% drift) and by increasing the story shear displacement, it was observed in the other sub plates. By increasing the story shear displacement, the tearing in the middle of the sub steel plates increased. No zipping happened between the steel plate and the surrounding frame in the specimen. The tearing gradually developed in the middle of the sub steel plates. In the end of the test, the steel plate shear strength decreased when the sub steel plates almost lost their continuity. The situation of the specimen at the end of the test is shown in Fig. 10.

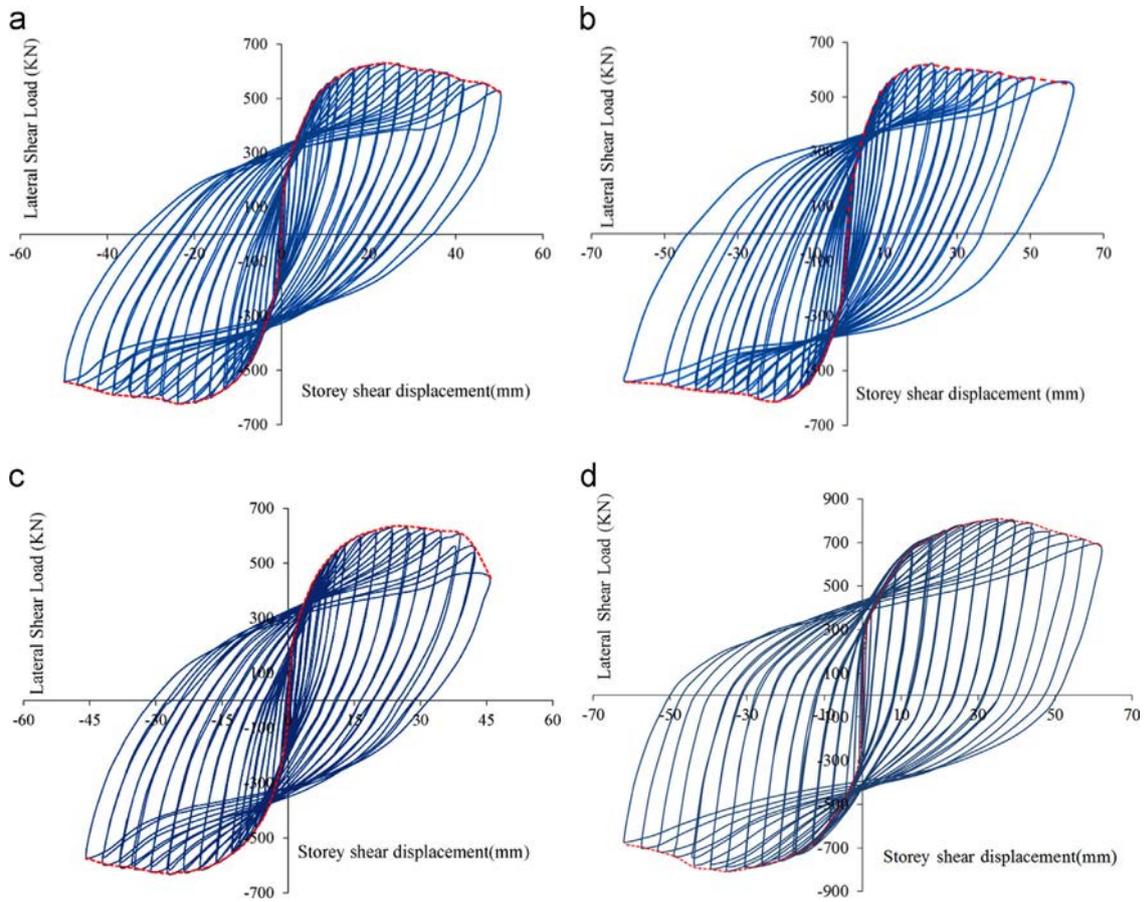
Fig. 11. Hysteresis and envelope curves of specimens. (a) SSW201, (b) SSW202, (c) SSW203, and (d) DS-SPSW-0%.

Hysteresis curves are created by applying cyclic loads to lateral load resisting systems as shown in Fig. 11. Hysteresis loops indicate the strength, stiffness and any kind of local or global instability of specimens. The cyclic tests showed that the specimens had spindle shape and stable hysteretic loops. The application of low yield strength steel in infill plate and high yield strength steel in the frame was caused the infill steel plate to be nonlinear in less shear displacement and improved the hysteresis loops in a sensible manner. In this situation, the columns as main vertical load bearing members, commonly remains safer. From comparison of the shape of loops corresponding to same drift, it was found that the tolerated load was greater in first cycle and was slightly lower in next loops because of residual strains and plastic deformations caused by first cycle.

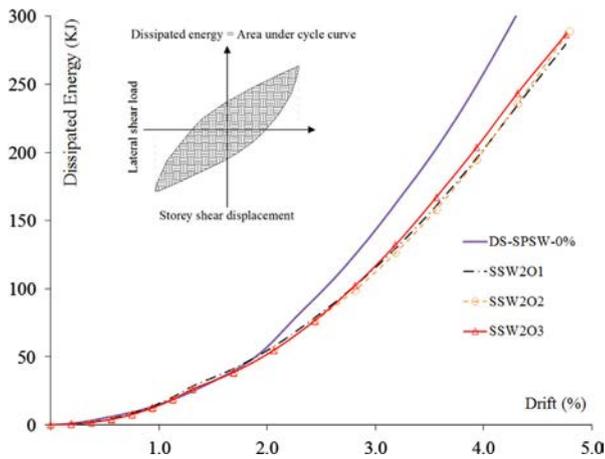
Fig. 12. Cumulative dissipated energy in the specimens.

One of the main properties of the hysteresis curve was its ability to calculation of energy dissipation. The dissipated energy in each loop was evaluated from the area surrounded in the loop. Fig. 12 shows the curves of the dissipated energy for the experimental specimens. The dissipated energy of the perforated specimens is relatively the same as shown in Fig. 12. The dissipated energy of the perforated specimens is similar to unperforated

specimens until 2% drift, whereas the energy absorption of this specimen was increased significantly with increment of drift. The loss of energy absorption in perforated specimens was due to the failure occurred at the corners of the openings that continued along the edge of the columns.

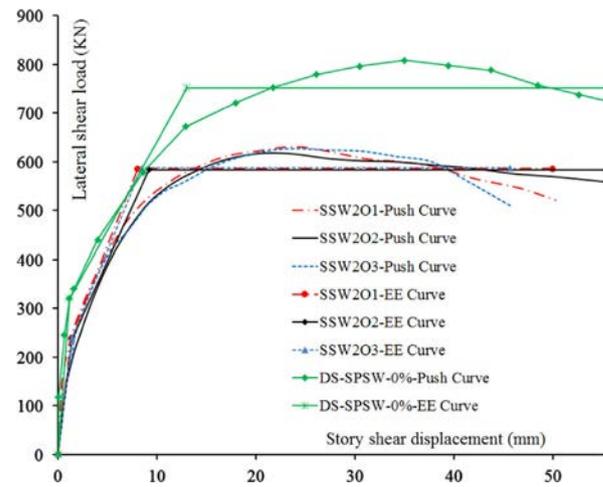
Fig. 13. Tri-linear EE and hysteresis envelope curves of specimens.

The hysteresis envelope curves of the specimens including the tri-linear EE curves were presented in Fig. 13. The ultimate shear strength and initial shear stiffness of Fig. 13 are given in Table 3. The values of ultimate shear strength and initial shear stiffness

Fig. 13 shows that the shear strength of the surrounding frame, which was caused by the formation of plastic hinges in column, was the same for all of three specimens. It is indicated that distance between the openings and the columns did not have an important influence on location of plastic hinges on the column flanges and, consequently, on the ultimate shear strength of the column.
