The Bam (Iran) Earthquake of December 26, 2003: Preliminary Reconnaissance Using Remotely Sensed Data and the VIEWS (Visualizing the Impacts of Earthquakes with Satellite Images) System

**Beverley J. Adams, Charles K. Huyck, Michael Mio, Sungbin Cho, Shubharoop Ghosh,
Hung Chi Chung and Ronald T. Eguchi, ImageCat, Inc. (www.imagecatinc.com)**

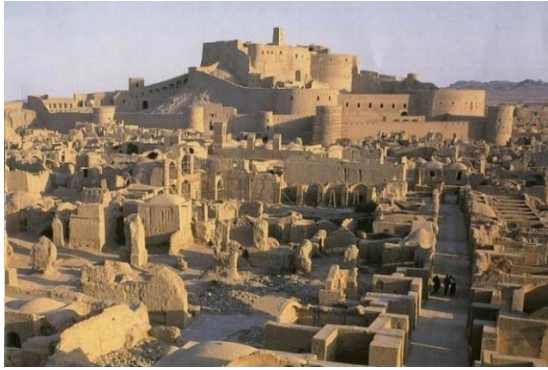
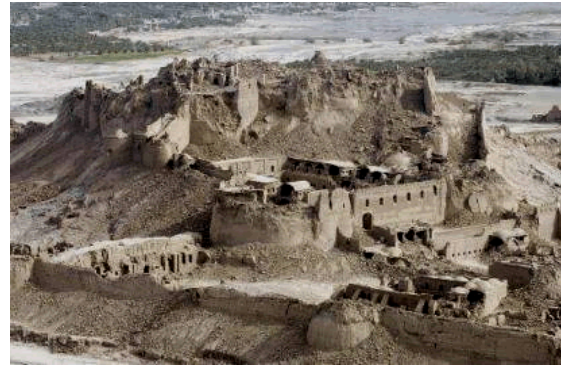
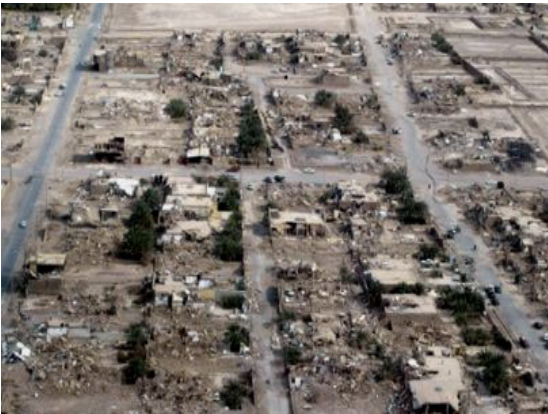
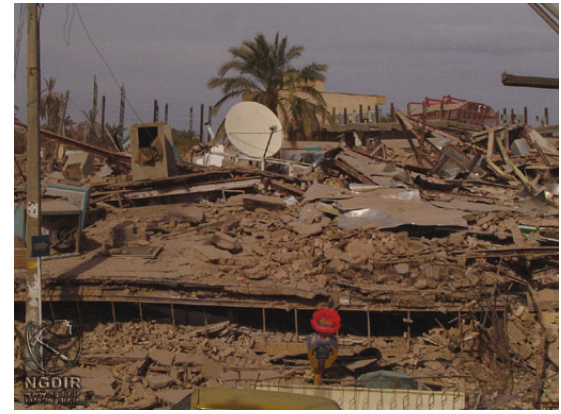
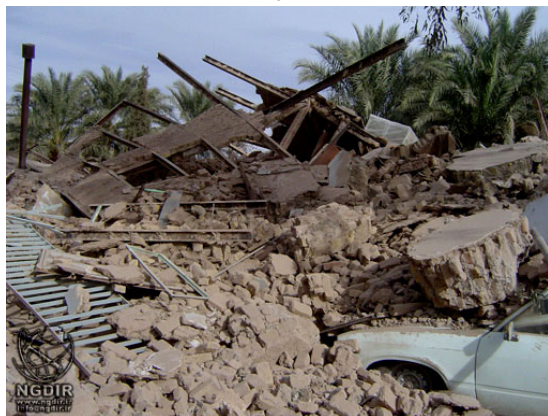
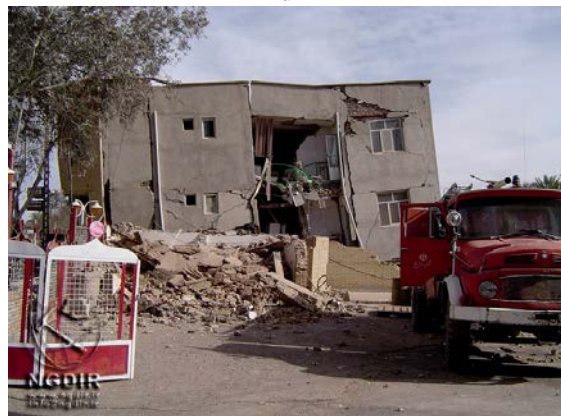
Figure 2 Photo mosaic of the Bam Citadel and surrounding urban districts. (a) The Citadel before the earthquake struck; (b) the Citadel after the December 26, 2003 earthquake; (c) residential city blocks razed by the earthquake; (d) mud-brick houses reduced to rubble; (e) sand-colored building debris smothered victims and crushed cars; (f) the 10% of structures still standing recorded 40-60% structural damage. (Photographs courtesy of <http://activistchat.com/gallery/albums.php>)

Damage was concentrated in a relatively small area, of roughly 16km radius, around Bam - a tourist destination on the old Silk Road, famed for its 2,500-year old citadel Arg-e-Bam (Figure 2a). According to recent reports, the death toll has reached 41,000 (IFRC, 2004c), with a final expected figure closer to 45,000. The Government of Iran estimates that a further 45,000 people have been displaced from their homes (USAID, 2004), which may rise to 75,000 as residents staying elsewhere with friends and relatives, begin to return.

A United Nations damage assessment team estimated that 90% of buildings in Bam sustained 60-100% damage (WFP, 2003) - some 25,000 of the 29,500 structures within the city center and surrounding villages (UN, 2004). The remaining 10% of building stock recorded 40-60% damage. Figure 2b through Figure 2f illustrate the nature and extent of damage: annihilation across entire city blocks; the historic city center and fortress in ruins; the main hospitals effectively destroyed, together with 94 health homes, 14 rural and 10 urban health centers; and 131 schools and 3 universities severely damaged (IFRC, 2004b).

According to field reports, up to 95% of buildings collapsed within the ancient Bam citadel. From Figure 6, the eastern wall of the fortress has collapsed (see also Figure 2b). Surrounding dwellings that were clearly defined in the before scene are replaced by indistinct piles of debris, where their walls and roofs have collapsed.

Within residential districts of Bam (Figure 7), entire blocks of family homes have been destroyed. Their distinct footprint and white roof in the before image, is replaced by chaotic piles of brown rubble (see also Figure 2c through Figure 2e). With buildings constructed from local materials, the sand-colored debris is difficult to distinguish from the sandy ground surface.

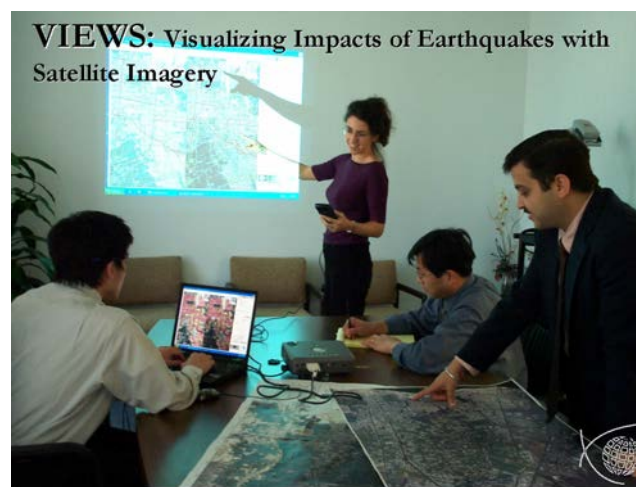
Figure 3 The VIEWS (Visualizing the Impacts of Earthquakes using Remote Sensing Images) system being tested prior to deployment in Bam with the EERI reconnaissance team.

Running on a notebook computer for portability in the field (Figure 3), VIEWS enables reconnaissance teams to compare satellite images acquired before and after an earthquake. The system directs responders to the hardest hit areas, using a preliminary regional damage assessment (Adams *et al.*, 2003b). For more detailed damage information, collapsed buildings are easily identified on the high-resolution satellite coverage.

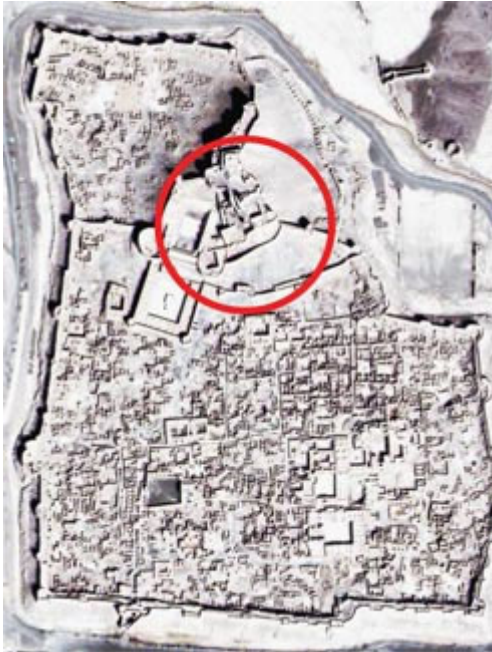
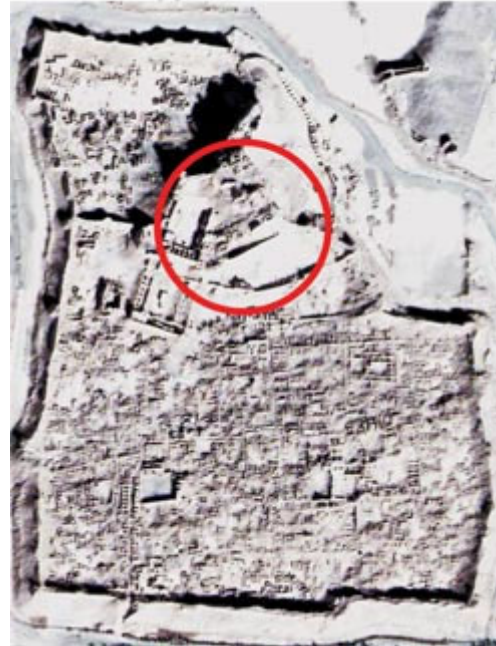
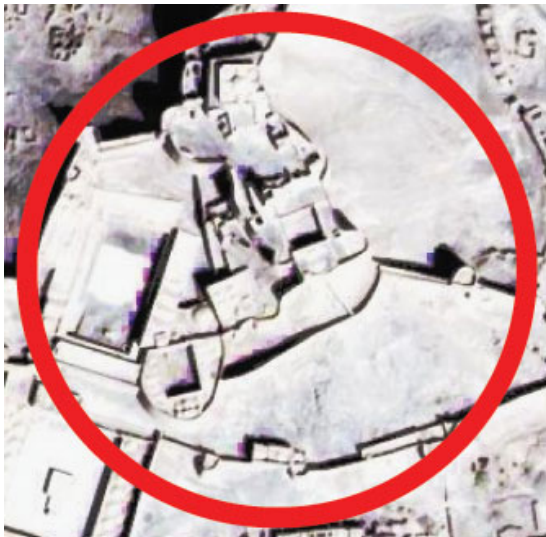
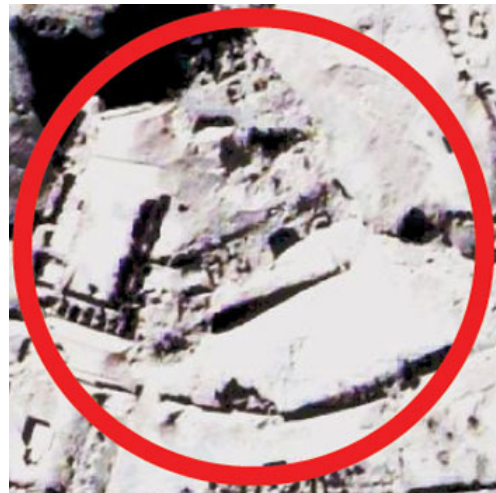
Figure 6 Visual comparison of (a) before and (b) after QuickBird satellite imagery reveals widespread devastation within the Bam citadel. Reports indicate that the December 26th 2003 earthquake destroyed the main fortress (see annotation), together with 95% of surrounding buildings. Imagery courtesy of DigitalGlobe, www.digitalglobe.com.

Figure 6 and Figure 7 provide a close-up view of damage within selected areas where the regional damage assessment recorded extreme changes. Identifying and visualizing building collapse in this way could guide search and rescue teams to the probable location of trapped victims.

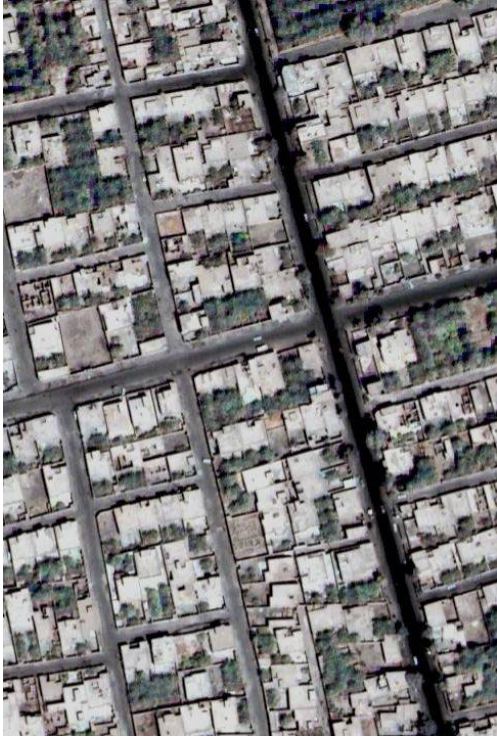
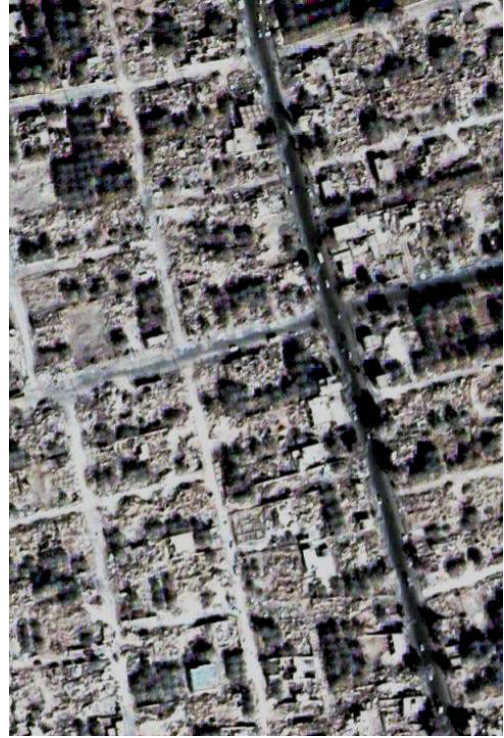
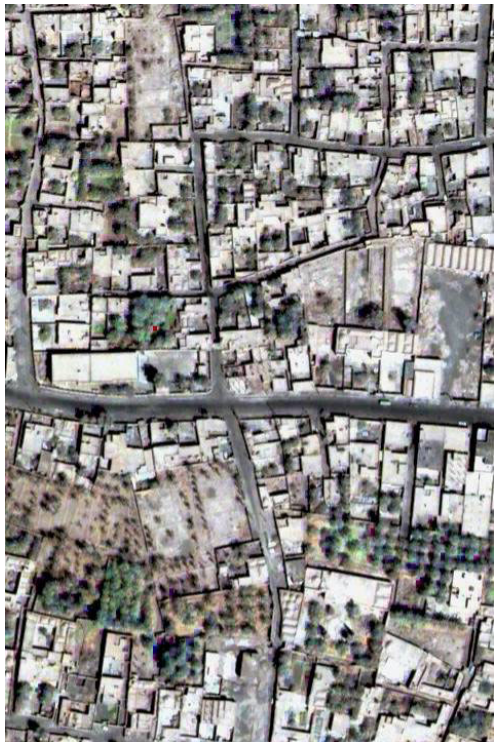
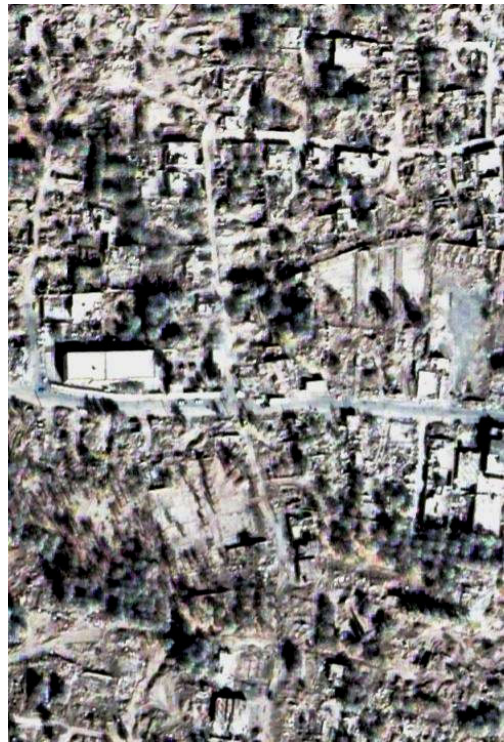
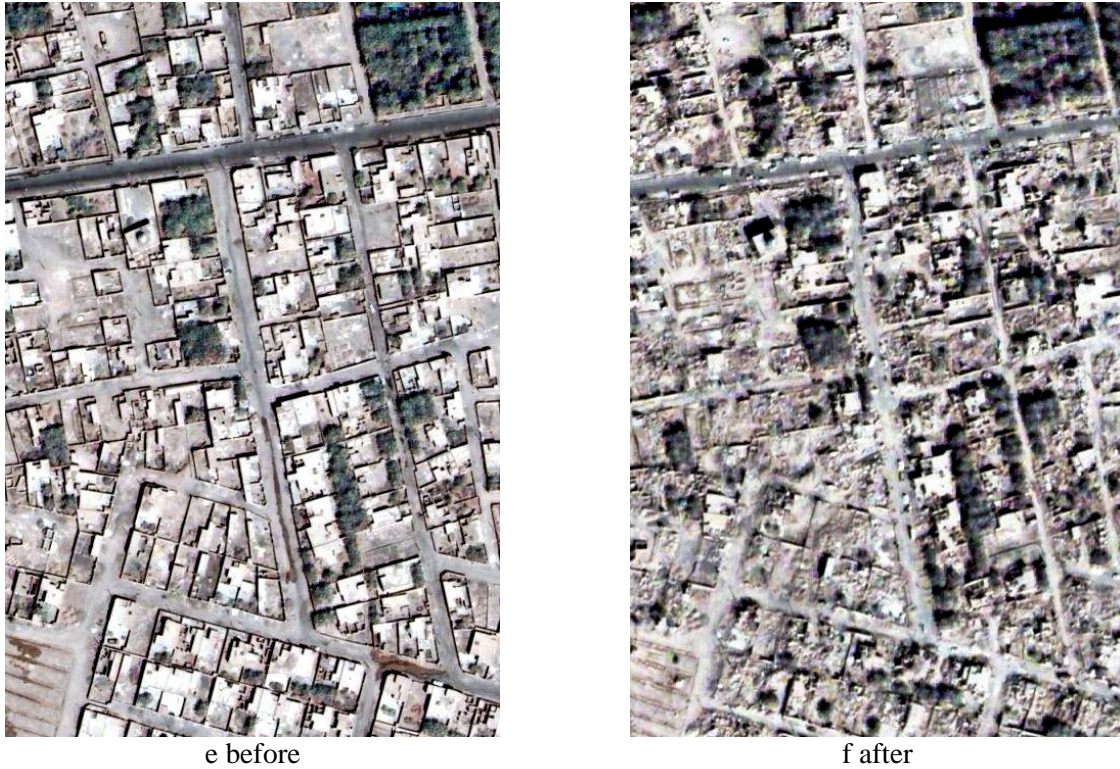
Figure 7 Building damage within eastern residential districts of Bam, visualized by comparing the ‘before’ and ‘after’ QuickBird satellite imagery. Imagery courtesy of DigitalGlobe, www.digitalglobe.com.
