Performance Evaluation of Different Masonry Infill Walls with Structural Fuse Elements Based on In-Plane Cyclic Load Testing

Andrew Kauffman ¹ and Ali M. Memari ^{2,*}

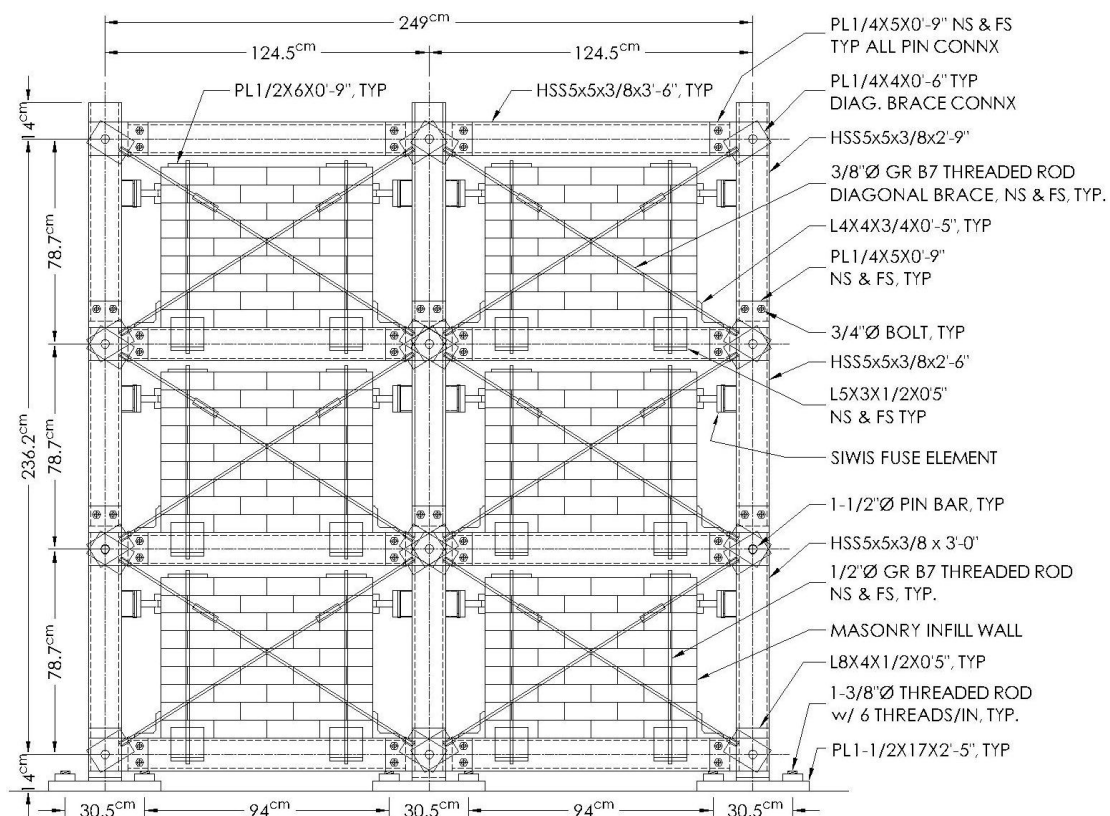
Figure 1. 1/4 scale, two-bay, three-story steel test frame.

Both series of tests were performed on the 1/4 scale, two-bay, three-story steel test frame shown in Figures 1 and 2, respectively. The test frame shown in Figure 1 consists of HSS 127 mm × 127 mm × 9.5 mm (5 × 5 × 3/8 in.) hollow structural steel members pin connected using 38.1 mm diameter steel bars to allow for adequate floor movements during racking and to enable the study of the system in a braced (stiff) and partially braced (flexible) configuration. The masonry infill wall specimens were supported by the bottom beam of each bay of the test frame with a 152.5 mm gap between the sides of the walls and the HSS columns, and a gap of between 38.1 mm and 60.3 mm between the top of the walls and the upper beam. Steel angles were welded to the top of the support beams on either side of the infill panels to prevent the base of the walls from sliding in the in-plane direction. Out-of-plane movement at the bottom of the infill panels was prevented by steel angles welded to the sides of the HSS beams. In order to prevent overturning of the infill panels, steel plates were secured to the top of the walls using 12.7 mm diameter threaded rods bolted to the outstanding legs of these angles.

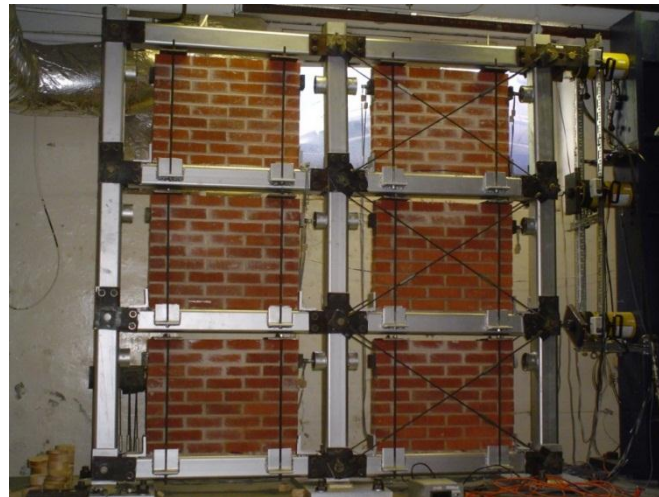
Figure 2. Concrete test platform and steel reaction frame.

During the structural fuse system tests, lateral loads were applied to the test frame at each story level using hydraulic cylinders attached to the steel reaction frame shown in Figure 2. The in-plane lateral loads were transferred from the steel test frame to the masonry infill walls through the fuse mechanism shown in Figure 5. As shown in this figure, the 100 mm diameter, lumber disk fuse elements were held in place by a steel seat disk and pipe assembly welded to the HSS columns near the top of the infill panels. The fuse punching mechanism consisted of a 22.4 mm diameter, half-threaded steel rod attached to a steel bearing plate which was epoxied to the infill panels. The lumber disk fuse elements used in the cyclic and parametric testing programs were cut from hard maple boards. Lumber disk puncture tests were performed to evaluate the strength of the fuse elements and determine the appropriate disk thickness to use with each type of masonry infill material [29]. The results of the initial series of lumber

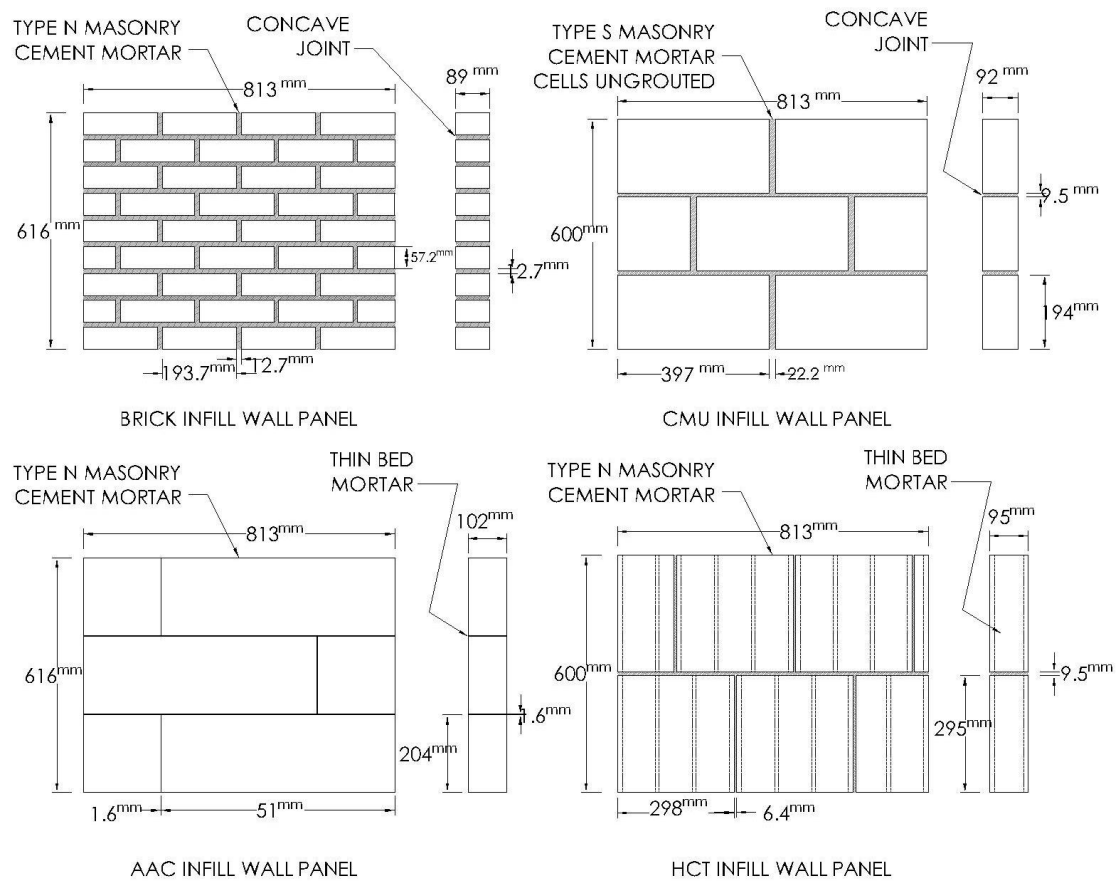
Figure 3. Masonry infill wall specimens.

The masonry infill walls used in the cyclic and parametric tests were constructed in the BCERL test facility by professional masons. Destructive shear tests were performed to determine the in-plane shear strength of each type of masonry wall panel. The brick, CMU, AAC, and hollow clay tile (HCT) infill wall specimens used for this testing program are shown in Figure 3. The brick wall panels were used for the cyclic tests, while the CMU and AAC specimens were used for the parametric study. The HCT infill wall specimens were included in the destructive shear tests, but not used in the structural fuse system tests due to their low in-plane shear capacity. The set-up for the destructive shear tests is shown in Figure 4. The results of these tests are given in Table 1.

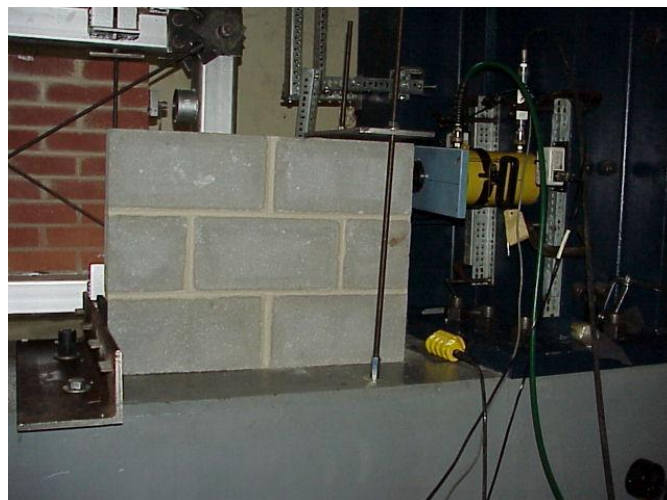
Figure 4. In-plane, destructive shear test set-up.

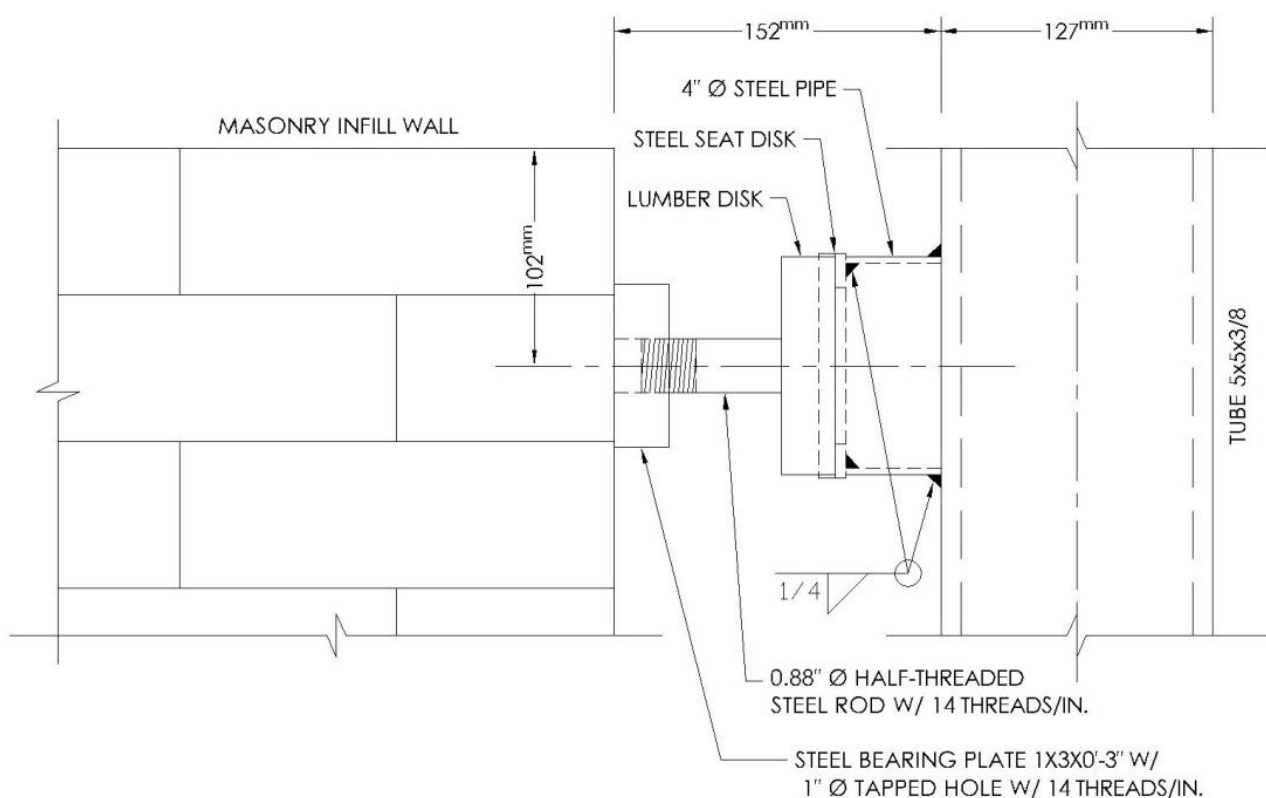
Figure 5. Fuse mechanism detail.

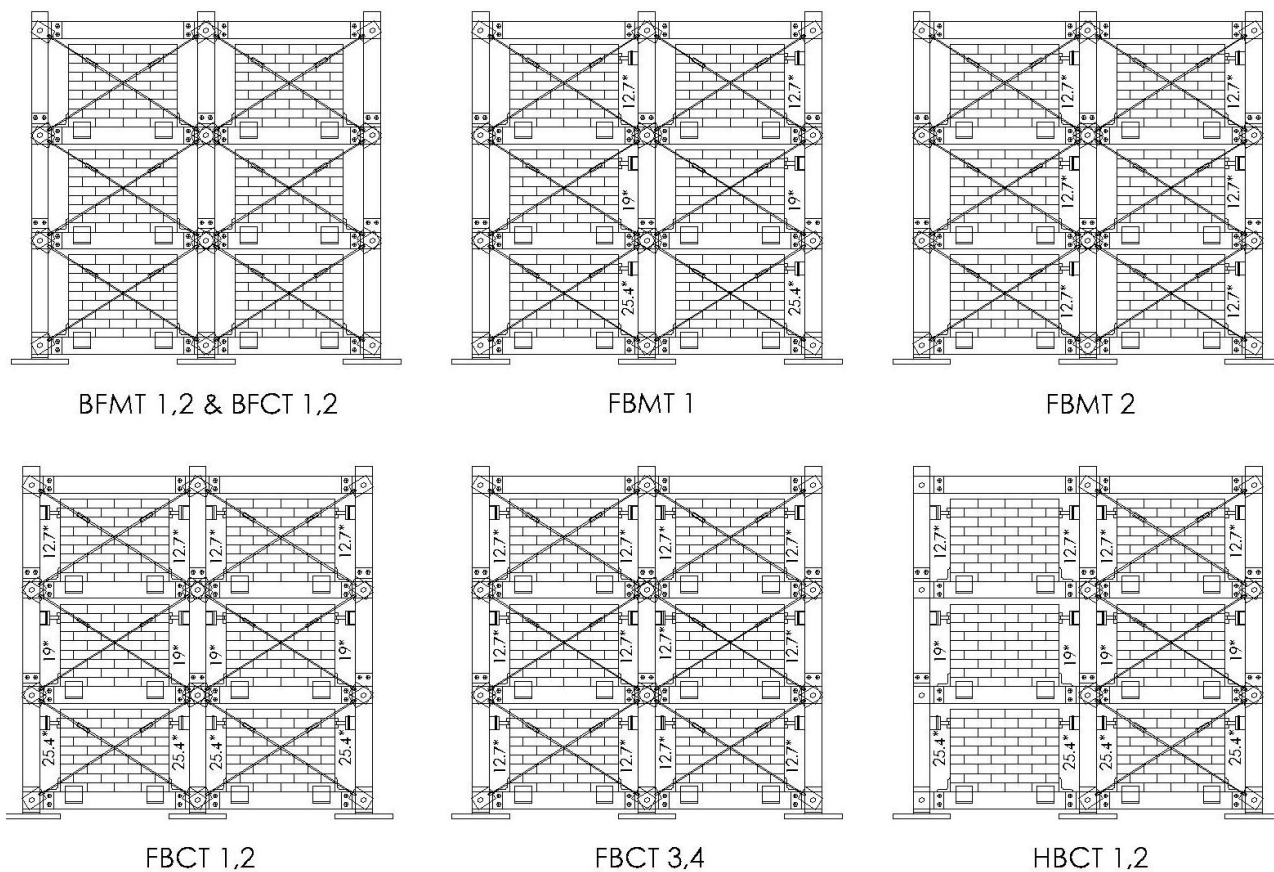
Figure 6. Test frame configurations for cyclic test program.

For the cyclic testing program, quasi-static, displacement-controlled loads were applied simultaneously at the first, second and third story levels using three hydraulic jacks. Two different bracing configurations were tested, including full-brace and half-brace, in order to observe the performance of the structural fuse system for frames with different in-plane stiffness properties. The fuse element thicknesses were also varied. For some of the tests, the same fuse element thickness was used at each story level. For other tests, a different fuse element thickness was used at each story level. A test matrix of the cyclic testing program is given in Table 3. As the table indicates, the test specimen included bare frame, full brace, and half brace configurations. Diagrams of each test configuration are shown in

Figure 6. Figure 7 shows the location of the fuse elements on the steel test frame during the cyclic tests. The data collected during the cyclic tests included the load applied to the test frame by the hydraulic cylinders, the in-plane deflection of the test frame at each story level, and the shear forces transferred from the test frame to the brick infill walls through the structural fuse elements.

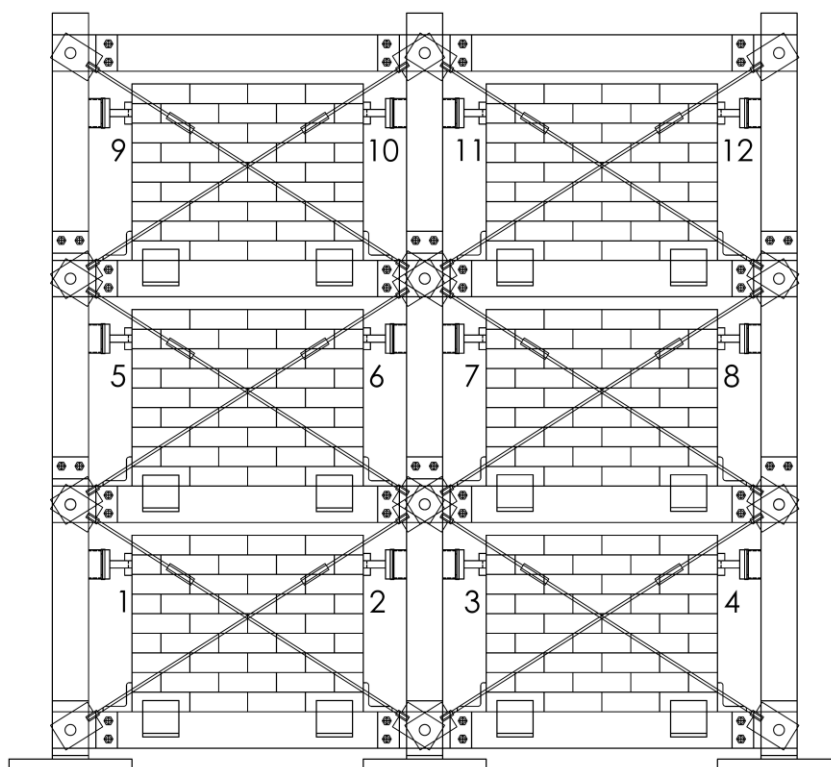
Figure 7. Fuse element locations on test frame.

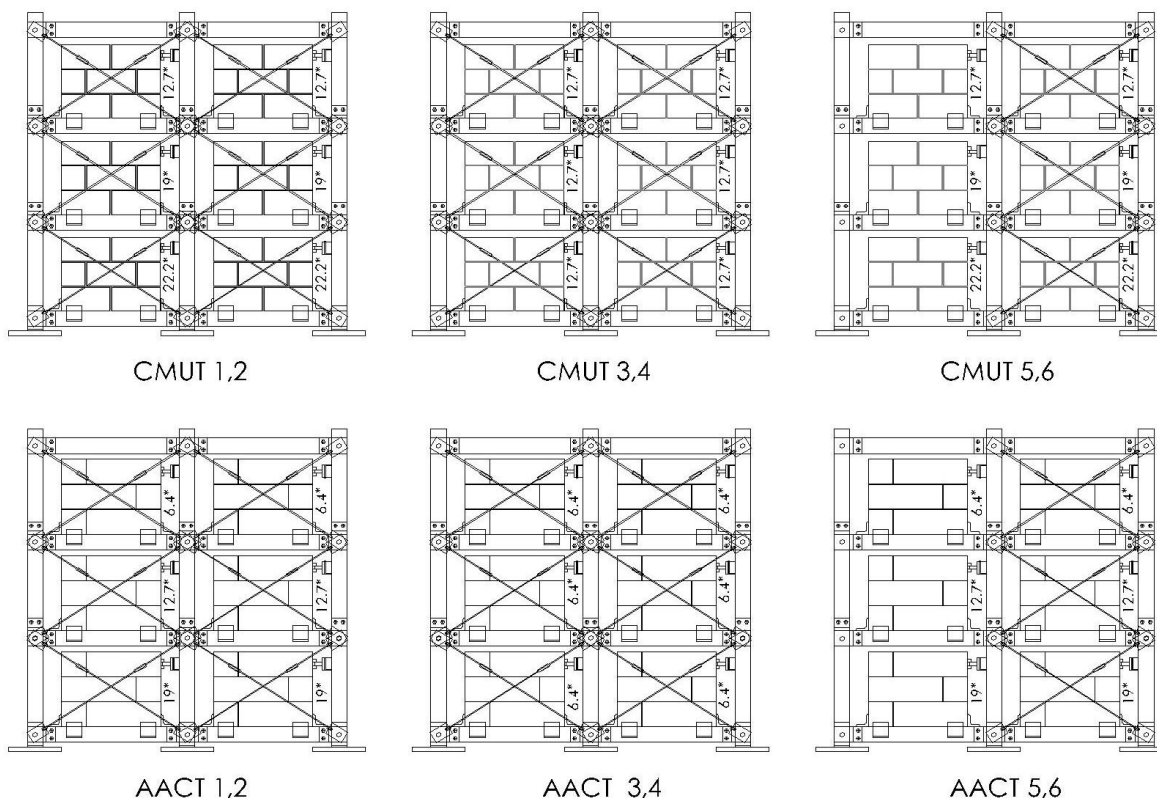
Figure 8. Test frame configurations for parametric testing program.

For the parametric tests, monotonic loads were applied at the third story of the test frame using one hydraulic cylinder. As with the cyclic tests, varying fuse element thicknesses and bracing configurations were tested. A test matrix for the parametric test series is given in Table 4. Figure 8 shows typical elevations of the fully braced and half braced specimens. The data collected during these tests included the load applied at the third story level of the test frame by the hydraulic cylinder, and the in-plane deflection of the test frame at each story level.

level 2, and 12.7 mm disks at level 3. For tests CMUT3 and CMUT4, 12.7 mm disks were used at all of the fuse element locations, as shown in Figure 8. As with the monotonic tests performed in the previous study [28], two different bracing configurations were considered in this testing program. The full-brace configuration was used during tests CMUT1–CMUT4, while the half-brace set-up was used for tests CMUT5 and CMUT6.

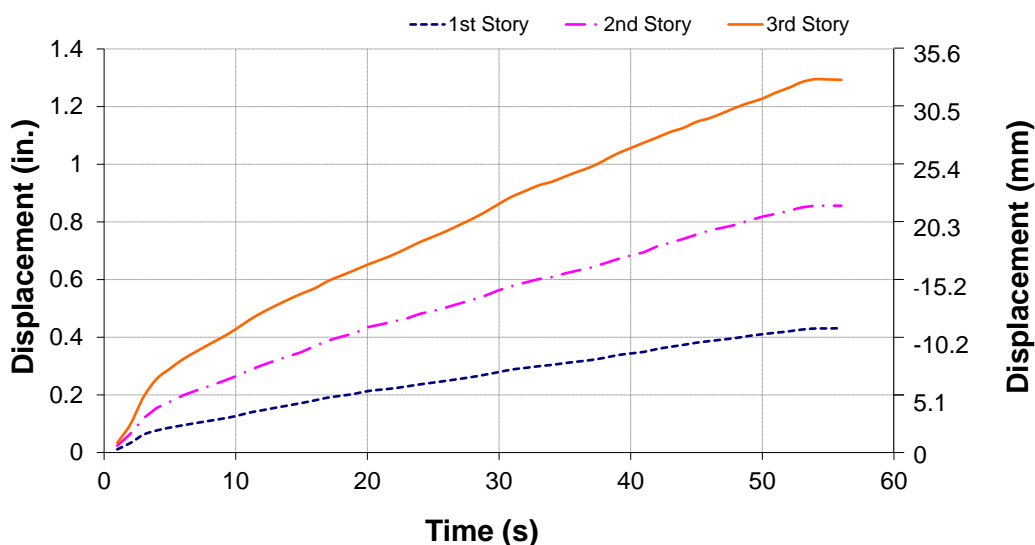
Figure 9. Bare frame cyclic test 2 (BFMT2) displacement history.

At the beginning of the cyclic testing program, bare frame monotonic tests were performed without fuse elements, so that the test frame could act independently from the infill walls. The full bracing configuration was used with all the diagonal bracing rods in place. The goal of these tests was to simulate a first mode, inverted triangle test frame displacement shape by applying simultaneous, displacement controlled loads at each story level using three hydraulic cylinders. According to Tomazevic and Klemenc [30], the dominant mode shape for masonry structures is typically the first mode response, which is characterized by an inverted triangle shape. The story displacement histories from BFMT2 (bare frame monotonic test 2), given in Figure 9, show that the displacements applied at each story level during this test resulted in an inverted triangle displacement shape of the test frame. During both bare frame monotonic tests, the force applied by the cylinder at the third story of the test frame was much greater than the load applied at the first and second story levels. For both of these tests, the maximum force applied at the third story level was between 10,680 N and 11,120 N, while the max force applied at the second and first story levels was less than 890 N. Since the geometry and stiffness of the bracing members was the same at each story level, the frame naturally assumed an inverted triangle deflection shape, and very little load needed to be applied at the first and second story levels to maintain this mode shape.

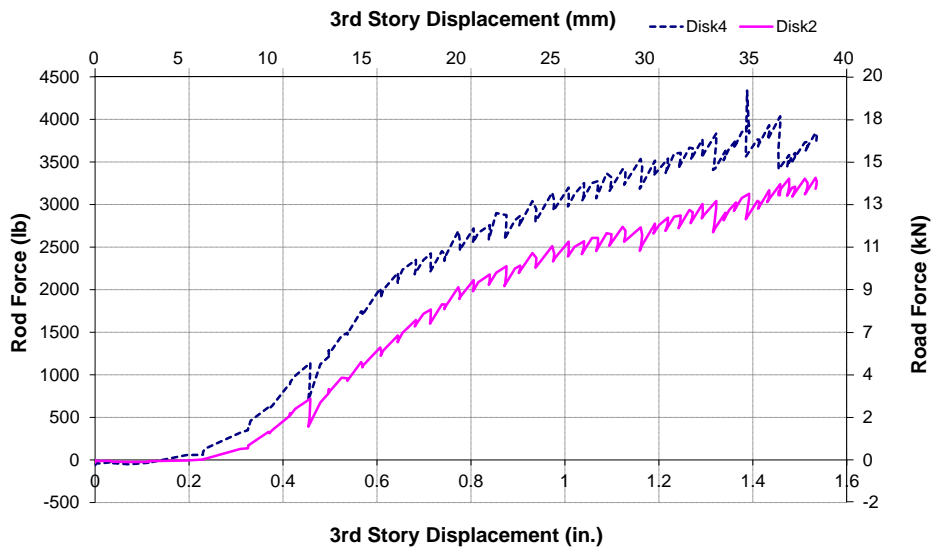
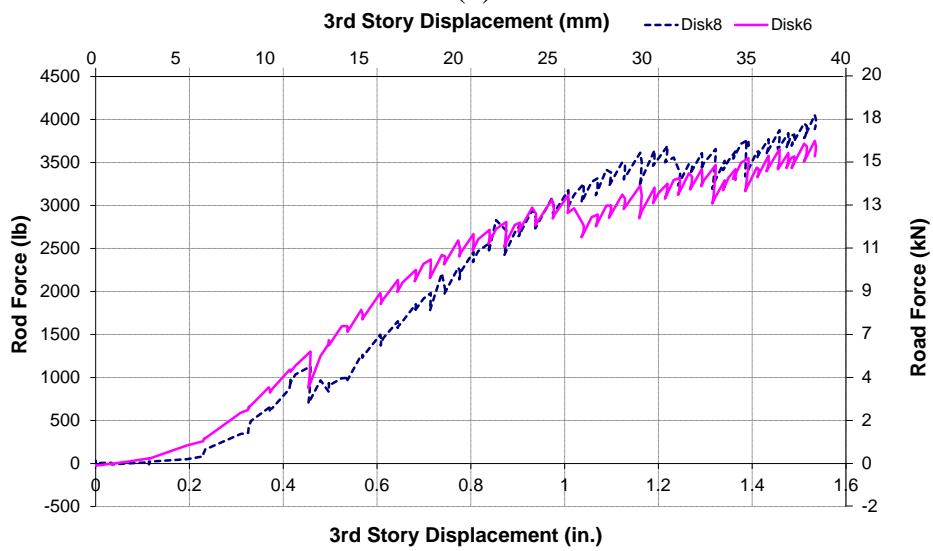
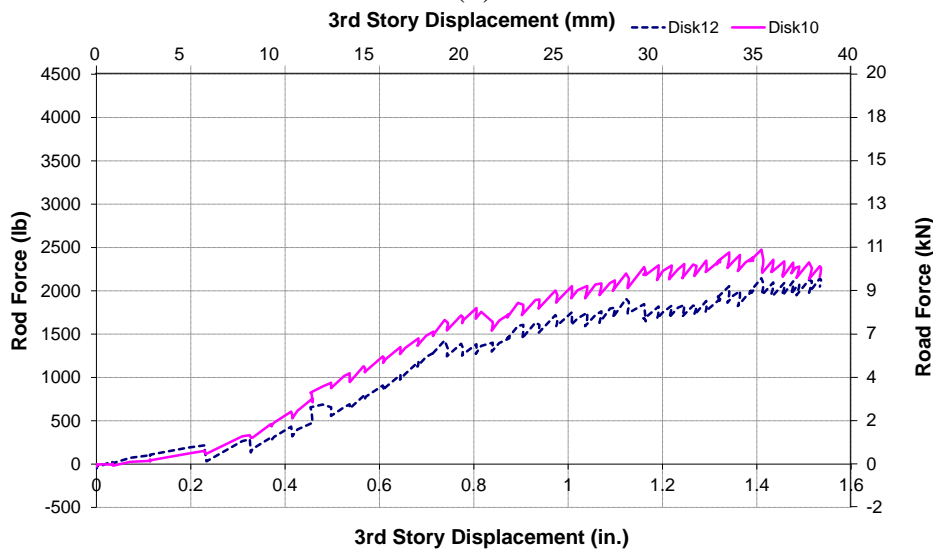
Figure 10. Test FBMT1 punching rod force histories. (a) FBMT1 1st story rod histories; (b) FBMT1 2nd story rod histories; (c) FBMT1 3rd story rod histories.

During both of the full brace monotonic tests, the desired story level displacement ratios were maintained resulting in an inverted triangle displacement shape of the test frame. As with the bare frame monotonic tests, the force applied by the hydraulic cylinder at the third story level was greater than the force applied by the cylinders at the first and second levels. The maximum punching rod forces measured at each disk location during both tests are given in Table 5. Plots of the force in the steel rod at each fuse element location vs. the third story frame deflection for test FBMT1 are given in Figure 10.

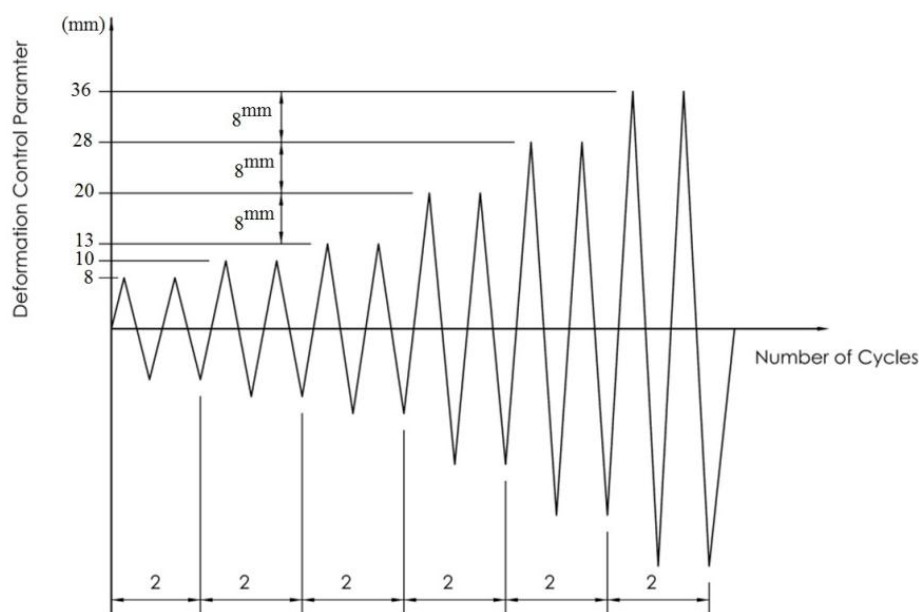
Figure 11. Quasi-static cyclic loading history.

During tests FBMT1 and FBMT2, the first fuse element cracking occurred at a third story displacement of between 7.6 mm and 12.7 mm. Based on these results, the value δ_y for the quasi-static loading protocol was set equal to a third story test frame displacement level of 12.7 mm. The upper bound of the third story displacement corresponding to fuse element crack initiation was chosen based on the loading protocol guidelines [32] that at least two load steps be performed before the deformation applied to the test specimen reaches δ_y . In order to prevent damage to the steel bracing rods, the maximum third story displacement level applied to the test frame during the cyclic tests was 35.6 mm. To allow for the maximum number of steps in the cyclic loading history, a third story displacement increment of 7.6 mm was chosen for the increment in peak deformation between load steps. A total of two load cycles were performed during each load step. The quasi-static loading protocol used for the cyclic tests is shown in Figure 11.

directions (advance and retract) based on the quasi-static loading protocol shown in Figure 11. The load applied at each story was controlled manually using a separate hydraulic pump attached to each of the load cylinders. The story level displacement histories for test BFCT1 (bare frame cyclic test 1) are shown in Figure 12. The story level load histories for test BFCT1 are shown in Figure 13. The load-displacement, hysteretic behavior at the first, second, and third story levels of the test frame during test BFCT1 is shown in Figure 14. In these figures the load applied at each story of the test frame is plotted vs. the displacement measured at that story. The hysteretic plots are fairly symmetrical at story levels two and three for both of the bare frame cyclic tests. This indicates that the work done by the hydraulic cylinders on the test frame at these story levels was similar in both in-plane directions of the load cycle. At the first story level, however, the work done by the cylinders on the test frame was not symmetrical with respect to the direction of the applied load.

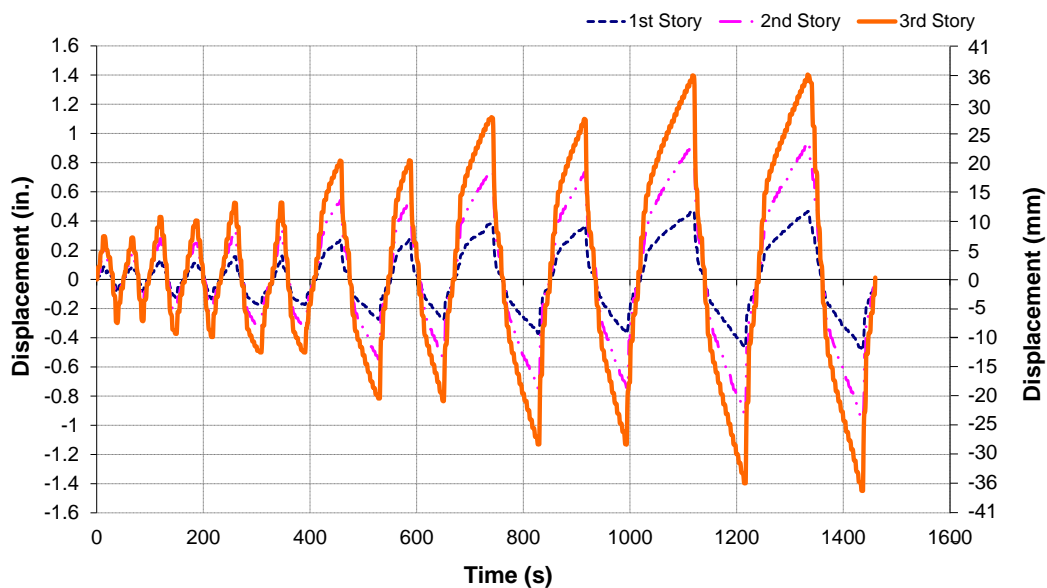
Figure 12. Bare frame cyclic test BFCT1 displacement history.

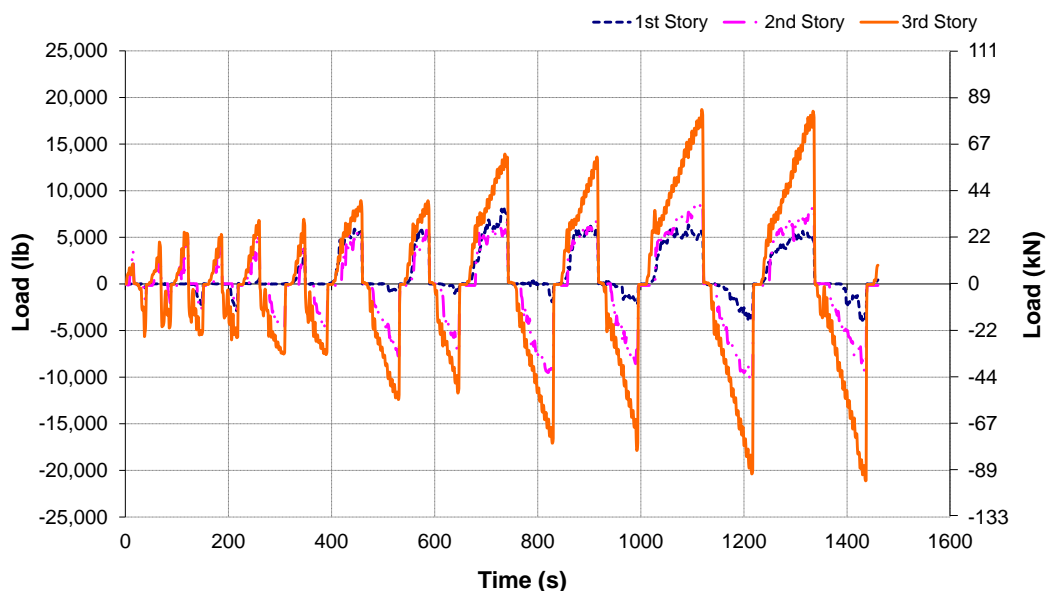
Figure 13. Bare frame cyclic test BFCT1 load history.

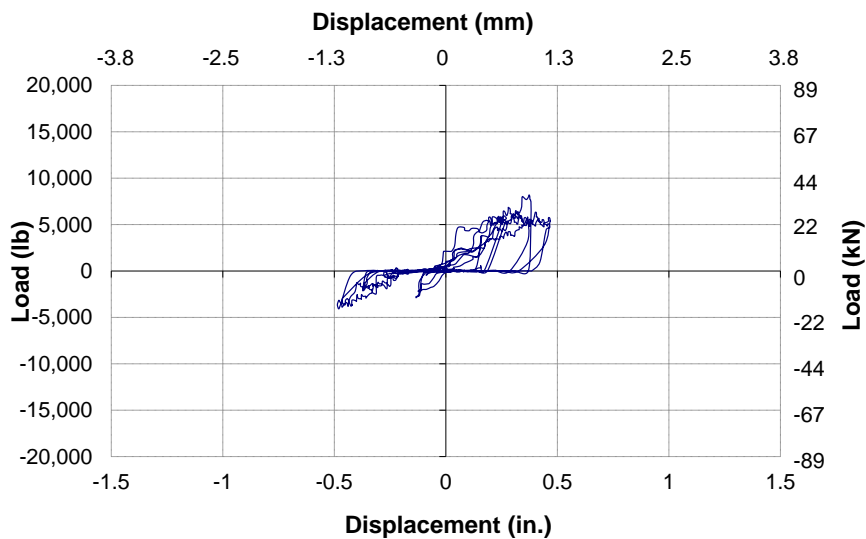
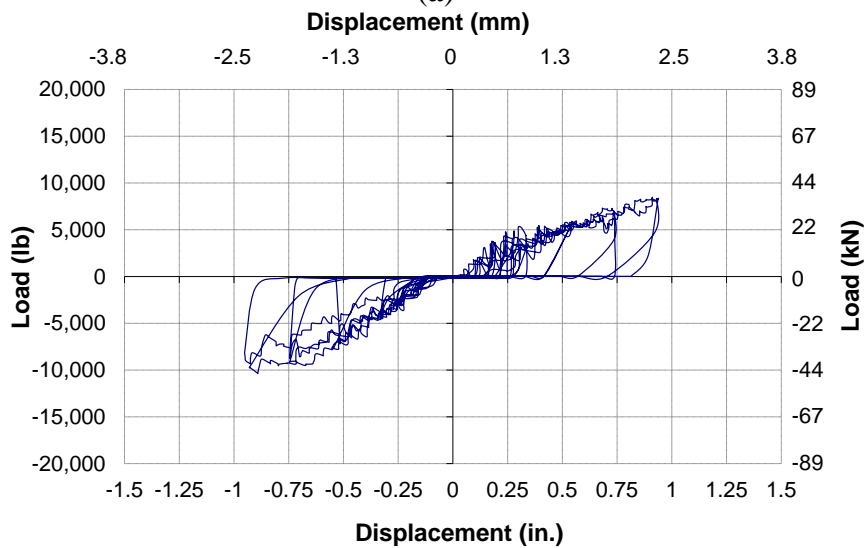
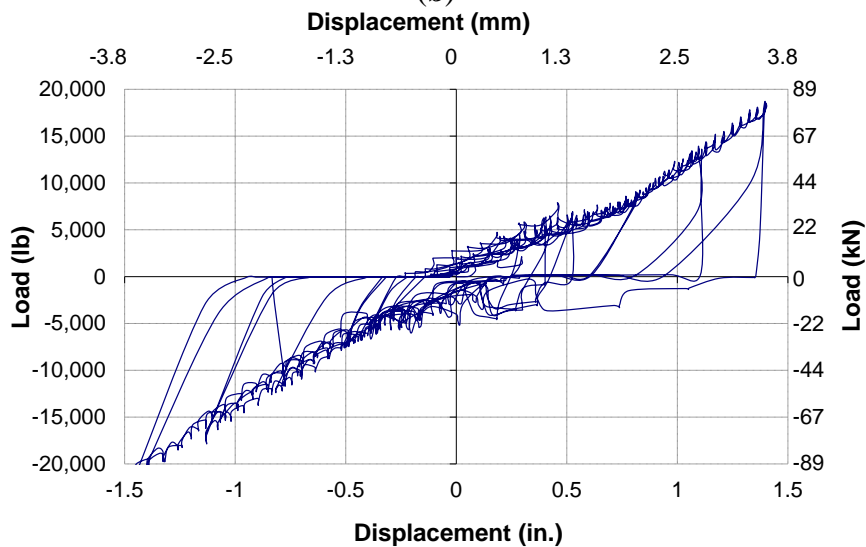
Figure 14. Test BFCT1 load-deflection hysteretic behavior. (a) BFCT1 1st story hysteretic behavior; (b) BFCT1 2nd story hysteretic behavior; (c) BFCT1 3rd story hysteretic behavior.

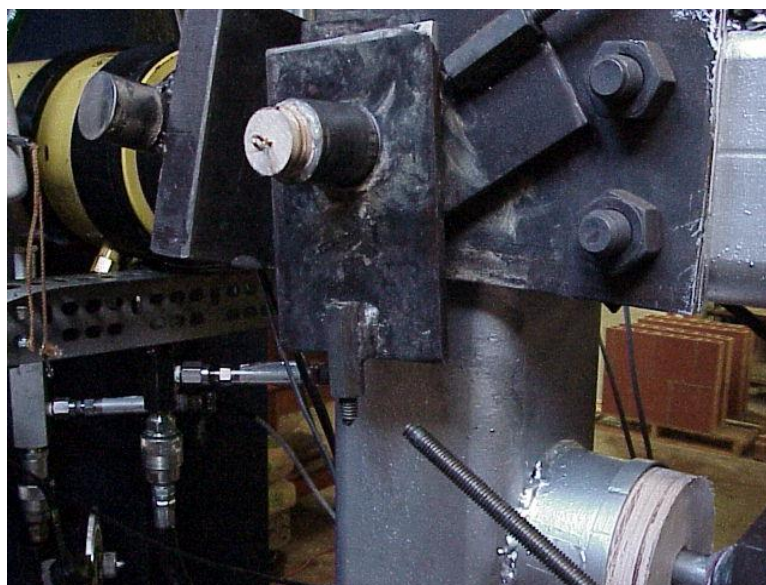
Figure 15. Typical bracing rod failure.

Diagonal bracing rod failures occurred during the final load step of tests FBCT1, FBCT2, and FBCT4. The failures occurred at the ends of the braces near the connection, as shown in Figure 15. Based on the results of rod tension tests performed by Aliaari [19], the bracing rods reach their yield point at a tensile load of around 31.6 kN and have an ultimate capacity of around 37.8 kN. The average total in-plane load applied to the test frame in either direction during both cycles of the final load step was around 141.9 kN. Depending on the proportion of the total in-plane load transferred to the infill walls by the fuse elements during this final load step, the force experienced by the bracing rods at the first story level of the test frame was between 31.1 kN and 35.6 kN. According to this data, the bracing rods were near or at their yield point during the final load step of the cyclic tests.

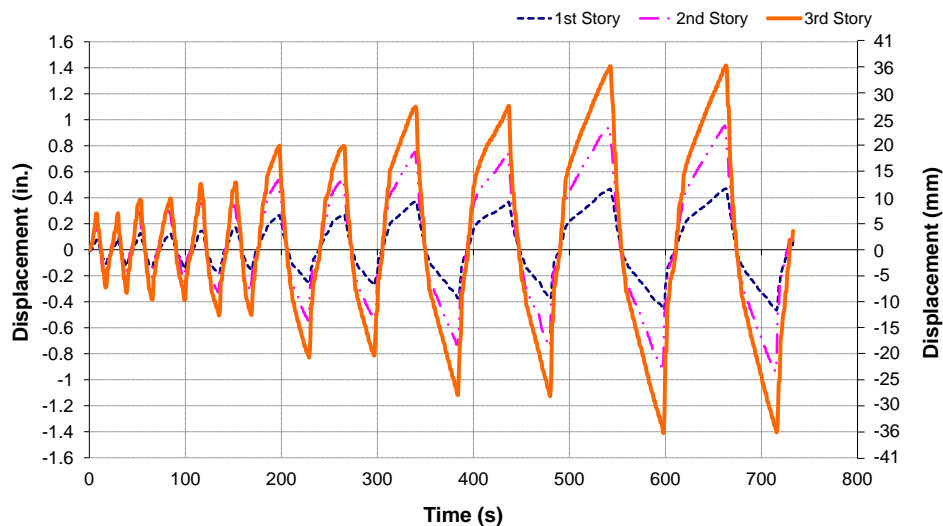
Figure 16. Full brace cyclic test FBCT2 displacement history.

The displacement histories for full brace cyclic tests for tests FBCT2 and FBCT4 are shown in Figures 16 and 17, respectively. The target quasi-static loading protocol was followed closely throughout the full brace cyclic tests. The load histories for tests FBCT2 and FBCT4 are shown in Figures 18 and 19, respectively. Comparison of Figures 16–19 with Figures 12 and 13 shows the effect of the infills on the bare frame including full brace. The load behavior during these tests was not very similar in the forward and retract portions of the load cycles. This was particularly true at the first and second stories of the test frame. Since these tests were displacement controlled, load was applied at these stories only as needed to maintain the desired displacement shape of the test frame. As with the bare frame cyclic tests, the load applied at the third story of the test frame in either displacement direction was typically higher than the loads at the first and second stories, however, a greater proportion of the total in-plane load was applied at the first and second stories of the test frame during the cyclic tests. The quasi-static loading protocol used for the cyclic tests resulted in greater loads at the first and second stories of the tests frame. This may be due to the cyclic deformation behavior of the lumber disk fuse elements after repeated cycles of damage.

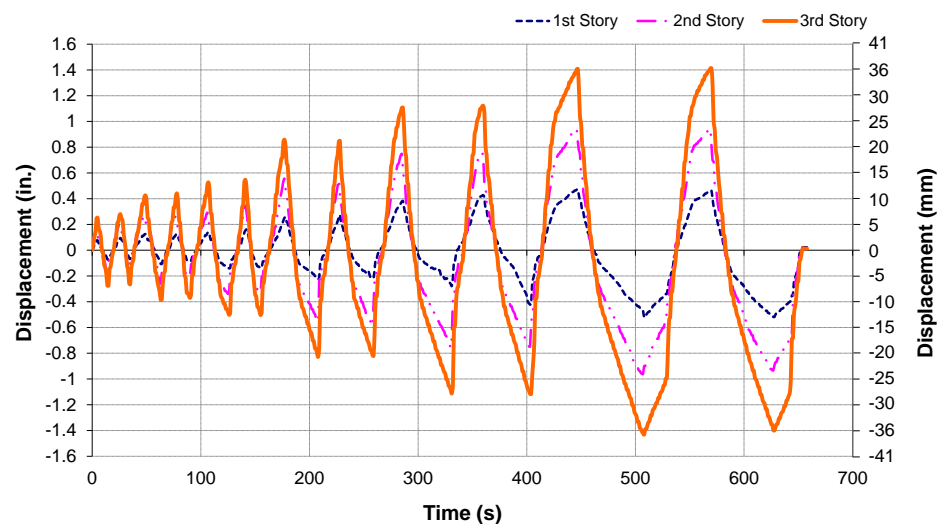
Figure 17. Full brace cyclic test FBCT4 displacement history.

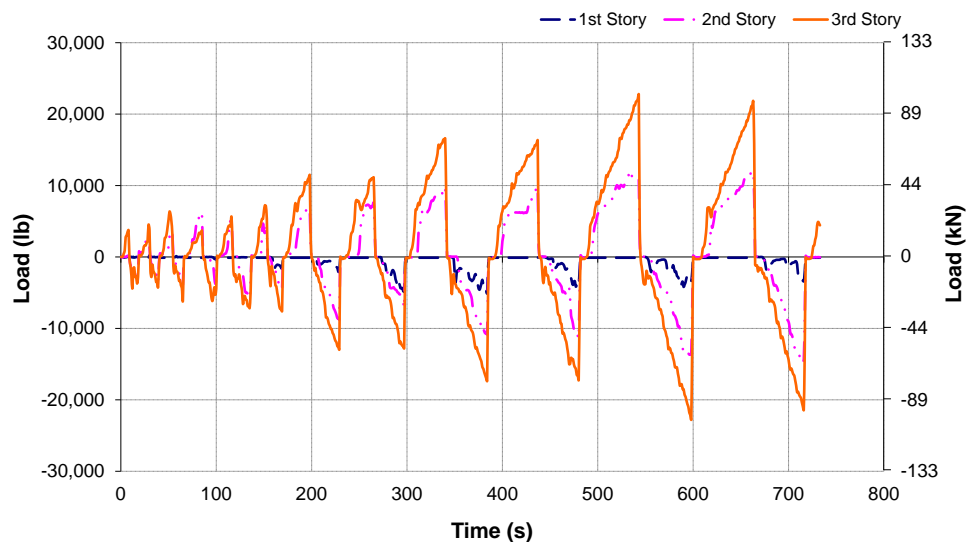
Figure 18. Full brace cyclic test FBCT2 load history.

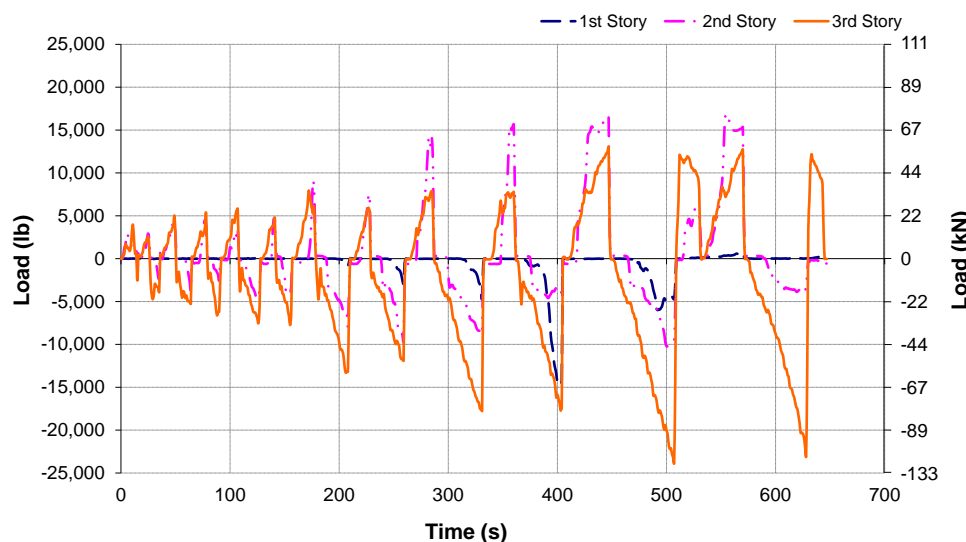
**Figure 19.** Full brace cyclic test FBCT4 load history.

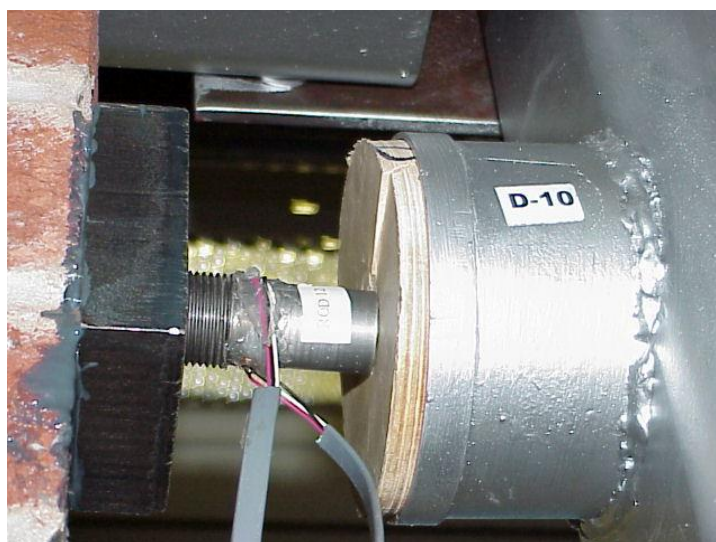
Figure 20. Cracking of 0.5 in. disk at fuse location 10 during test HBCT1.

During test HBCT1 (half-brace cyclic test 1), fuse element cracking was not observed until the displacement at the third story of the test frame reached 17.8 mm. Additional cracking occurred in both displacement directions as the load history was continued and the peak displacements were increased at each story level during subsequent load steps. During this test, the greatest fuse element damage occurred in the 12.7 mm lumber disks located at the third story of the test frame. Figure 20 shows the damage to the 12.7 mm lumber disk at fuse location 10. During test HBCT2, the first fuse element cracking occurred at a third story deflection of 12.7 mm. From this point, increased cracking occurred in the fuse elements as the quasi-static load history was continued.

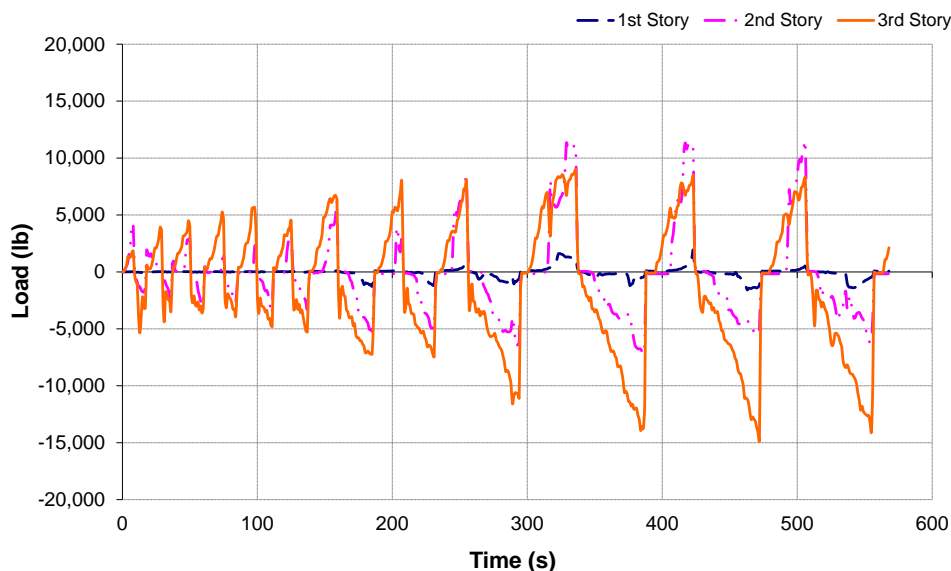
Figure 21. Half-brace cyclic test HBCT1 load history.

The load histories for the two half-brace cyclic tests are shown in Figures 21 and 22. The load behavior during these tests was similar to the full-brace cyclic tests. Comparison of these figures with Figure 13 shows the effect of the infill on bare frame with half brace. As with the full-brace tests, the loads applied to the test frame at each story level were not similar in the advance and retract directions. For these tests, very little load was applied to the test frame at the first story level. The magnitude of the loads at the second story, however, was significant. During the advance portion of several of the load cycles the load applied at the second story level was greater than the load at the third story, particularly toward the end of the tests. Similar behavior was seen for the full brace cyclic tests.

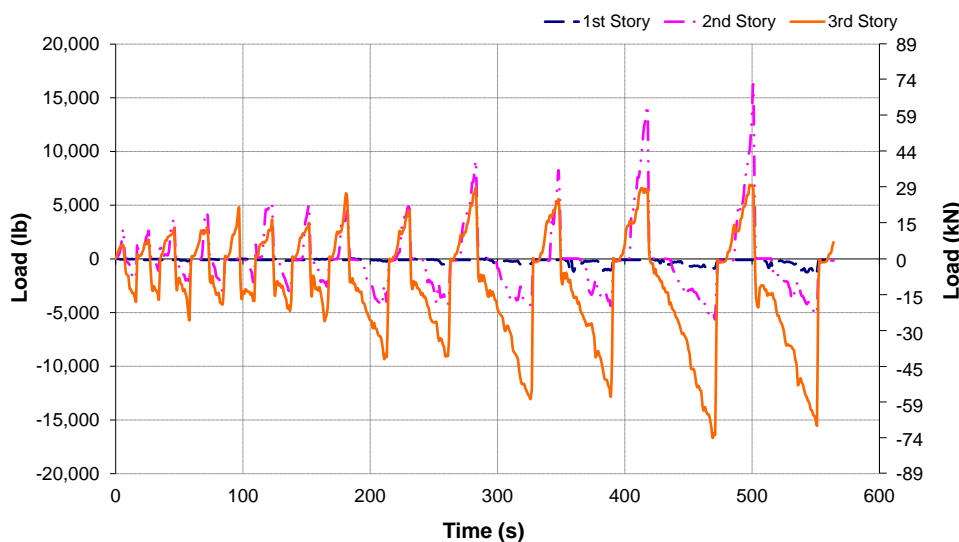
**Figure 22.** Half-brace cyclic test HBCT2 load history.

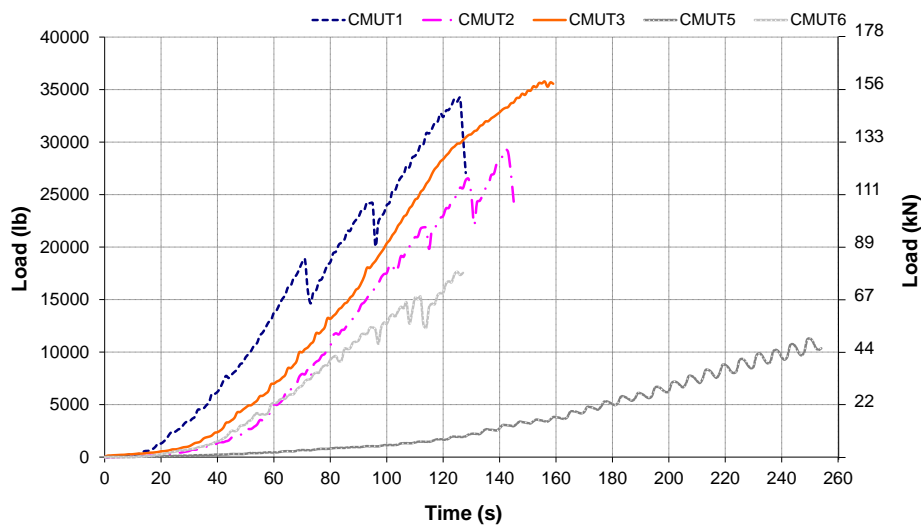
Figure 23. Concrete masonry unit test (CMUT) third story load histories.

The load histories for the CMU parametric tests are shown in Figure 23. During test CMUT4, a problem occurred with the pressure transducer, resulting in a loss of load data for this test. A plot of the load-displacement behavior for each of the CMU parametric tests is given in Figure 24. The load-displacement behavior for tests CMUT1 and CMUT2 was very similar until the displacement at the third story reached around 27.9 mm. At this point of CMUT2, the stiffness of the test frame began to decrease. The stiffness of the test frame during test CMUT3 was slightly less than that of tests CMUT1 and CMUT2. This was expected since 12.7 mm lumber disk fuse elements were used at each story level during this test.

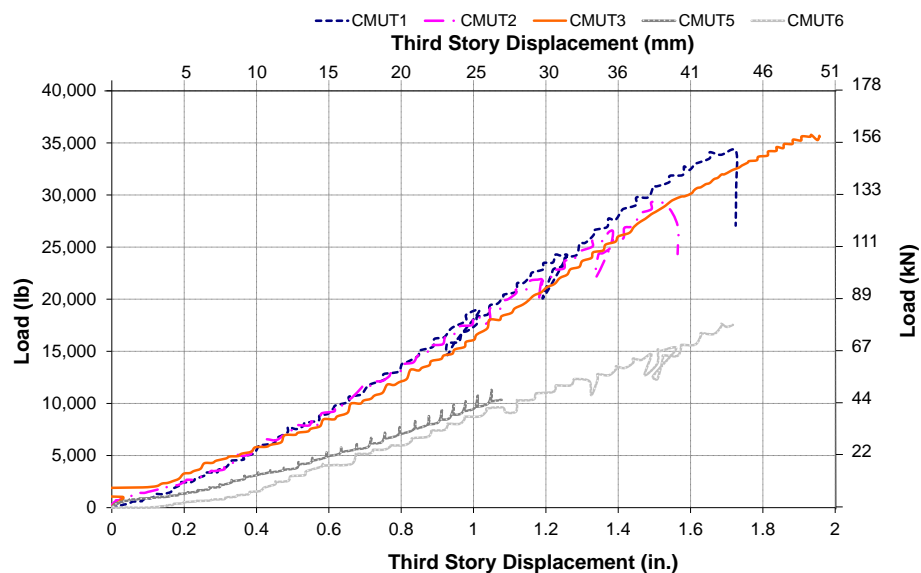
Figure 24. CMUT third story load-deflection behavior.

For tests CMUT5 and CMUT6 the half-brace configuration was used, resulting in significantly less in-plane frame stiffness, as shown in Figure 24. Although the slope of the load-displacement curve was slightly smaller for test CMUT6 than for test CMUT5, the overall load-displacement behavior for these two tests was very similar. In general the load-displacement curves for these tests were fairly linear following the first stage of behavior. During this initial stage, the bracing rods were tightening up, and the 22.4 mm dia. punching rods were just beginning to push against the lumber disk fuse elements. Toward the end of the tests, the slope of the load-displacement curves decreased due to the loss of stiffness resulting from failure of the lumber disk fuse elements and disengagement of the CMU infill panels from the in-plane load resistance.

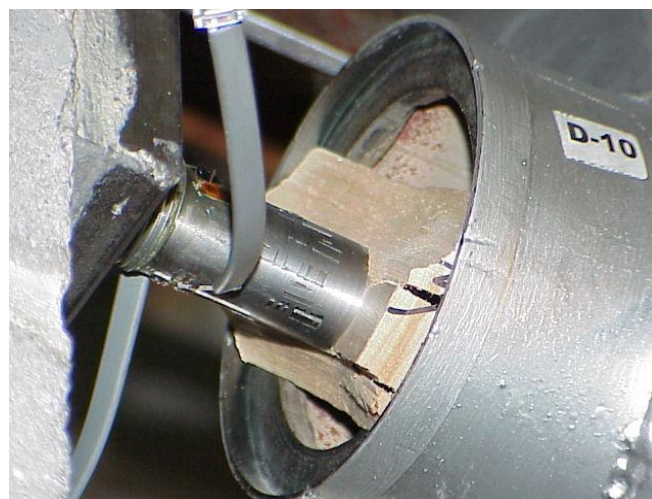
Figure 25. Damage to fuse 10 during test CMUT2.

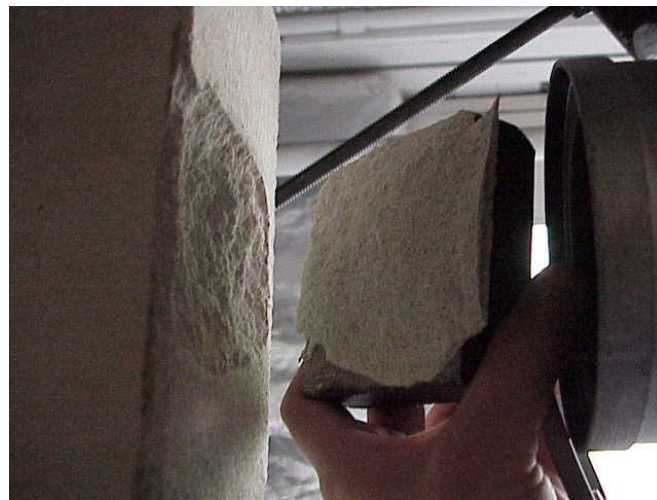
Figure 26. Plate separation from AAC wall panel during AACT3.

At the end of AACT1, the 25.4 mm × 76.2 mm × 76.2 mm steel bearing plates at fuse locations 6, 10, and 12 were separated from the AAC infill wall panels. This was the result of local crushing failures of the AAC material during the test. The bearing plates were reattached to the wall panels using epoxy. At the end of test AACT3, the 25.4 mm × 76.2 mm × 76.2 mm steel bearing plate at fuse location 10 also had to be re-epoxied onto the AAC infill wall panel due to local crushing of the AAC material, as shown in Figure 26.
