Engineering Failure Analysis

Numerical analysis of structural damage in the church of the Poblet Monastery

Savvas Saloustros*, Luca Pelà, Pere Roca, Jorge Portal

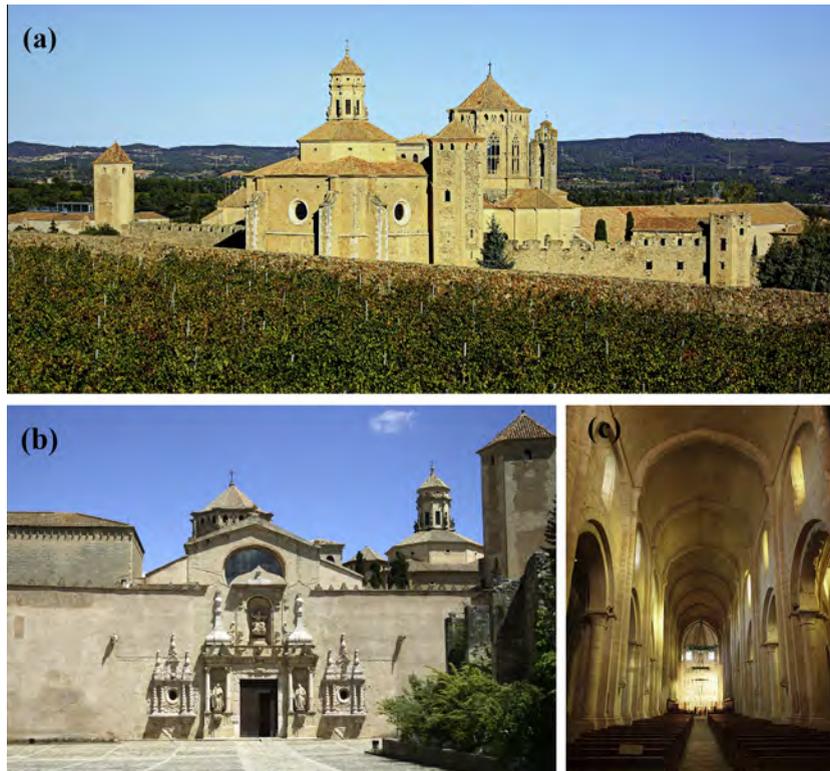
Fig. 1. The Royal Monastery of Santa Maria de Poblet: (a) southern–eastern view of the monastic complex, (b) external view (the Nativity façade) and (c) internal view of the church.

The Royal Monastery of Santa Maria de Poblet (Fig. 1) is one of the three Cistercian monasteries in Catalonia, known as the Cistercian triangle, along with Santes Creus and Santa Maria de Vallbona. It was founded in 1153 by twelve Cistercian monks from Fontfroide of France, who developed the monastery using constructive and architectural solutions previously exploited in Saint-Gaal, Fontfroide, Cîteaux and Clairvaux Abbeys. It is considered as one of the biggest and most complete existing Cistercian abbeys. In addition to the monastic use, it has also served throughout the centuries as a defensive complex, a royal palace, residence and pantheon for the kings of Aragon. In 1921 the Spanish government recognized it as a national monument and since 1991 it is a World Heritage Site by UNESCO.

Fig. 5 illustrates the construction stages of the different parts of the church. The construction started in 1170 with the east end. Following the completion of this part at the end of the 12th century, the church expanded towards the west with the transept, the main nave and the two lateral aisles, finalizing the main body of the structure in 1276. Thenceforth, the church underwent several alterations and additions. During the end of the 13th century, the western entrance of the church was completed by the addition of the Galilee. Later additions to the church are also the cimborio above the crossing (15th century) and the expansion of a chapel in the southern part of the church (17th century). The façade of the Galilee was decorated in baroque style in the 18th century (see Fig. 1b).

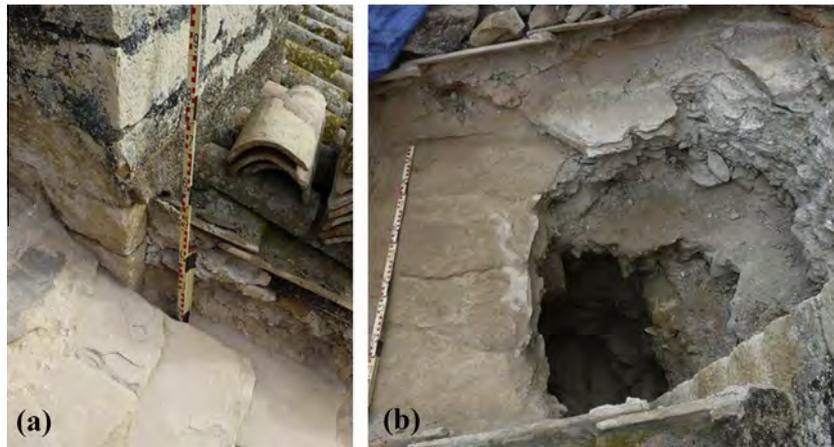
Fig. 4. Infill of the barrel vault: (a) upper part of clay tiles, sand and stone tiles and (b) lower part of poor quality filling materials [32].

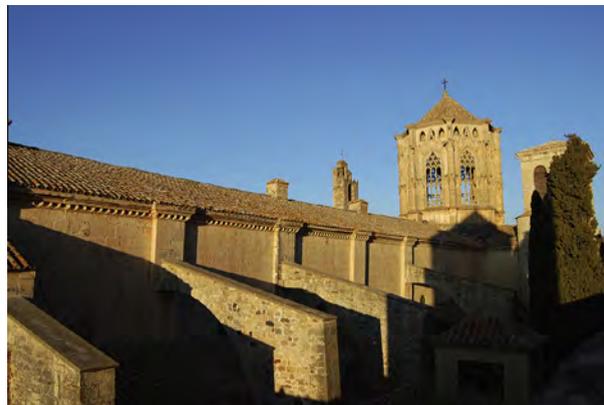
The structure has undergone two major strengthening works during its life. The first took place between 1823 and 1830, and included the construction of three flying buttresses in the southern part of the church aligned with the 4th, 6th and 7th arches of the main nave as well as one buttress bracing the southern end of the western façade (Figs. 5 and 6). A possible reason for this action was to restrain the outwards rotation of the clerestory walls in the main nave. The second intervention, during the 20th century, involved the introduction of metal elements in the open joints, the cracks of the barrel vault (Fig. 7) and the piers of the southern side. Moreover, the destroyed rose window was reconstructed and damaged stones in some arches of the main nave were replaced by bricks.

Fig. 6. The three flying buttresses at the southern part of the church constructed during the restoration of the 19th century.
