Reinforced concrete members under drop-weight impacts

Y. Chen MSc, PhD and I. M. May MSc, PhD, CEng, FICE, FIStructE

This paper describes a series of experimental studies to investigate the high-mass, low-velocity impact behaviour of reinforced concrete members including beams and slabs, and to provide high-quality input data and results to validate numerical modelling. Fourteen 2.7 m and four 1.5 m span beams, four 0.8 m square 76 mm thick and two 2.3 m square 150 mm thick slabs were tested under impact loads using a drop-weight facility. Measurements included transient impact loads, accelerations and strains in the steel reinforcement. Additionally the impact events were recorded using a high-speed video camera operated at up to 4500 frames per second. For the beam tests, the local failure pattern of a beam under the impact zone was examined by correlating the images of development of cracks, spalling and scabbing with the impact load history. For the slab tests, the imposed energy on a slab was compared with the minimum energy causing the slab to scab, which was predicted using empirical formulae. The investigations enabled a better understanding of the behaviour of reinforced

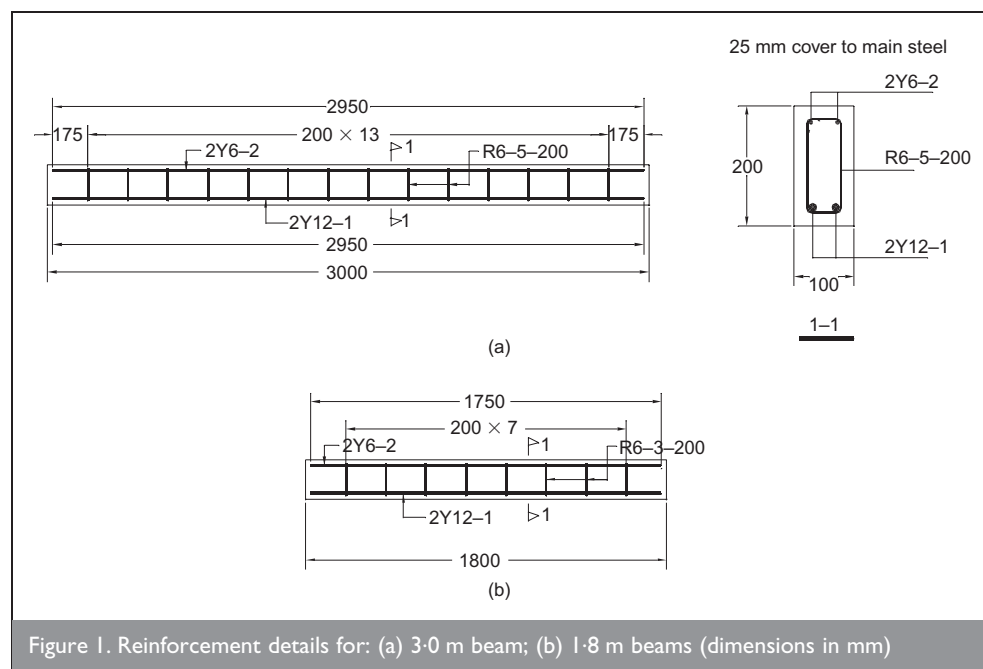
Figure 1. Reinforcement details for: (a) 3.0 m beam; (b) 1.8 m beams (dimensions in mm)

The beams, were either 1.8 or 3.0 m long, of span 1.5 and 2.7 m respectively, reinforced with two 12 mm diameter high yield steel bars at the bottom and two 6 mm diameter mild steel bars at the top, 6 mm diameter mild steel shear links at 200 mm centres, and 25 mm concrete cover to the main steel. The tests on the beams were classified as type A and type B. Type A tests had a 12 mm thick plywood pad placed between a beam and the impactor, similar to some of the beams tested by Hughes and Speirs.⁷ The results from the first few tests of type A beams were used to check the test procedure while also gathering additional data including video from the high-speed camera. Type B tests were used to investigate the effect of the impactor directly striking a beam. The details of the beam tests, including the dimension of the beams, the layout of the test and material properties can be found in Figure 1 and Table 1.

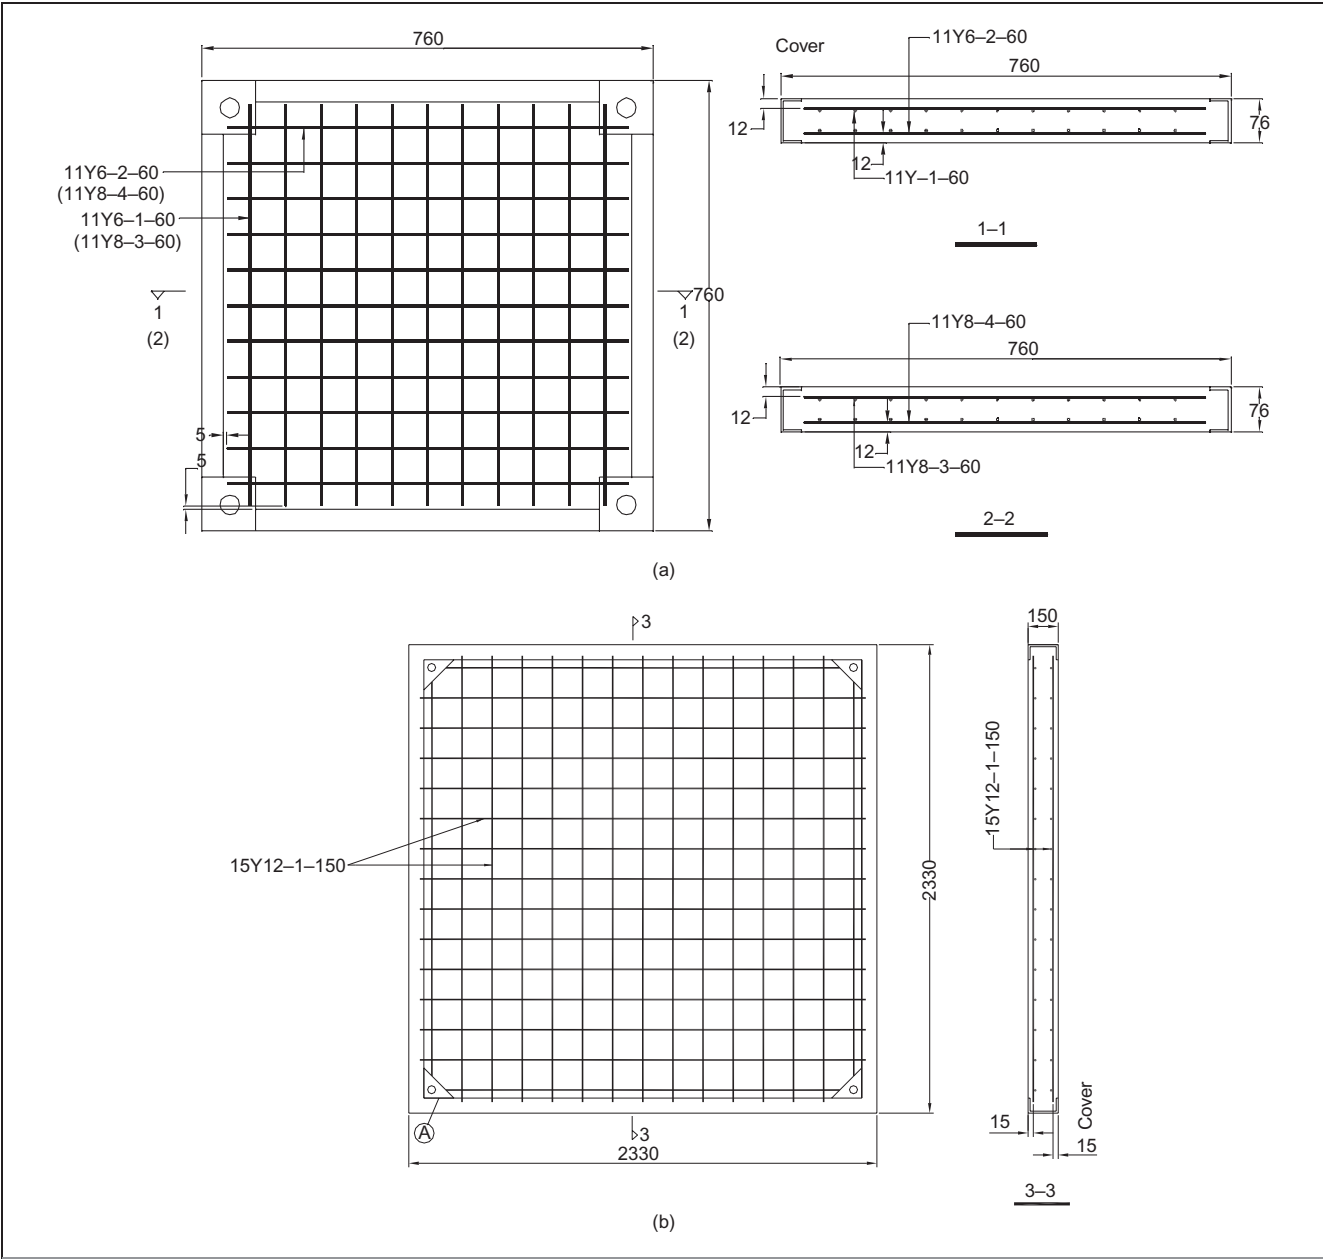
Figure 2. Details of slabs: (a) 0.76 m square slabs; (b) 2.3 m square slabs (dimensions in mm)

Two sizes of slab were tested: 760 mm square and 76 mm thick, and 2320 mm square and 150 mm thick. Details are given in Table 2 and Figure 2.

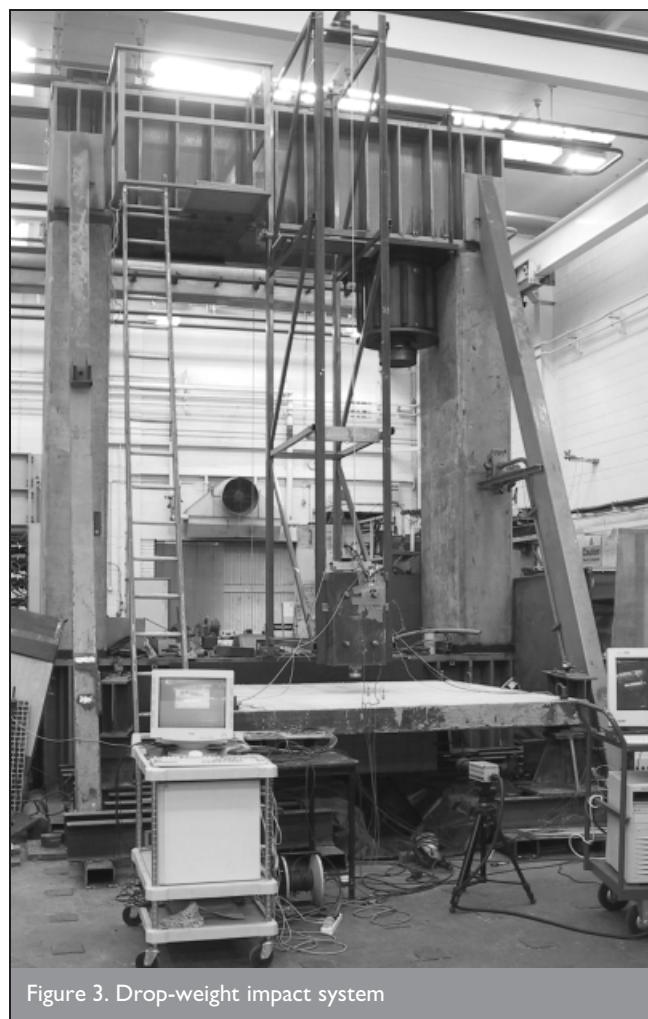
Figure 3. Drop-weight impact system

The drop-weight system, as shown in Figure 3, can be used to test up to 3 m span beams and up to 2.4 m square slabs. A frame with two vertical steel angle legs was used to guide the striker, which can be raised up to 4 m high. The striker comprised a mass, a load cell and an impactor. The mass had two guides on each side, which were lined with acetal, a

thermoplastic material, in order to reduce the friction. The striker was lifted, using a winch, by a steel wire rope that is attached to the striker by an electromagnet. When the striker was at the required height it was released by switching off the magnet. To prevent an accidental release of the striker owing to a failure of the magnet, there was a mechanical link between the rope and striker, which was released prior to switching off the magnet.

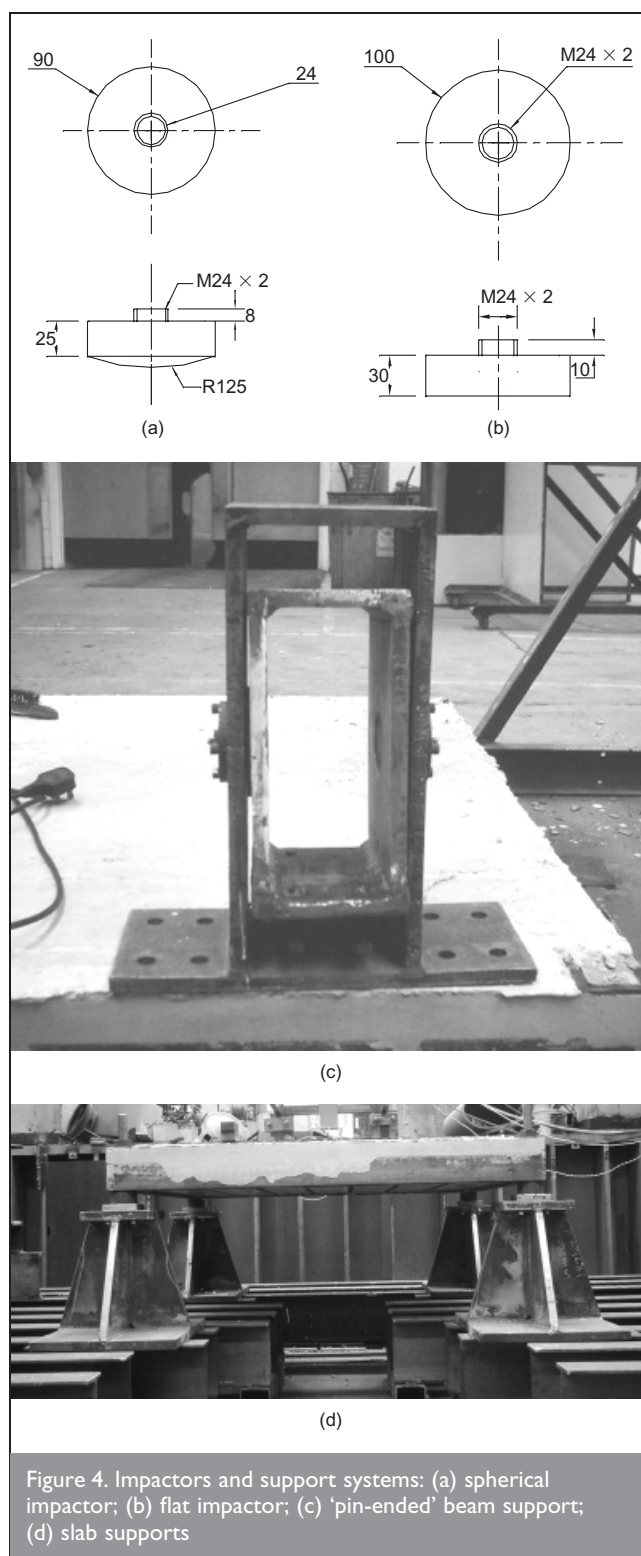
Figure 4. Impactors and support systems: (a) spherical impactor; (b) flat impactor; (c) 'pin-ended' beam support; (d) slab supports

Two types of impactors were used in the tests. The first was a stainless steel impactor with a 90 mm diameter and a hemispherical profile of 125 mm radius, the second was made of mild steel with a 100 mm diameter and a flat contact face (Figures 4(a) and (b)).

In the beam tests, a beam was either pin-ended or simply supported at the two ends. The 'pin-ended' supports, as shown in Figure 4(c), allowed rotation but were restrained axially and vertically by means of plates that clamped the beam. The supports were converted to 'simply supported' by releasing the clamps to allow horizontal movement and a small amount of upwards vertical movement, up to 50 mm, but no downward vertical movement.

The slabs were clamped at the four corners with both horizontal and vertical movement restrained (Figure 4(d)).

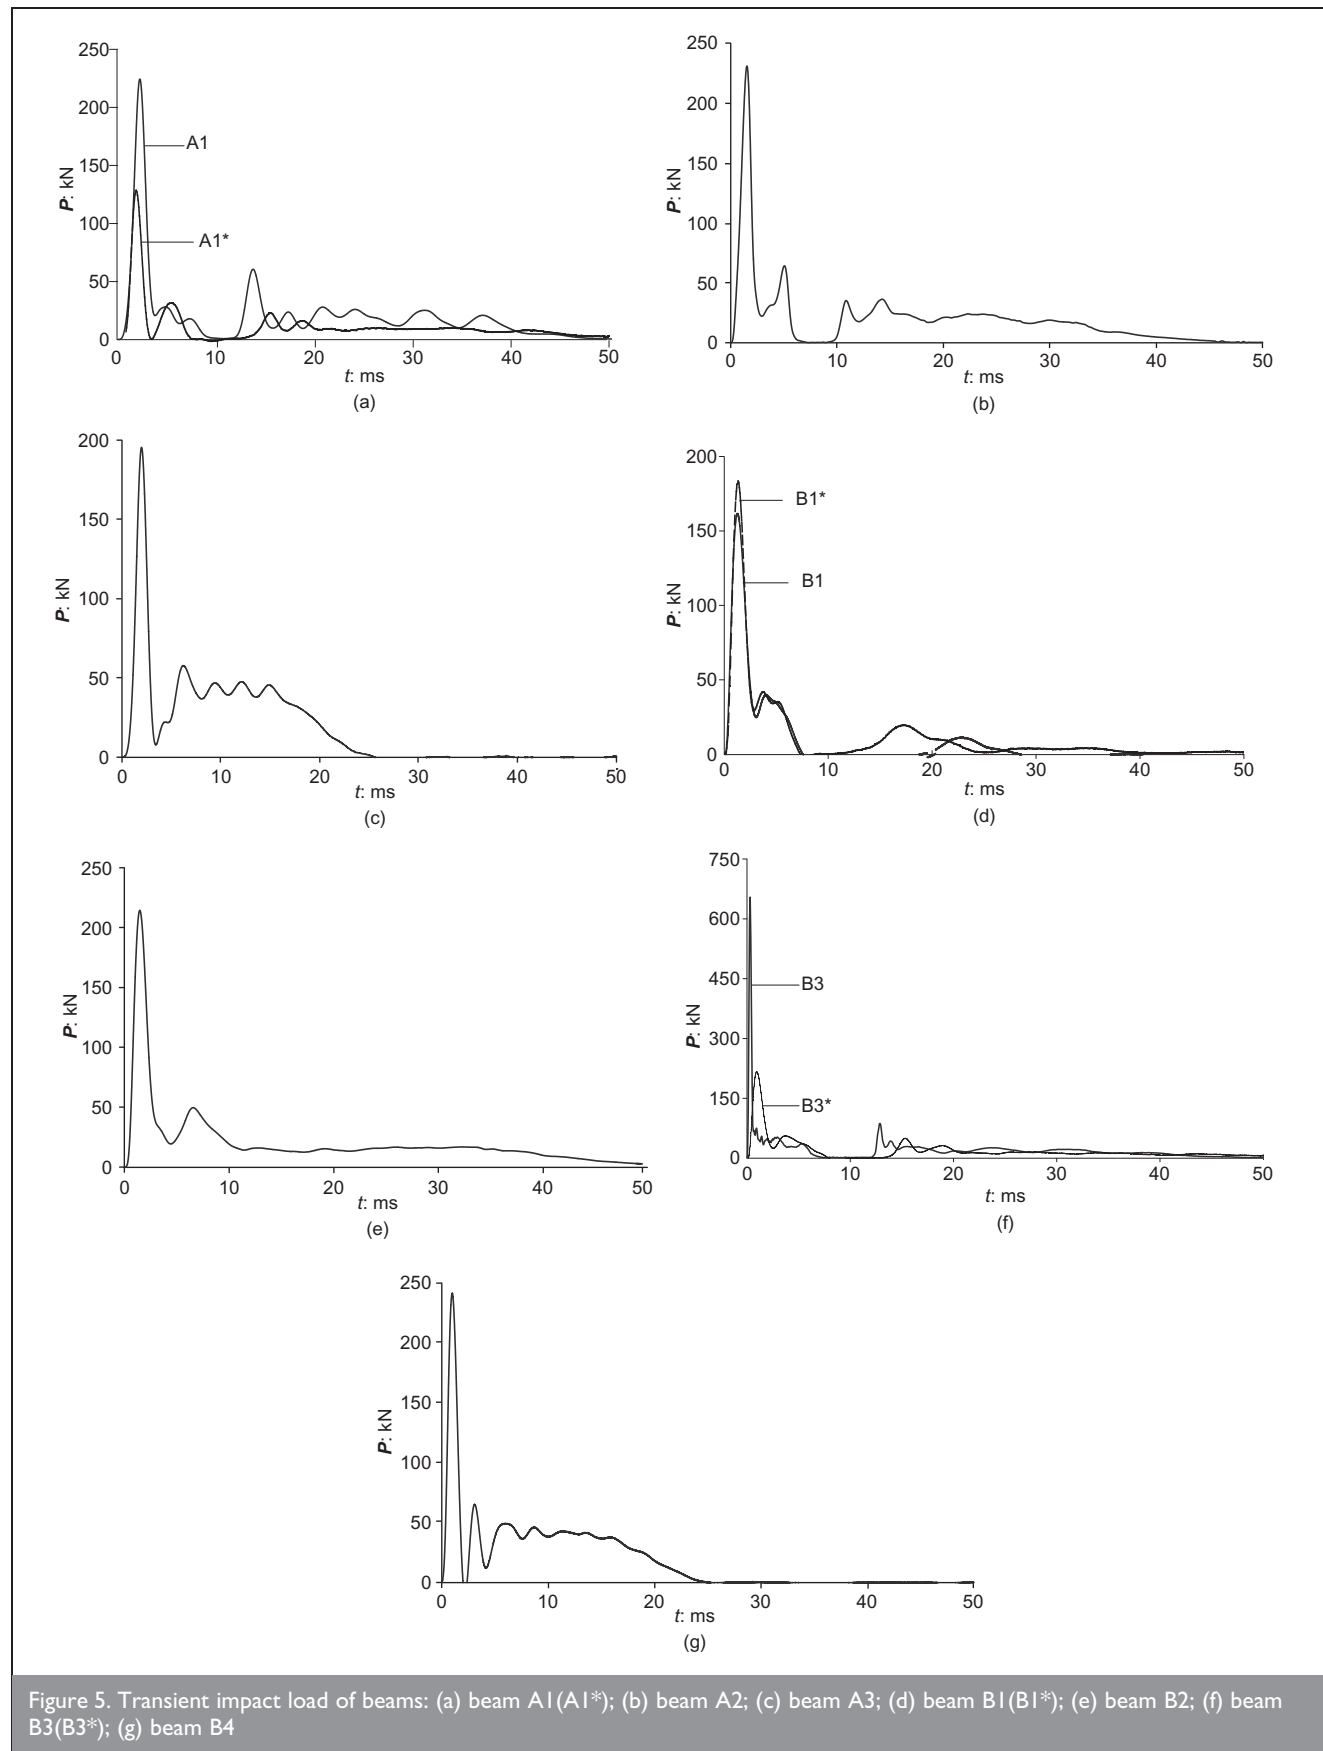
Figure 5 shows typical impact load–time histories for a number of beams. Comparing Figure 5(a) for beam A1, which was pin-ended, and Figure 5(b) for beam A2, which was simply supported, both of 2.7 m span, it is found that the load–time histories are very similar. It would therefore appear that the end conditions have little effect on the impact response of the beams; however, the impact force is dependent on the span of a beam. This finding is similar to that noted elsewhere.⁷

The plywood interface, the properties of which are given by Hughes and Speirs,⁷ and the flat impactor appear to have distributed the impact force in a similar way. Thus the impact load–time histories of, for example, beam A3, which had a 12 mm thick plywood section between the impactor and the beam, and beam B4, which was struck directly by a flat impactor, are similar.

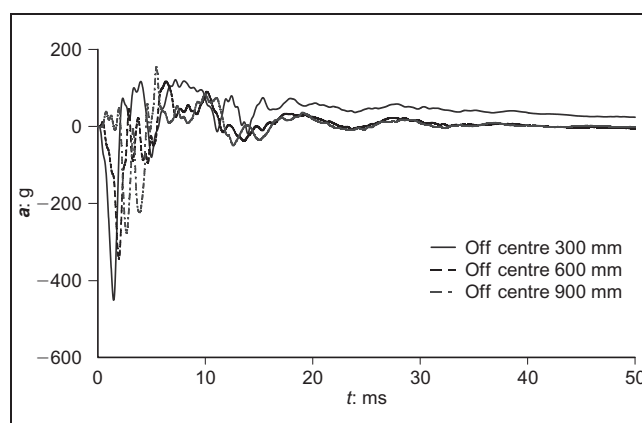
Figure 6. Transient acceleration of beam A2

Figure 6 shows the acceleration–time histories from the records of accelerometers attached to the top of beam A2.

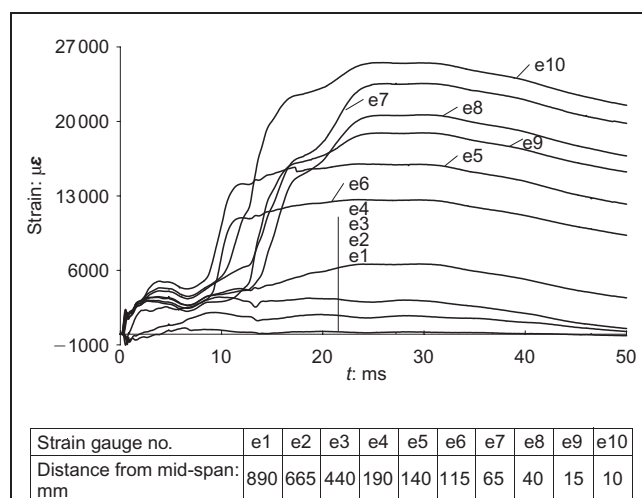
Figure 7. Transient reinforcement strain measurement for beam B3

The strains in the steel reinforcement in the bottom of a beam were measured in a number of tests. Figure 7 shows the reinforcement strain–time history for beam B3. The yield strain of the reinforcement was of the order of 3000 $\mu\epsilon$ and thus it can be seen that generally the reinforcement had yielded during the initial impact.

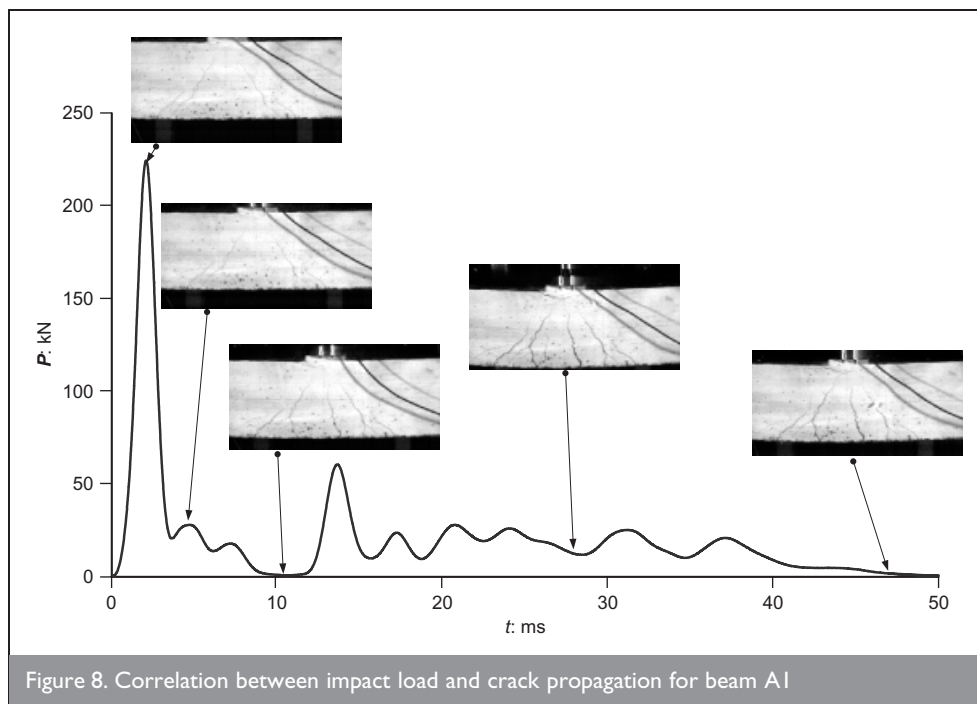
Figure 8. Correlation between impact load and crack propagation for beam A1

Figures 8 and 9 show the impact load–time histories, together with a number of images taken from the camera, to show the crack development adjacent to the impact zone for beam A1 and beam B3, respectively.

Figure 8 shows that, initially a group of diagonal shear cracks formed on beam A1 as the load reached its maximum at 2 ms. This was followed by the development of vertical flexural cracks. Separation between the impactor and beam occurred at about 10 ms, which is indicated by zero impact load, though both the beam and striker continued to move downwards. At this time some spallation of the concrete can be observed directly beneath the impactor. The impactor and beam then regained contact, more cracking occurred and the spallation became more apparent. At 50 ms the beam and impactor separated again as the latter started to move upwards.

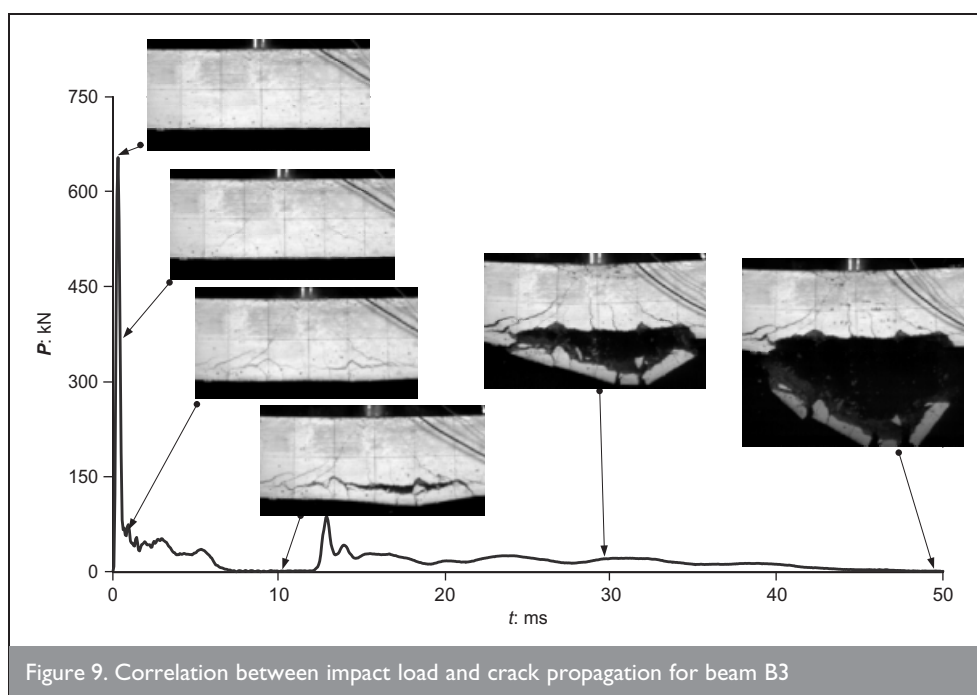
Figure 9. Correlation between impact load and crack propagation for beam B3

In Figure 9 it can be seen, however, that there was virtually no cracking on beam B3 before the impact force reached its maximum at 0.3 ms. Two major diagonal shear cracks formed symmetrically about mid-span beneath the impact zone at about 0.5 ms, together with some minor vertical flexural cracks at the bottom and in the central part of the beam. Further,

different to beam A1, a number of horizontal cracks were observed at the level of the bottom steel reinforcement below the impact zone. They subsequently joined to become one crack as the time increased while the load decreased. A short period of separation between the impactor and beam occurred as the beam deformed at a faster rate than the impactor at around 8 ms. The opening of the horizontal crack became so large that the concrete cover below the crack started to separate, or scab, from the rest of the beam. From 10 ms to 30 ms the impactor and beam contacted again leading to a relatively small impact load. Spallation also occurred during this period beneath the impact zone. The scabbing of the concrete became more significant between 30 and 50 ms. Finally a substantial amount of the concrete cover at the

bottom of the beam broke off from a triangular region enclosed by the two diagonal shear cracks. At about 50 ms the striker started to move upwards and the beam and impactor separated again.

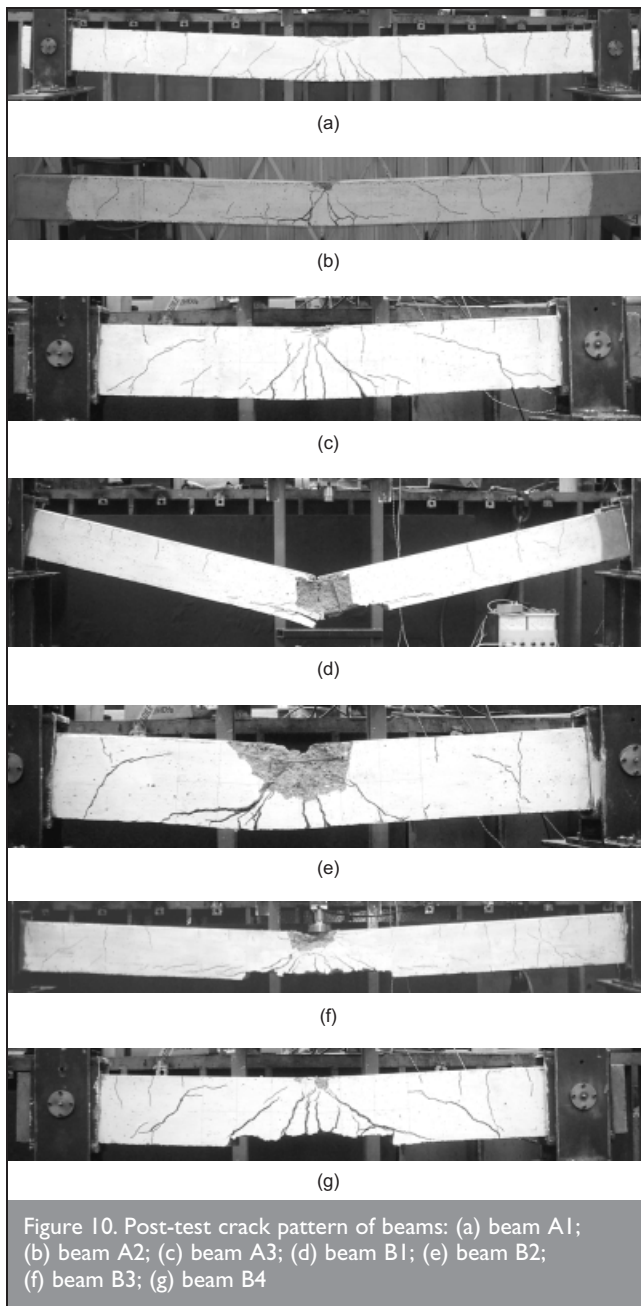
Figure 10. Post-test crack pattern of beams: (a) beam A1; (b) beam A2; (c) beam A3; (d) beam B1; (e) beam B2; (f) beam B3; (g) beam B4

Mode a. This was a predominantly flexural failure with some crushing beneath the impactor and some shear cracking in the impact zone. Vertical cracks starting from the top of a beam were found along the beam section away from the impact zone, as shown in Figures 10(a) and 10(b) for beams A1 and A2 respectively. Further shear cracking and short vertical cracking occurred in beam A3, as shown in Figure 10(c). Mode a failure occurred on type A beams, namely those with the plywood interface. There was less damage in this type of failure than in modes b and c, described below, owing to some of the impact energy being absorbed in deforming the plywood.

Mode b. This was a mainly localised failure at the impact zone with extensive concrete crushing below the impactor, and yielding of the tension steel bars, as shown in Figures 10(d) and 10(e) for beams B1 and B2 respectively. Away from the impact zone the cracking was

similar to that of mode a failure. This mode of failure occurred on beams impacted directly with the hemispherical impactor.

Mode c. This was similar to mode a failure, but was accompanied by loss of the concrete cover to the tension steel reinforcement at the bottom of a beam owing to scabbing, as shown in Figures 10(f) and 10(g) for beams B3 and B4 respectively. It occurred on beams impacted directly with the flat impactor.

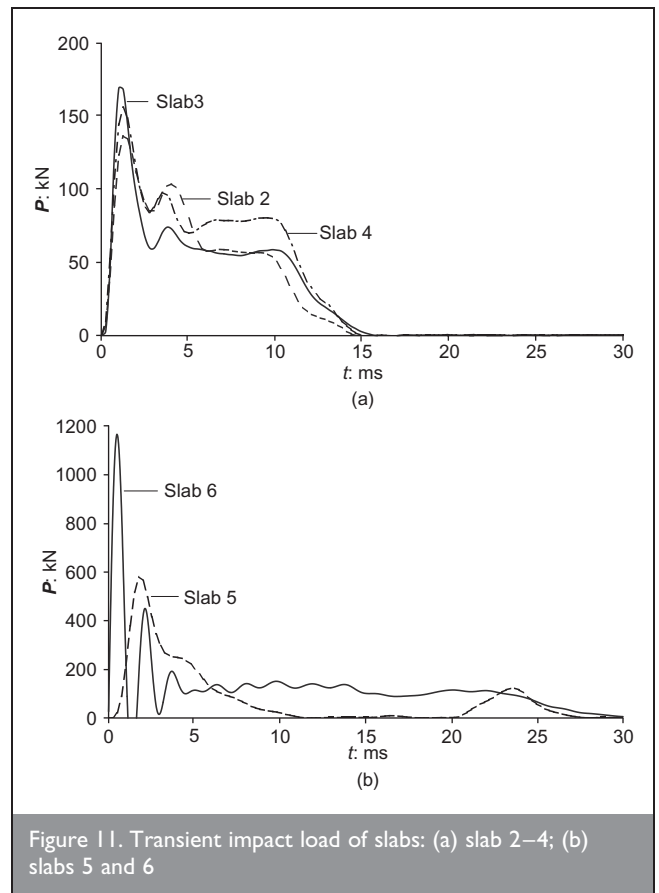
Figure 11. Transient impact load of slabs: (a) slab 2–4; (b) slabs 5 and 6

From Figure 11(a) it is seen that for slabs 2 to 4 after reaching the peak load the load fell until it arrived at a plateau of approximately half of the peak load. In slab 6 the magnitude of the plateau load is about one-ninth of the peak load, in slab 5 the plateau is absent. During this time local failures owing to penetration and scabbing, accompanied by yielding of the reinforcement, were observed to various degrees in slabs 2 to 4 and 6. Slab 5 shows little signs of failure, as will be discussed later.

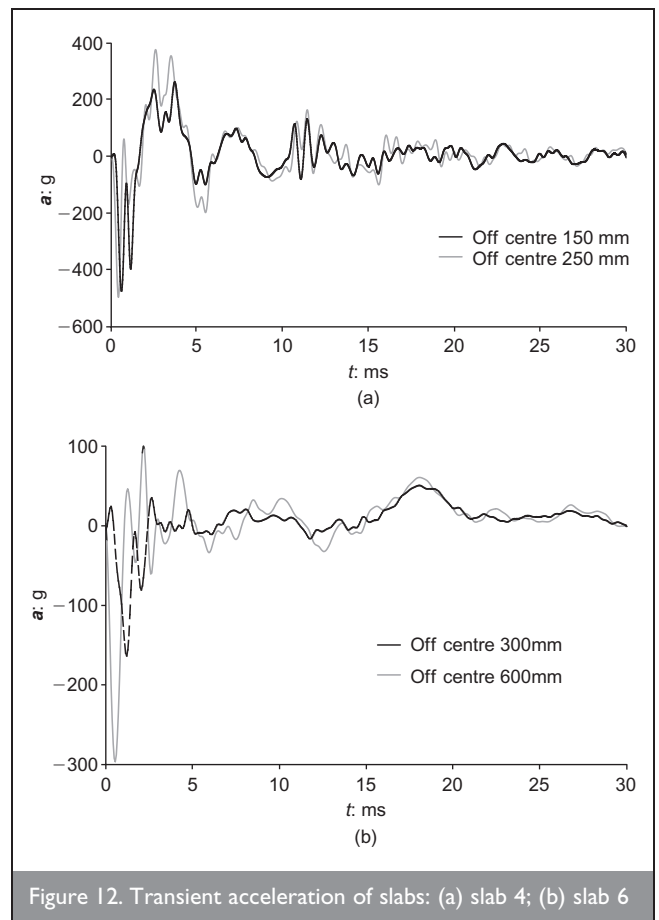
Figure 12. Transient acceleration of slabs: (a) slab 4; (b) slab 6

The transient accelerations measured on the top surfaces of slabs 4 and 6 are shown in Figures 12(a) and 12(b), respectively. There is little difference between the phases of the two accelerations measured at different points on slab 4. On slab 6, the difference in the phases of the accelerations is more

evident for the first 5 ms but reduces as time increases. On slabs 5 and 6 the accelerometers were placed further apart than those on 0.76 m square slabs and it is considered that the difference in the phases of the accelerations reflects the lag in response of the various parts of the 2.3 m square slabs owing to the wider spacing.

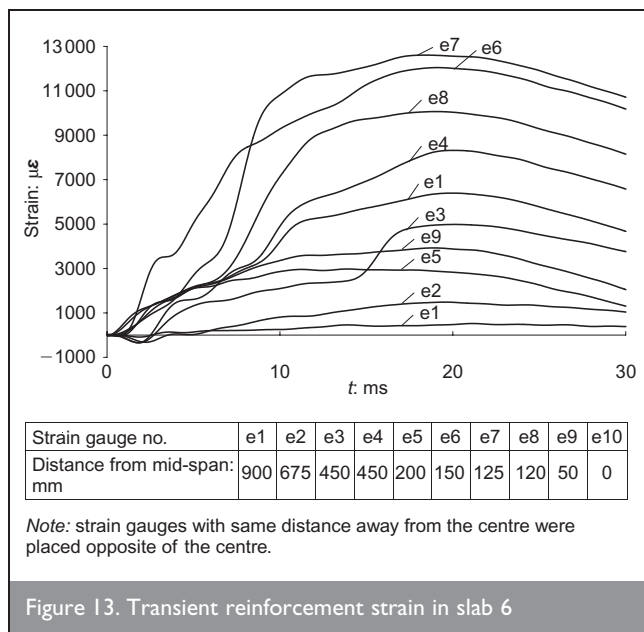
Figure 13. Transient reinforcement strain in slab 6

The strains in the reinforcement in slab 6 were also measured and the results are shown in Figure 13. The strains indicate that some of the reinforcement yielded during the test.

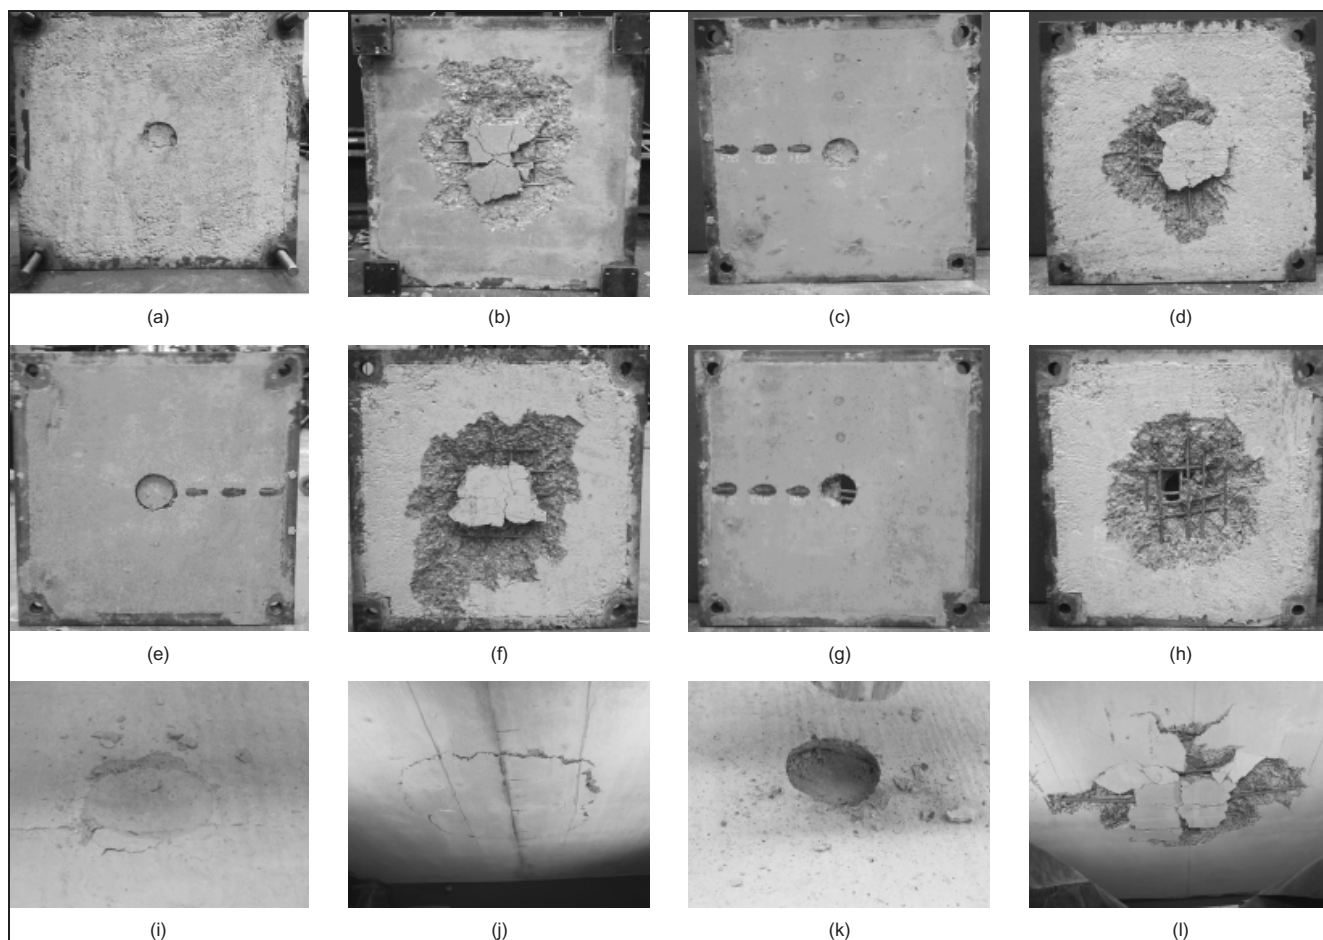
Figure 14. Slabs after impact: (a) top face of slab 1; (b) bottom face of slab 1; (c) top face of slab 2; (d) bottom face of slab 2; (e) top face of slab 3; (f) bottom face of slab 3; (g) top face of slab 4; (h) bottom face of slab 4; (i) top face of slab 5; (j) bottom face of slab 5; (k) top face of slab 6; (l) bottom face of slab 6

Figure 14 shows the damage, after the impact, to the top and bottom faces of the slabs. On the 76 mm thick slabs 1 to 4 there was a larger amount of concrete debris, in the form of both small particles and larger blocks, ejected owing to scabbing than on the 150 mm thick slabs. This was due to the proportionally more significant amount of energy in the impacts on the thinner slabs. There was also some scabbing on slab 6, but on the other thick slab, slab 5, in which the mass of the impactor was approximately half that for slab 6, scabbing was not fully developed. There was also a significant amount of penetration of the impactor in slabs 1 to 4 and 6 but very little in slab 5.
