Structural and Non-Structural Measures for Flood Risk Mitigation in the Bâsca River Catchment (Romania)

Gabriel MINEA¹, Liliana ZAHARIA²

Abstract

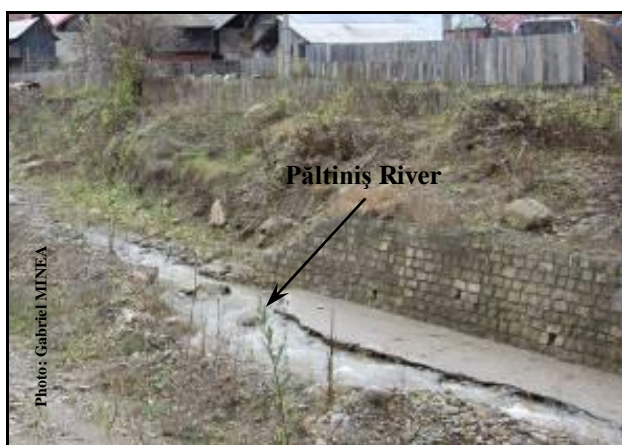
Photo 1 Hydrotechnical work destroyed by the flood from July 20th 2002 (near the confluence of the Păltiniș with the Bâsca River)

- landslide reactivation and destabilization of slopes;
- destruction of some hydrotechnical works (Photo 1);
- affecting sections of the local road DC75;
- homes flooded in the area of the confluence with the Bâsca River and
- one human death.

These consequences are probably due also to the fact that the works were in most cases hydrologically (exceeded by flood values and channel shifting) and lithologically (alternating layers with hard resistance with friable rocks), limited.

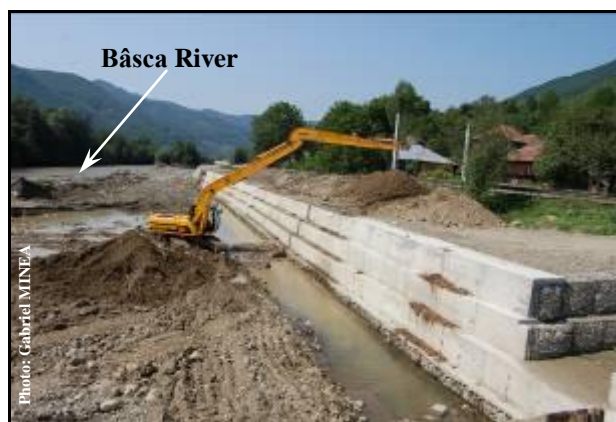
Photo 2 New hydrotechnical arrangements (gabion baskets) on the Bâsca River (august 10th 2010)

After 2007, in the lower sector of the Bâsca River, new longitudinal hydrotechnical works (dykes from gabion mattress) are started (Photo 2). On the Bâsca River the project "Hydropower Siriș – Surduc Development", has been developed (being now in construction stage). This project includes a permanent water reservoir "Cireșu" on the upper part of the Bâsca River and an underground derivation "Surduc - Nehoiașu", from Cireșu Accumulation, The Bâsca River towards the „CHE Nehoiașu II" hydroelectric power station. This reservoir will mitigate the water volumes contributing to flood effects diminution.

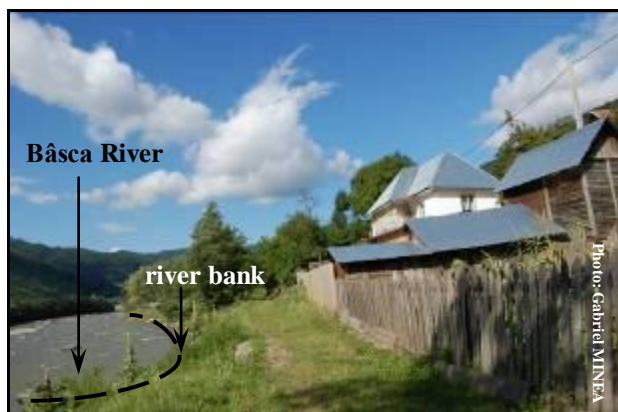
Photo 3. Houses located in the floodplain on the right river bank of Bâsca, downstream Păltiniș Village (August 10th 2010)

One of the reasons amplifying the negative effects of floods is human settlements exposure due to their location in the floodplains (Photo 3).
