Construction and Building Materials

Fatigue behavior of corroded prestressed concrete beams

Weiping Zhang, Xiguang Liu, Xianglin Gu*

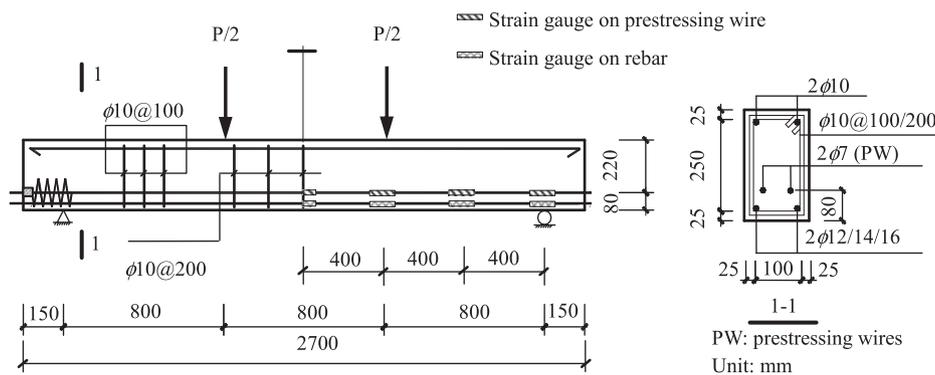
Fig. 1. Beam dimensions and cross-section details.

Two 7-mm-diameter low-relaxation prestressing wires ran straight through all the beams. The nonprestressed longitudinal rebars consisted of two hot rolled ribbed bars with a nominal diameter of 12, 14, or 16 mm, respectively. Furthermore, two hot rolled ribbed bars with a diameter of 10 mm were used as compression steel. Bottom and side cover thickness was 25 mm. A diameter of 10 mm plain stirrups spaced at 100 mm in the shear zone and 200 mm in the flexural zone were used as shear reinforcement so that the beams were expected to fail in the flexural mode. Additional chuck anchors for individual prestressing wires near the ends of the beams were placed to reduce the slip between prestressing wires and concrete. Confining reinforcements in the form of spirals were placed in the concrete directly behind the anchors, as shown in Fig. 1. Mechanical properties of prestressing wires and steel bars were tested, and the results are given in Table 2. The concrete was designed for a 28-day nominal cubic compressive strength of 40 MPa. The cement, water, aggregate and sand proportions by weight were: 1:0.36:2.87:1.48.

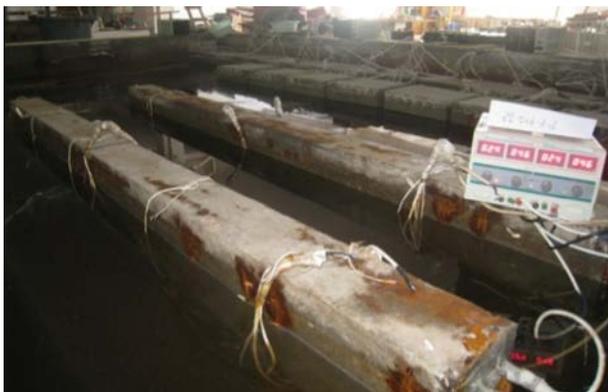
Fig. 2. Accelerated corrosion of prestressed concrete beams.

The accelerated corrosion process was started by immersing the beams partially into a solution of 5% sodium chloride with wires or rebars about 50 mm above the solution. To keep stirrups from corroding, an epoxy cloth covering was used at locations where the stirrups contact with the longitudinal steel bars, and nylon cable ties were used instead of steel wires during assembly of reinforcement cages. The wires or rebars were then connected to the positive terminal of a DC galvanostatic power supply, while the copper plate placed underneath the solution was connected to the negative terminal. Fig. 2 shows a built-in ammeter and potentiometer in the power supply used to monitor and control the current intensity. The applied current density was kept at approximately 100 μA/cm² [23]. In compliance with Faraday's law, different durations of impressed current were employed to achieve various degrees of corrosion of the wires or rebars in the beams.

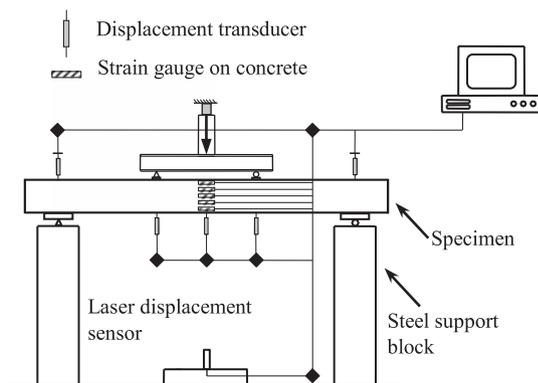
Fig. 3. Layout of displacement transducers and strain gauges.

of concrete at midspan. Five displacement transducers with a 50 mm range were set at the supports, loading points and midspan to measure vertical displacements of the beams under static loading. Layout of displacement transducers and strain gauges are shown in Fig. 3.

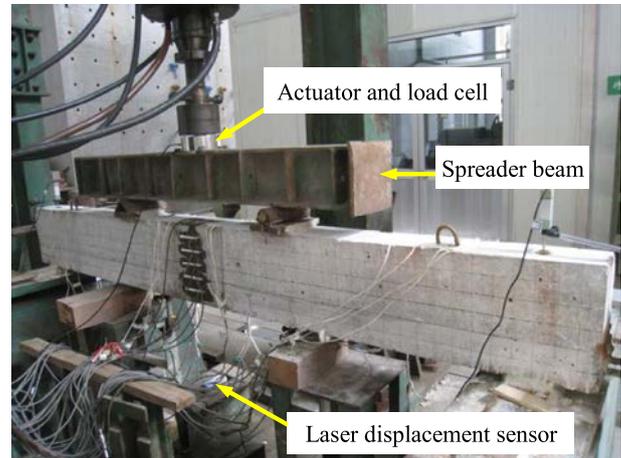
Fig. 4. Fatigue test setup.

The fatigue tests were performed under load control. Prior to conducting the cyclic loading, three static load cycles were applied. The load was gradually increased to P_{max} ; then, it was unloaded to zero. Cracking loads, initial deflections, strains and crack widths were recorded. Then a cyclic loading with a constant load range was applied at a frequency of 4.5 Hz.

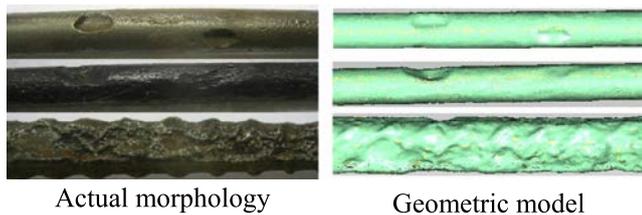
Fig. 5. Actual morphology and 3D geometric model of corroded wires and rebars.

To achieve a deeper understanding of the influence of longitudinal distribution of the cross-sectional area along the length of wires or rebars on the fatigue behavior of the beams, a 3D laser scanning technique was employed to obtain the geometric models of the corroded wires or rebars [27–30]. Comparisons between actual morphology and the 3D geometric model of corroded wires and rebars are shown in Fig. 5. By using Pro/ENGINEER software®, the cross-sectional areas were evaluated along the length of a wire or rebar at intervals of 1 mm [15].

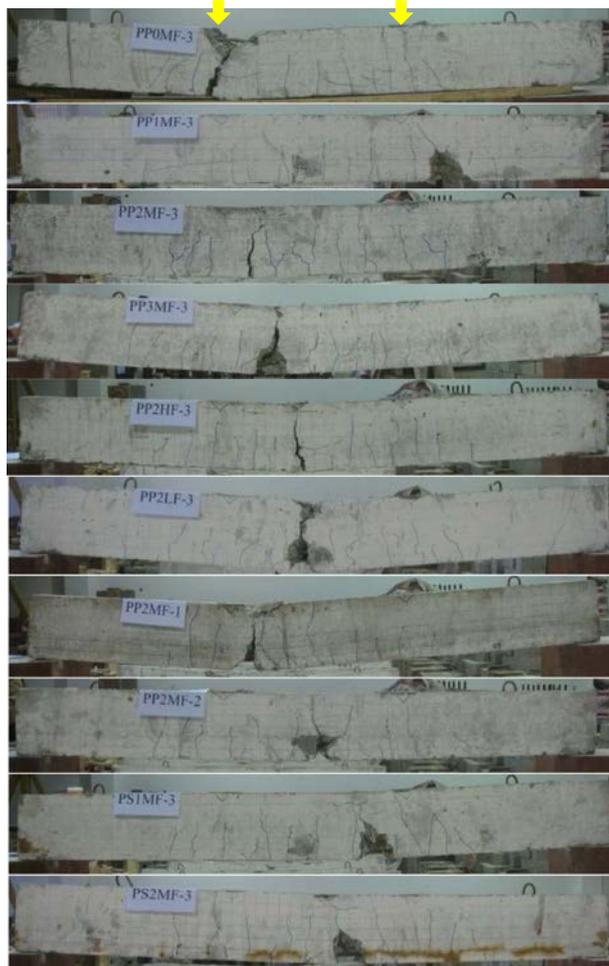
Fig. 6. Failure modes of beams in fatigue tests.

Ten beams all failed in fatigue tests, and the failure modes are shown in Fig. 6. Nine in ten beams failed in the constant moment region at the location of the main crack except for beam PP1MF-3. Therefore, the first ruptured prestressing wires in the constant moment region of ten beams were scanned by a 3D laser scanner of Faro® to relate longitudinal distribution of corrosion pits to failure location. For beam PP1MF-3, the wire in the shear span region was also scanned.

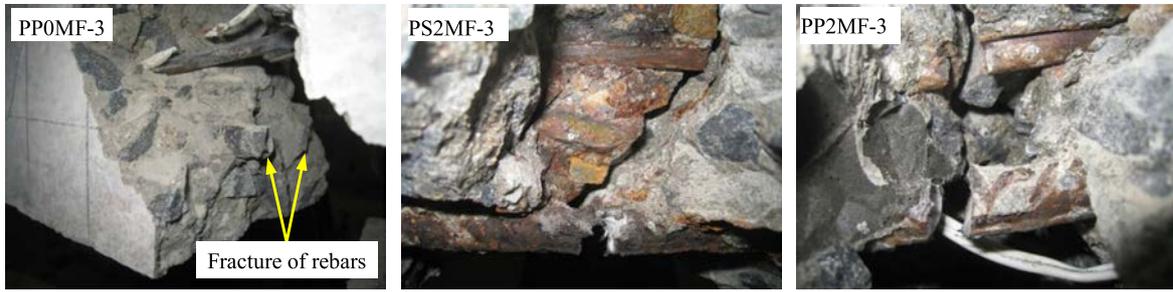
Fig. 7. Details of failed cross-sections in fatigue tests.

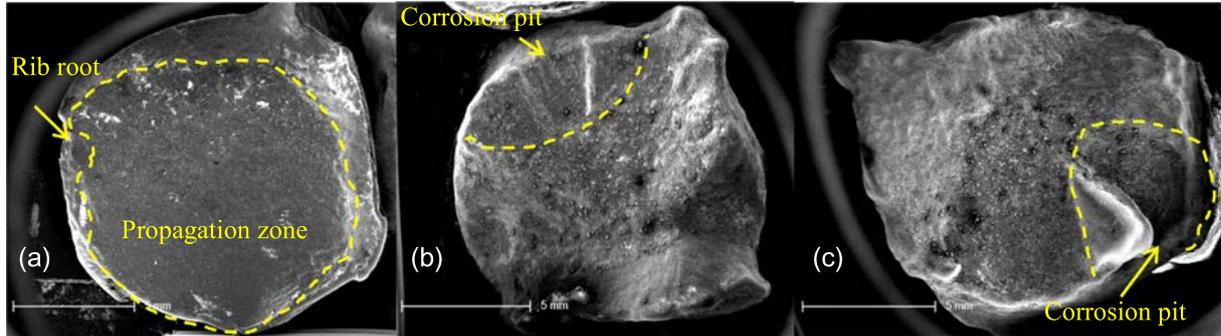
Fig. 8. SEM images of the fatigue fracture surfaces of rebar (a) beam PP0MF-3; (b) beam PS1MF-3; (c) beam PS2MF-3.

Take the beam PPOMF-3 as an example, the initial stress range of rebars was 12% higher than prestressing wires. The fracturing of rebar occurred at approximately 1,969,000 cycles, and the beam collapsed immediately in a brittle mode. This is in agreement with previous test results [31]. The two rebars both failed at the main crack, and the fracture surface was even without obvious plastic deformation, as shown in Fig. 7. This is a common characteristic of fatigue fracture. It can be seen from a scanning electron microscope (SEM) image of the fatigue fracture surface in Fig. 8a that the fatigue crack starting from the root of one transverse rib.

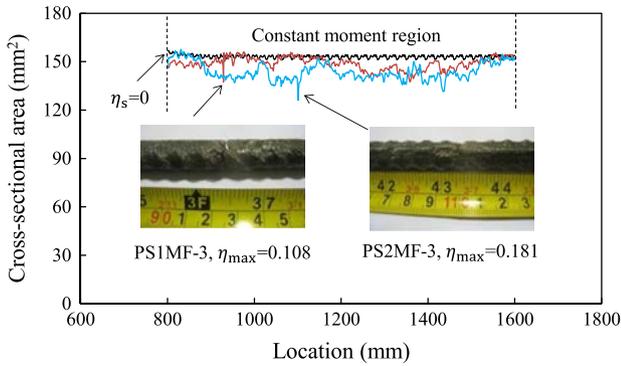
Fig. 9. Distribution of cross-sectional area of rebars with various corrosion degrees.

For beams with corroded rebars, local stress concentration and cross-sectional area loss induced by corrosion made the rebars into a more adverse status. The longitudinal distribution of the cross-sectional area of the first ruptured rebars in the corroded beams is presented in Fig. 9, and it can be seen that the fracture of the first rebars occurred at the minimum cross-sections. The initial stress range of the rebar in beam PS2MF-3 was 123% higher than that in prestressing wires due to the reduced cross-sectional area, as shown in Table 4. Moreover, fatigue cracks initiated around corrosion pits, as shown in Fig. 8b and c. Finally, the fracture of the tension rebar occurred at the main crack after approximately 57,000 loading cycles, followed by the instant rupture of prestressing wires at the same cross-section.

The measured average corrosion degrees of beam PS1MF-3 and beam PS2MF-3 were 0.034 and 0.066, respectively. Compared with the uncorroded beam PP0MF-3, their measured initial stress ranges of the rebars at midspan were increased by 1% and 40%, as shown in Table 4. The actual cross-sectional loss ratios at the failed cross-section beam PS1MF-3 and beam PS2MF-3 reached 0.108 and 0.181 as shown in Fig. 9, and the calculated initial stress ranges

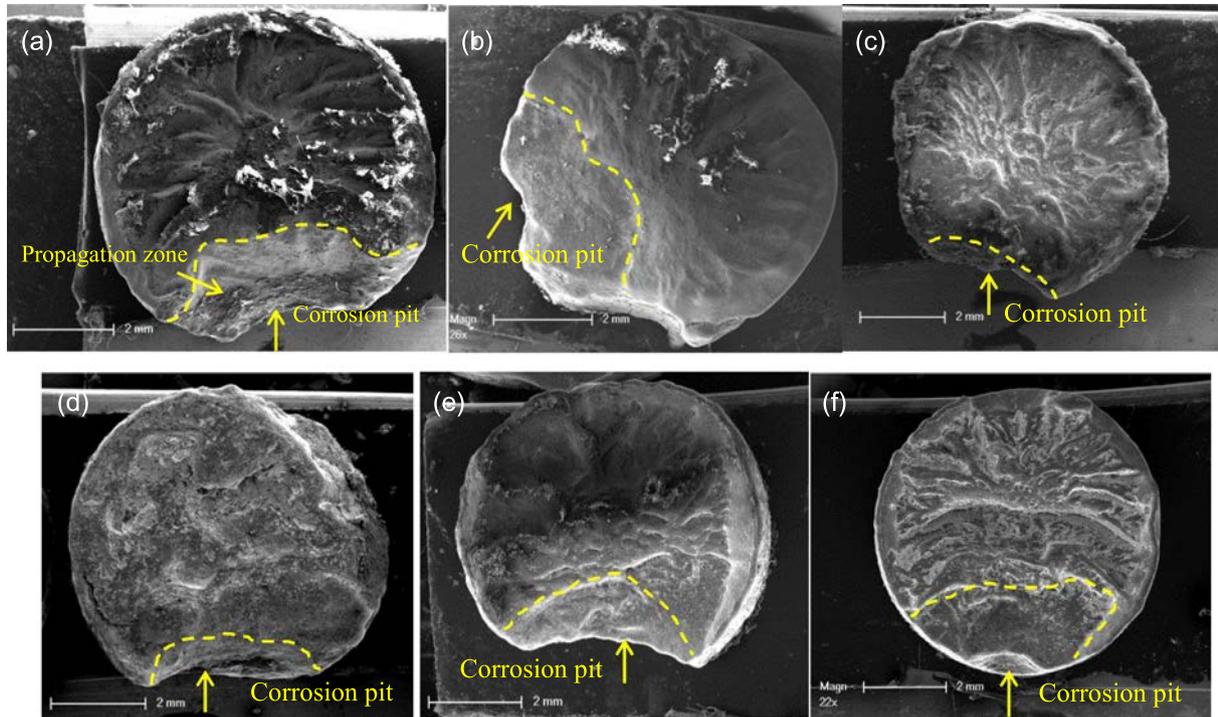
Fig. 10. SEM images of the fatigue fracture surfaces of wire (a) beam PP1MF-3; (b) beam PP2MF-3; (c) PP3MF-3; (d) beam PP2MF-3; (e) beam PP2HF-3; (f) beam PP2MF-1.

For beams with corroded prestressing wires, fatigue cracks also initiated and propagated rapidly around corrosion pits under cyclic loading, as shown in Fig. 10. The fracturing of corroded prestressing wires took place prior to that of uncorroded tension rebars under the same fatigue loading, even though the nominal stress range was lower in the wires. The subsequent fatigue fracturing of the residual prestressing wires and rebars took place in succession until finally, the brittle failure of the beams occurred.

Deformation behavior of corroded beams with different PPRs at P_{max} is presented in Fig. 20. Under the same fatigue loading, beams with higher levels of PPR have a smaller area of nonprestressed steel, and therefore, a higher stress range and stress level, as presented in Table 4 and Fig. 20b. This results in an earlier fracturing of the first wire and a shorter fatigue life. Compared with beam PP2MF-3, the first fractured wire had an actual cross-sectional loss ratio of 0.189 in beam PP2HF-3, which occurred after approximately 86,000 loading cycles. Eventually, its fatigue life had a reduction of 44%, as shown in Fig. 12 and Table 4. This can be further demonstrated by the smaller propagation zone on the fatigue fracture surface, as shown in Fig. 10b and e.

It can be observed from Table 4 and Fig. 21 that an increase in the maximum load caused an increase in the stress range and stress levels of prestressing wires, leading to a fast growth of fatigue cracks and an increase in granular rough zones before final fatigue fracture, as shown in Fig. 10b and f. Correspondingly, a

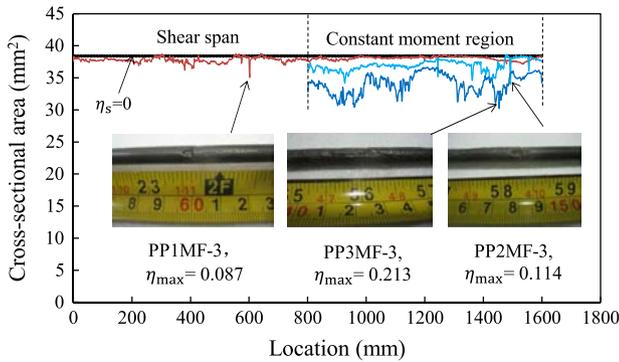
Fig. 11. Distribution of cross-sectional area of prestressing wires with various corrosion degrees.

Figs. 11–13 present the distribution of the cross-sectional area of the first ruptured prestressing wires in the corroded beams. The fracture of the first prestressing wire occurred at the minimum cross-section where corrosion pits had formed; additionally, a sharp groove appeared in the cross-sectional area distribution curves around the failed cross-section. These curves were much steeper than those found in the other cross-sections, which resulted in high stress concentrations. Fig. 11 shows that the minimum cross-section of the first ruptured wire in beam PP1MF-3 was located in the shear span. This can reasonably explain how this beam failed at a cross-section which was not subjected to the maximum moment.

The measured average corrosion degrees of prestressing wires in beams PP1MF-3, PP2MF-3 and PP3MF-3 were 0.013, 0.025 and 0.056, respectively. It can be seen from Fig. 11 that, the actual cross-sectional loss ratios at the failed cross-section of the first wire in beams PP1MF-3, PP2MF-3 and PP3MF-3 were up to 0.087, 0.114 and 0.213, respectively. The calculated initial stress ranges at the minimum cross-section of wires in the constant moment region were 1.08, 1.13 and 1.27 times greater than that in the uncorroded beam under the same fatigue loading. Similarly, due to effects of cross-sectional loss and stress concentrations, the more severe the corrosion is, the sooner the fracture of the first wire occurs, and the shorter the interval is between two wires' failure and the lower the fatigue life of the beam. The fracturing of the first wire in three corroded beams occurred at approximately 421,000, 219,000 and 166,000 cycles, respectively. Compared with the uncorroded beam, the fatigue life of the three corroded beams had a reduction of 44%, 80% and 83% respectively, as shown in Table 4.

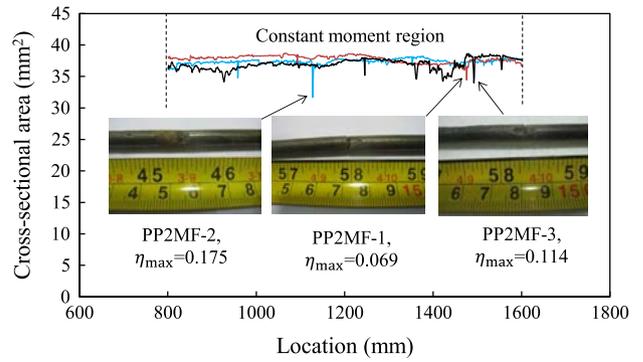
Fig. 13. Distribution of cross-sectional area of corroded prestressing wires for beams under different load ranges.

Fig. 13 shows that the fractured cross-sectional area of the first wire in beam PP2MF-2 ($\eta_{max} = 0.175$) was much smaller than that in beam PP2MF-3 ($\eta_{max} = 0.114$) due to uneven corrosion, which

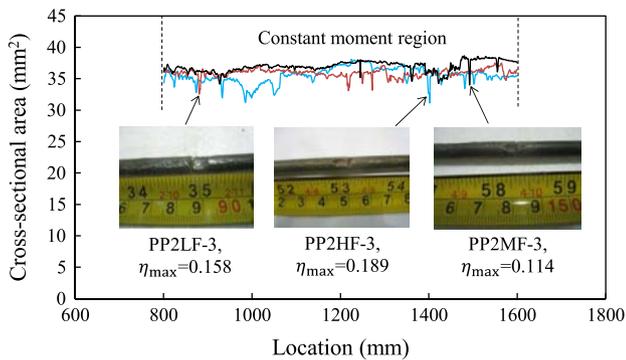
Fig. 12. Distribution of cross-sectional area of corroded prestressing wires for beams with different PPRs.

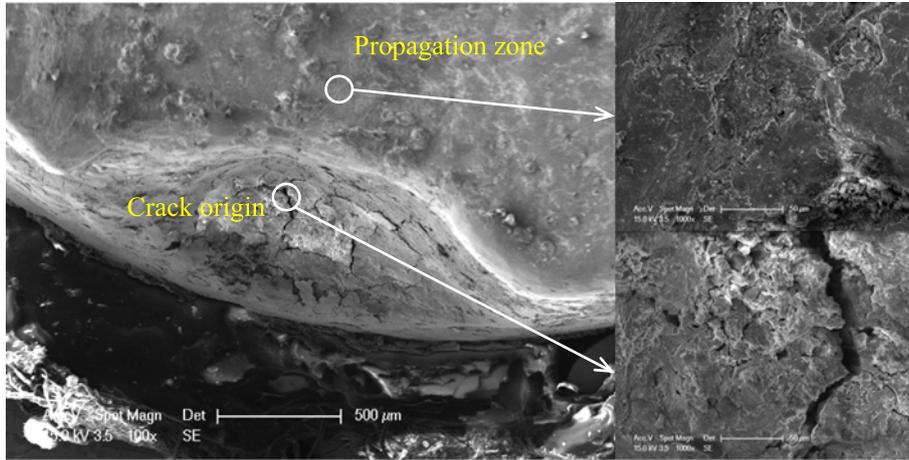
Fig. 14. SEM high magnification image of the fatigue fracture surface in beam PP2MF-1.

Fig. 14 is a SEM image of fatigue fracture surface of the first ruptured wire in beam PP2MF-1. The crack origin zone around the corrosion pit contained a large number of interconnected cracks and voids, which is thought to have served as a fatigue crack trigger. The propagation zone shows an apparently flat surface and contains a few fine, randomly dispersed, and isolated microscopic cracks, which were formed with the increase in loading cycles. The fatigue fracture surfaces of two wires in beam PP2MF-3 are given in Fig. 10b and d. Compared to the first fractured wire in Fig. 10b, the second fractured wire has an obviously reduced crack propagation zone as shown in Fig. 10d caused by a significant increase in stress range, which occurred after the first wire failed.

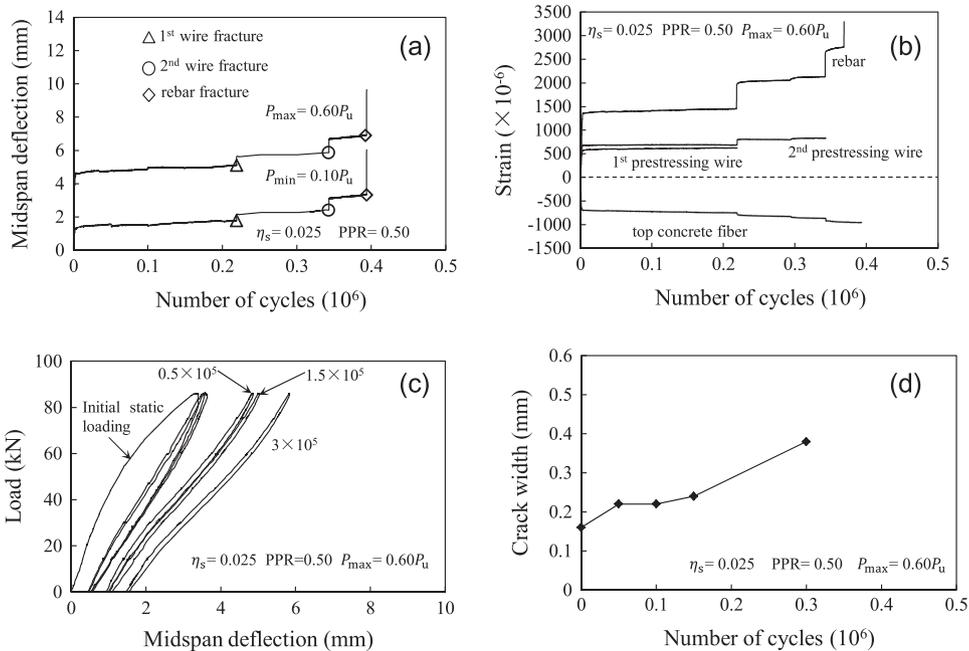
Fig. 15. Deformation behavior of beam PP2MF-3 (a) midspan deflection versus number of cycles; (b) strains versus number of cycles; (c) load–deflection curves at predetermined number of cycles; (d) crack width versus number of cycles.

The failure process of a typical beam PP2MF-3 is described as an example in the following. Deflections and strains versus number of cycles of beam PP2MF-3 are shown in Fig. 15a and b. In the first hundred cycles there was a sharp increase in the strains of concrete and rebar. In Fig. 16, the neutral axis shifts slightly upwards, resulting in an increased midspan deflection. Then, flexural cracks alternated opening and closing stably. At the same time, midspan deflection and strain gradually increased under cyclic loading. The stable state extended to a critical point where the fracture of the first prestressing wire occurred.

Fig. 15c shows the load–deflection curves of beam PP2MF-3 after a predetermined number of cycles during fatigue loading. It can be observed that the progressive stiffness degradation and the residual deflection increased with the increasing number of loading cycles. Crack width gradually increased at the beginning of loading, and then increased significantly after the first wire failure, as shown in Fig. 15d.

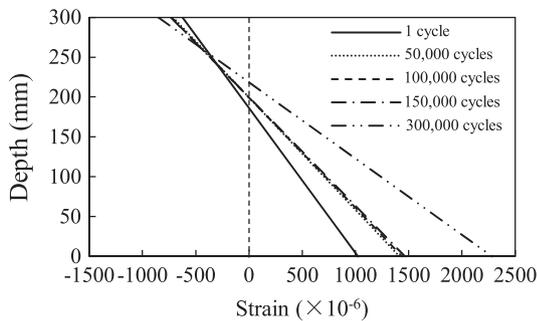
Fig. 16. Variations of strain distribution at midspan of beam PP2MF-3 during cyclic loading.

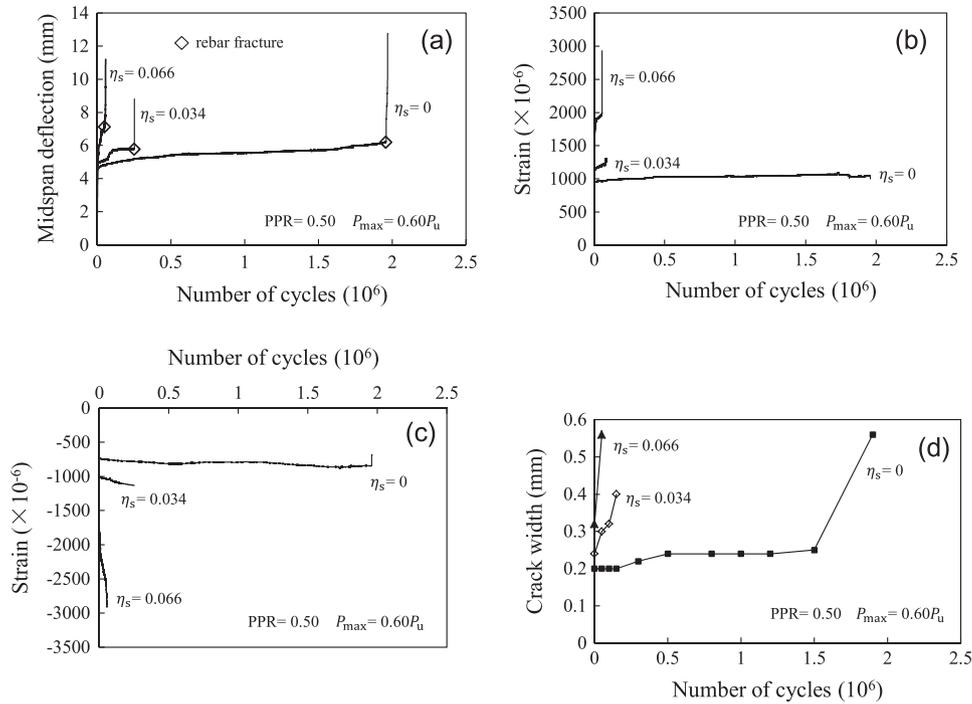
Fig. 17. Deformation behavior of beams with various degrees of corroded rebars at P_{max} (a) midspan deflection versus number of cycles; (b) rebar strain versus number of cycles; (c) top concrete fiber strain versus number of cycles; (d) crack width versus number of cycles.

Deformation behavior of corroded beams with various degrees of corrosion in rebars is presented in Fig. 17. For brevity, only the development trend of deflection, strains and crack width of beams at P_{max} are shown. It can be seen that corroded beams had larger deflections, strains and crack widths, which increased much faster under cyclic loading than the uncorroded beam.

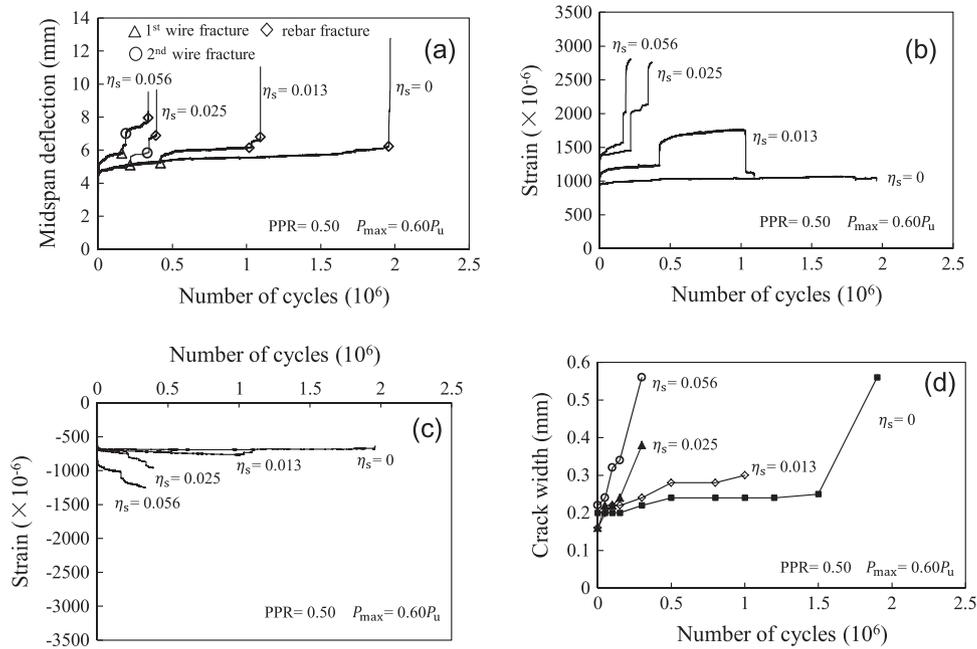
Fig. 18. Deformation behavior of beams with various degrees of corroded prestressing wires at P_{max} (a) midspan deflection versus number of cycles; (b) rebar strain versus number of cycles; (c) top concrete fiber strain versus number of cycles; (d) crack width versus number of cycles.

Deformation behavior of beams with various degrees of corroded prestressing wires at P_{\max} is presented in Fig. 18. Fig. 18a shows that the deflection of beams increased consistently with an increasing number of cycles, and a sudden jump and a faster

increase was observed following the fracture of prestressing wires. The rebar strain, concrete strain and crack width of corroded beams shared similar development trends. Owing to the severest corrosion, the deflection and strains of beam PP3MF-3 increased faster than that occurring in the other beams.

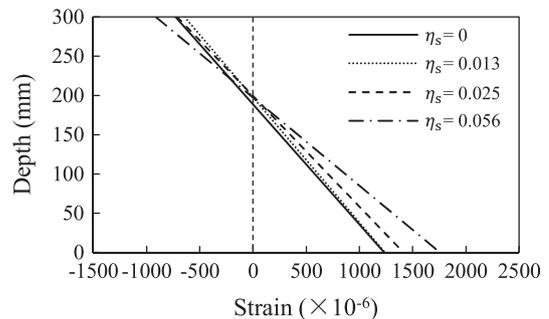
Fig. 19. Strain distribution at midspan in the first cycle loading.

Fig. 19 presents the strain distribution of the midspan section in the first cycle of cyclic loading for four beams and shows that, for the two minor corroded beams PP1MF-3 and PP2MF-3, there is little change on the top concrete fiber strain, whereas an increase in the rebar strain and crack width is evident. Therefore, the neutral axis shifts upward, and the curvature and deflection increase slightly. With a further increase in corrosion, there is an obvious increase in both the top concrete fiber strain and rebar strain of beam PP3MF-3, leading to a faster growing crack width and deflection with the increasing number of cycles.

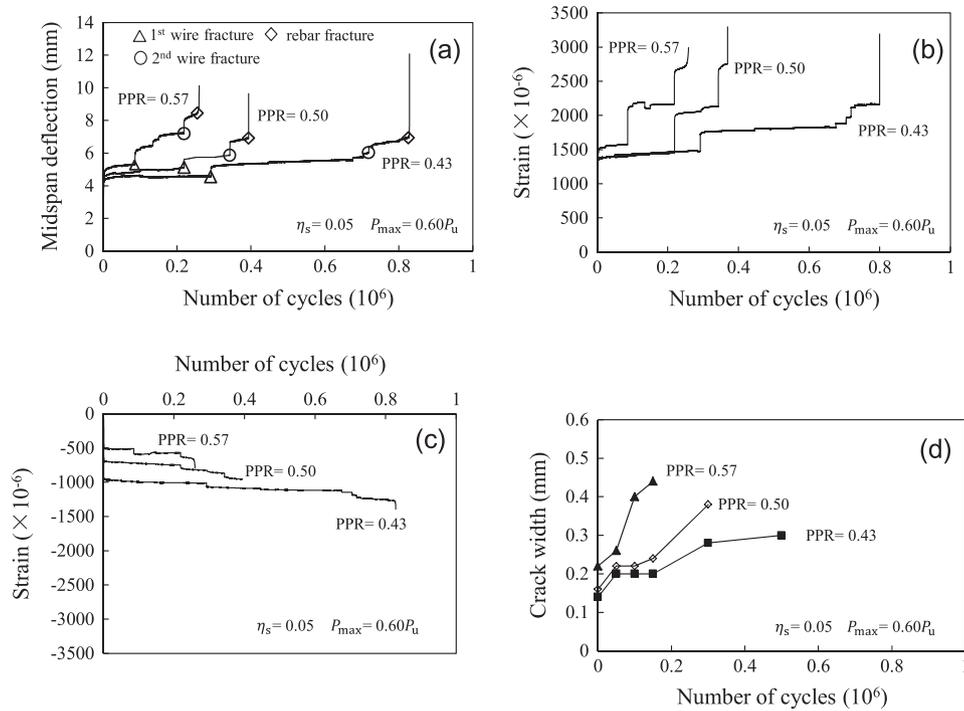
Fig. 20. Deformation behavior of corroded beams with different PPRs at P_{max} (a) midspan deflection versus number of cycles; (b) rebar strain versus number of cycles; (c) top concrete fiber strain versus number of cycles; (d) crack width versus number of cycles.

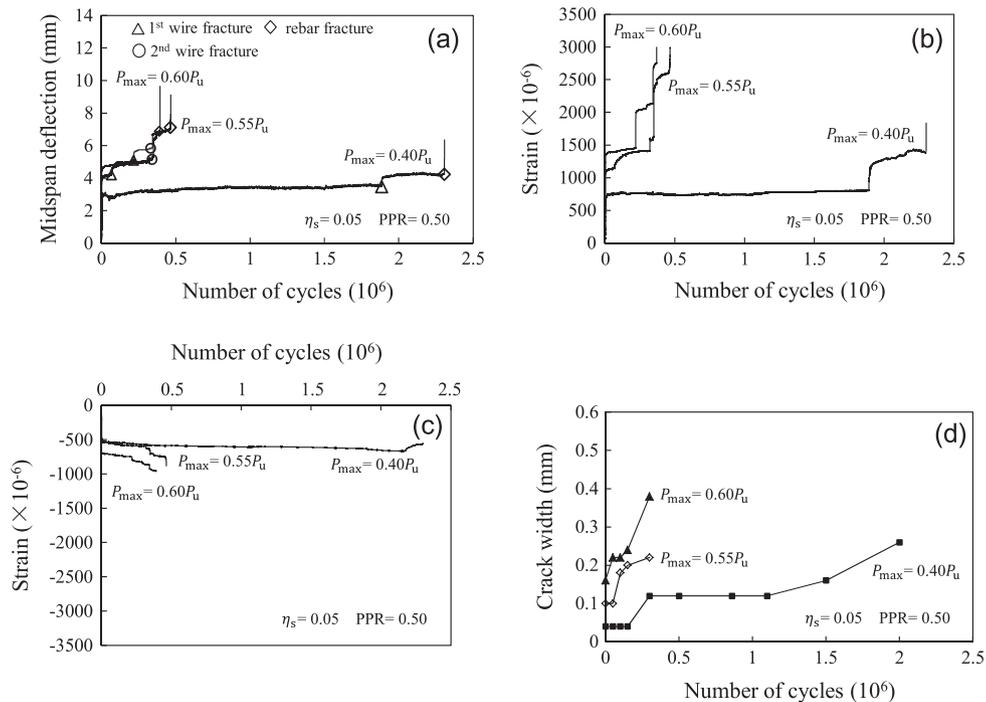
Fig. 21. Deformation behavior of corroded beams at P_{max} under different load ranges (a) midspan deflection versus number of cycles; (b) rebar strain versus number of cycles; (c) top concrete fiber strain versus number of cycles; (d) crack width versus number of cycles.
