Shake-Table Studies of Repaired Reinforced Concrete Bridge Columns Using Carbon Fiber-Reinforced Polymer Fabrics

by Ashkan Vosooghi and M. Saiid Saiidi

ACI Structural Journal, V. 110, No. 1, January-February 2013.

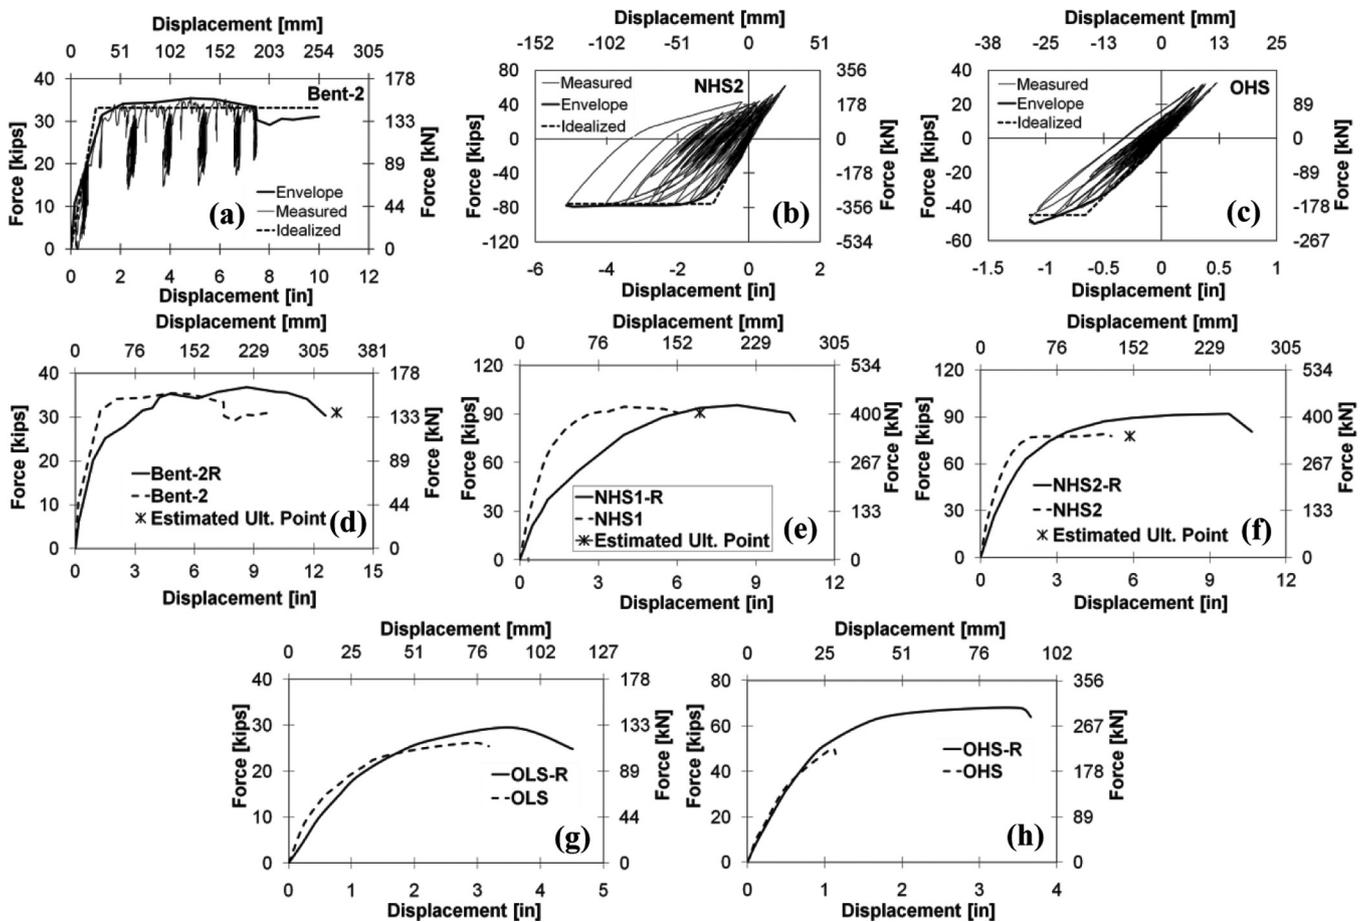
The cumulative measured force-displacement hysteresis curves of Bent-2, NHS2, and OHS are shown in Fig. 3(a) to (c), respectively. Other test models had comparable hysteresis curves, although energy dissipation (area enclosed by the hysteresis hoops) in Column OLS was larger than that of OHS. The envelope of each hysteresis curve was determined and idealized by an elasto-plastic curve (Vosooghi and Saiidi 2010a). Using idealized force-displacement curves, the yield drift ratio, maximum drift ratio, displacement ductility, and strength of the columns were determined and are listed in Table 1. Note that the ductilities in the table are not the ductility capacities because the original columns were not tested to failure. Generally, the low shear columns (Bent-2 and OLS)

Fig. 3—Force-displacement relationships.

The force-displacement response of the original and repaired column models were used to evaluate the repair performance. The measured force-displacement envelopes of all column models are shown in Fig. 3(d) to (h). It should be noted that the end points in the original models do not indicate failure because these columns were not tested to failure. The ultimate points were estimated using a method described in the following sections (displacement capacity index) and marked on the graphs. The envelopes indicate that the strength and displacement capacity of the columns were fully restored and the stiffness of the models was not restored by the repair. The lower stiffness of the repaired

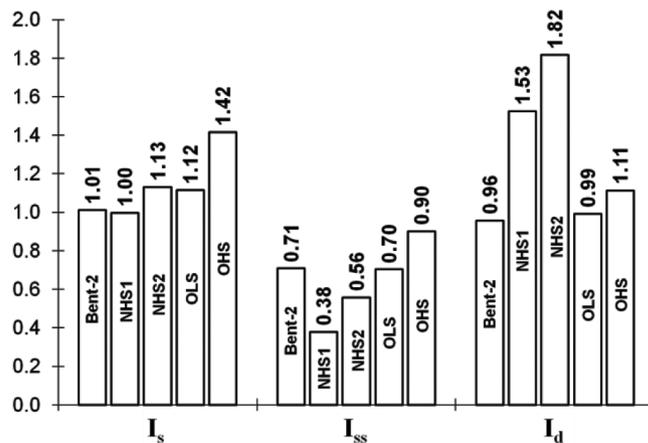
where F'_p and F_p are the lateral strengths of the repaired and original columns, respectively. A strength index equal to or greater than 1 indicates that the column strength was fully restored through the repair. The strength index is plotted in Fig. 6 for all columns. It can be seen that the strength index is greater than 1 for all repaired columns, thus indicating that the repairs were successful. Due to insufficient transverse steel, the shear strength of OHS was significantly lower than its plastic flexural capacity. After repair, the shear strength was increased and OHS-R reached the plastic lateral load capacity. Consequently, a considerably high-strength index is observed for this column.

where K' and K are the elastic stiffnesses of the repaired and original columns, respectively. The elastic stiffness of the columns was defined as the initial slope in the idealized elasto-plastic force-displacement relationship. Indexes equal to or greater than 1 indicate that the column service stiffness was fully restored by the repair. The index was calculated for all column models and is plotted in Fig. 6. The plots show that all of the indexes are smaller than 1, meaning that the stiffness of the repaired columns was smaller than that of the original columns due to the reasons discussed previously. In addition, the fact that the epoxy injection of the cracks could not fill the relatively thin cracks in the original column led to stiffness degradation of concrete.

The service stiffness index in the substandard columns was higher than that of the standard columns because the damage level in the original substandard columns was lower than that of the standard columns. Therefore, the stiffness

Fig. 6—Nondimensionalized response indexes.

deterioration in the original substandard columns was less significant—particularly in OHS, where the maximum damage state in the original column was DS-2.
