Safety inspections and seismic behavior of embankment dams during the 2011 off the Pacific Coast of Tohoku earthquake

Dam and Appurtenant Structures Research Team, Hydraulic Engineering Research Group, Public Works Research Institute, Japan

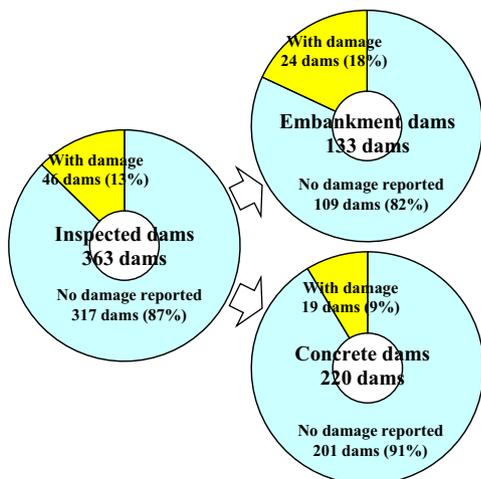
Fig. 1. Number of inspected dams with/without earthquake damage.

Although not severe, damage was reported at more than 10% of the inspected dams, as shown in Fig. 1. The ratio rises to 18% for embankment dams, with more damage reported at dams managed by water users for irrigation or power generation (Yamaguchi et al., 2012). Fig. 2 indicates the breakdown of the damage reported at embankment dams. “Cracking on dam body” includes cracks on the dam crest and cracks with slippage on the upstream and/or downstream slope, which were mainly reported at earthfill dams, and cracks of the impervious membrane at AFRDs. The managers of the dams that had sustained some damage were required to carefully monitor various measured data such as the amount of leakage. At several dams, reservoir drawdown was necessary to ensure safety and enable investigations to identify the area and cause of the damage.

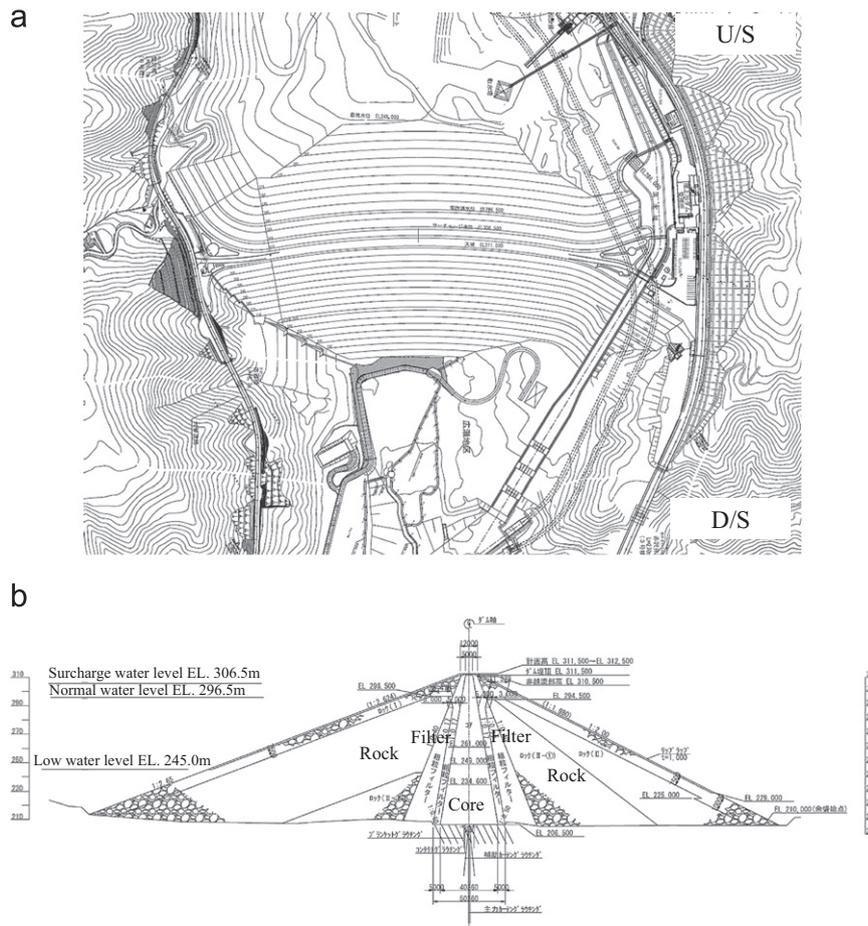
Fig. 4. Surikamigawa Dam.

The Surikamigawa Dam, shown in Fig. 4, is a central earth-core type rockfill dam (ECRD) with a height of 105.0 m completed in 2006. The maximum horizontal acceleration observed at the rock foundation was 110 gal. Earthquake-induced damage and abnormalities at this dam were as follows:

- Cracking of the pavement on the dam crest near both abutments, primarily in the stream direction (Photo 1).
- Settlement of the dam body of approximately 170 mm at the crest near the maximum cross section.
- Increase in total leakage from approx. 70 L/min to 100 L/min.

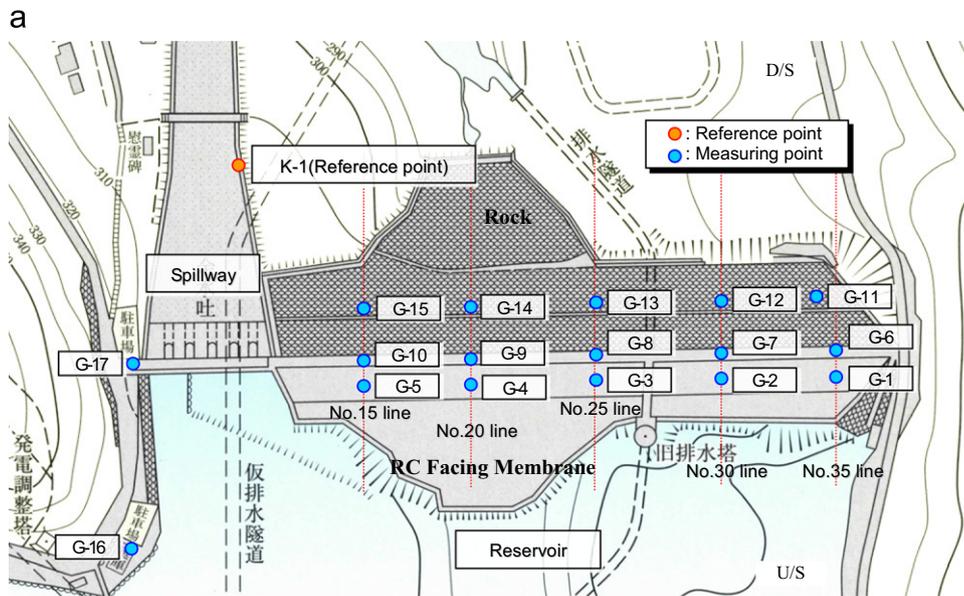
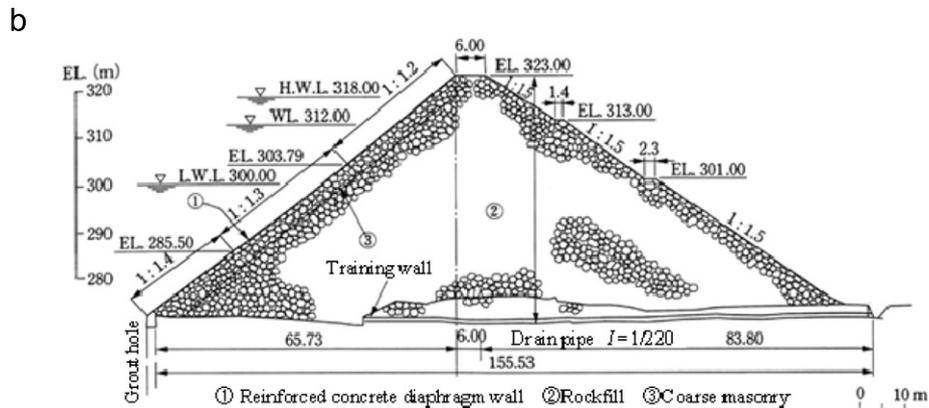
Fig. 6. Ishibuchi Dam.

Fig. 6 shows the Ishibuchi Dam, a concrete faced rockfill dam (CFRD) with a height of 53.0 m completed in 1953. The maximum horizontal acceleration observed at the downstream right-bank terrace, which is not bedrock, was 184 gal. Earthquake-induced damage and abnormalities at this dam were as follows:

- Maximum settlement of dam body of approximately 12 mm at the crest around the maximum cross section,
- Cracks in the foundation of the crest railing.

deformation at the measurement point at the center of the dam crest, namely No. G-9 indicated in Fig. 6(a). The results revealed that the main shock of the 2011 earthquake on March 11 caused 12 mm of settlement at the crest, and the largest aftershock, which occurred on April 7, resulted in a bit more settlement. Considering the GPS measurement data and the fact that no damage occurred at the concrete facing along the upstream slope, it was concluded that there was no threat to the safety of the dam.

In view of the relatively large settlement of over 500 mm caused by the 2008 earthquake, a new deformation measurement system using GPS to continuously monitor dam behavior was implemented at this dam (Yamaguchi et al., 2010). Fig. 7 shows the time series of

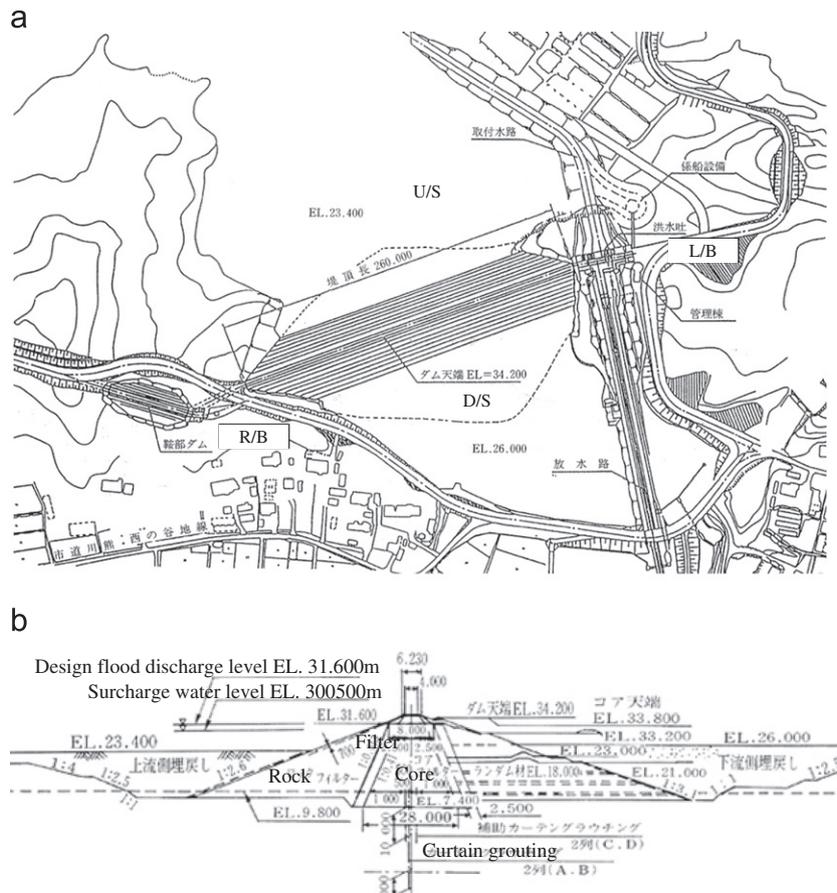
Fig. 8. Kejonuma Dam.

The Kejonuma Dam, shown in Figs. 8 and 9, is a zoned earthfill dam with a height of 24.0 m completed in 1995. The maximum horizontal acceleration observed at the foundation was 269 gal. The earthquake-induced damage and abnormalities at this dam were as follows:

- (a) Several small cracks in the stream direction on the dam crest including cracks of 25–30 mm in maximum width at the left bank side, as shown in Photo 4.
- (b) A slight opening between the pavement and curb on the dam crest.
- (c) A rapid but temporary increase in the total amount of leakage from 20 L/min to 430 L/min.
- (d) A maximum settlement of 139 mm (much smaller than the height of freeboard) and deformation of 58 mm in the downstream direction at the center of dam crest.

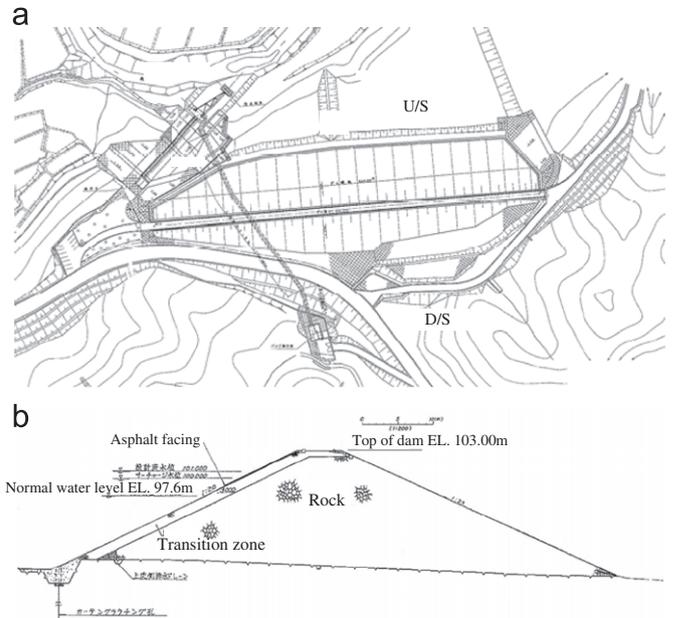
Fig. 10. Minamikawa Saddle Dam.

The Minamikawa Saddle Dam, shown in Fig. 10, is an AFRD with a height of 19.6 m completed in 1987. It is located approximately 1 km from the upstream side of the main Minamikawa concrete gravity dam (height 46.0 m), which forms a reservoir with the saddle dam. Seismometers were installed at the main dam, but not

- (a) Two relatively long cracks in the asphalt facing forming the impervious membrane (Photo 5).
- (b) Maximum earthquake-induced settlement of the dam body of approx. 90 mm at the dam crest around the maximum cross section.
- (c) Temporary increase in leakage of 19 L/min–91 L/min.

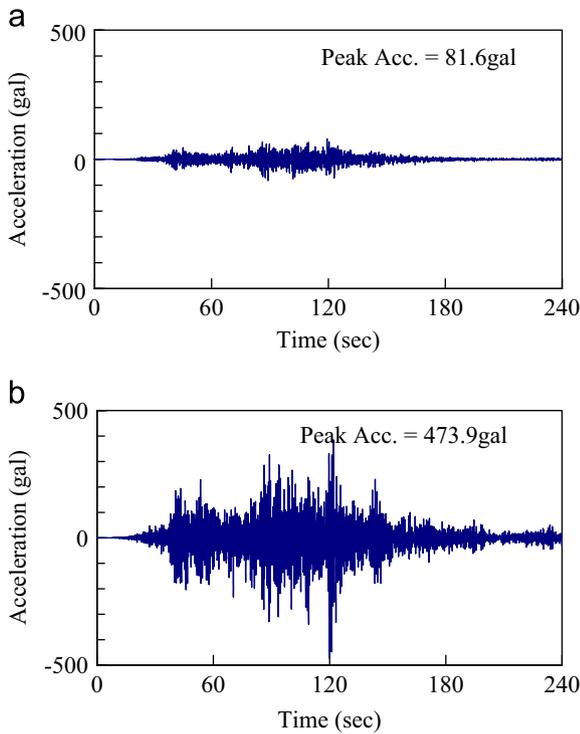
Fig. 11. Example of observed acceleration waveform (in the stream direction at the Surikamigawa Dam).

At almost all of the dams under the jurisdiction of MLIT, seismometers are installed at or near the foundation and the crest. An example of an acceleration waveforms observed at the dam foundation and on the dam crest are shown in Fig. 11. As seen from this example, a major feature of the observed earthquake motion is its very long duration, while the peak acceleration value is not extremely large in comparison with earthquake motions observed during past inland active fault earthquakes in Japan. This feature becomes more distinct when comparing the duration of principal motion with various records observed during previous earthquakes, as shown in Fig. 12.

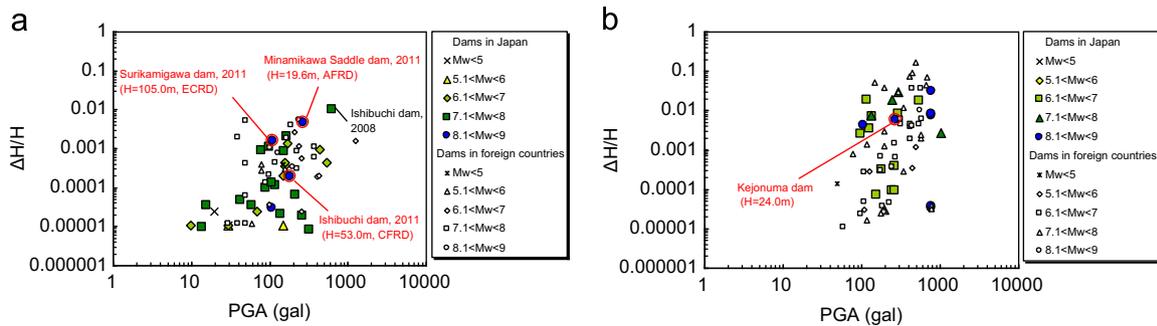
Fig. 15. Peak acceleration at dam foundation and settlement ratio of embankment dams. (a) Rockfill dams and (b) Earthfill dams.

areas of the world (Swaisgood, 2003; Singh and Debasis, 2009) is also shown in these figures for comparison. Although the amount of settlement could change depending on the difference in material properties and internal structure of the dam body, geotechnical conditions and age of dams, these figures indicate that the settlement ratio for dams affected by the Mw9.0 earthquake of 2011 was not smaller in comparison with that for previous earthquakes with similar peak acceleration values, except in the case of the Ishibuchi Dam, which had previously settled by more than 500 mm after the 2008 Iwate-Miyagi Nairiku (Inland) Earthquake that occurred very close to the dam just two and a half years earlier.

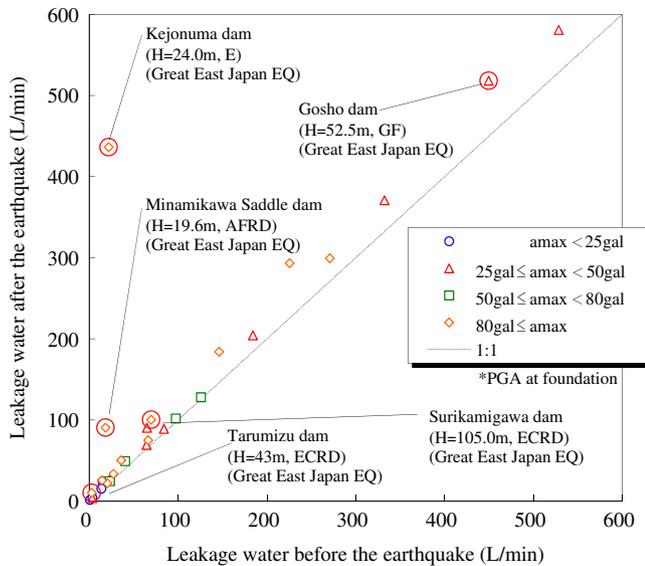
Fig. 16. Rate of change in amount of leakage at embankment dams before and after the earthquake.

The relationship between the change in leakage measured at embankment dams before and just after the earthquake was studied. The results are shown in Fig. 16 together with data on past earthquakes in Japan. It should be difficult to find a simple relationship between a feature of the earthquake motion and the amount of leakage, because the amount of leakage at an embankment dam is affected by not only the soundness of the dam body but also the permeability of the foundation, change in groundwater level, rainfall and so on. However, looking at the rate of change in amount of leakage, it can be seen that some dams experienced a relatively large increase in leakage just after the 2011 earthquake in comparison to data on past earthquakes. Although we do not have any experimental or analytical findings on the relation between the amount of leakage and the characteristics of earthquake motion, when considering that the cyclic loading may cause the cumulative damage to embankment dams, the relatively large amount of leakage might be related to the long duration of the earthquake motion.
