## Cyclic Response of Reinforced Concrete Moment Resisting Beams Repaired with Epoxy Injection

Engr. Muhammad Rashid<sup>1</sup>, Dr. Naveed Ahmad<sup>2,\*</sup>

### ABSTRACT

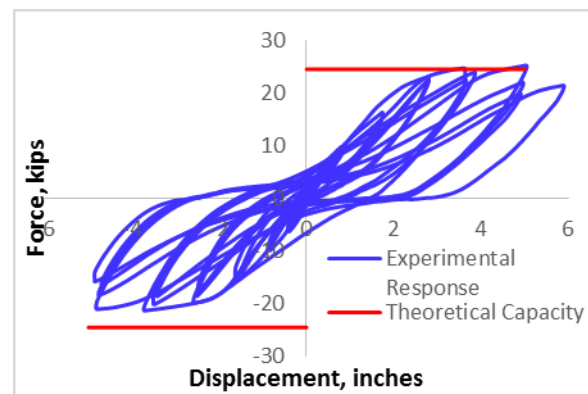
Figure 6: Hysteretic Response

Spalling of the concrete cover started on the northern and southern faces at a displacement of 4.5 in., which escalated at final the displacement cycles of 5.5 in exposing the reinforcing bars on the southern face. The specimen could not be displaced further because the maximum stroke of the hydraulic jack was 6 in. The hysteretic response was marked by a strong pinching due to the slip of longitudinal bars. No strength drop was observed in the hysteretic response due to the fact that the specimen was not tested till failure as shown in Fig. 6.
