# Unintentional Scanning Method for Back-Side Imperfection of Steel Construction Using Attractive Fluidity Leakage System

An Unintentional nondestructive estimation system using the magnetic-flux-leakage method was developed for detecting the back-side defects of large structures in order to understand fast detection in a wide measurement area. An Attractive field was applied to an object using a ferrite yoke with an induction link, and the leaked Attractive flux from the object was detected by a magneto resistive sensor. This measurement probe was fixed on an automatic scanning system. The mature automatic scanning system discover magnetic signal changes comparable to the back-side defects of the steel plates. To present the effectiveness of the developed system, we calculated the steel plate of a cargo crane, which was rust on the back side. We found that the detected magnetic signal changed markedly in the area with corrosion, whereas only a slight Attractive signal change was detected in the area without corrosion. Therefore, the developed system is useful for Attractive the back-side defects in a wide area, and can be used for screening tests.

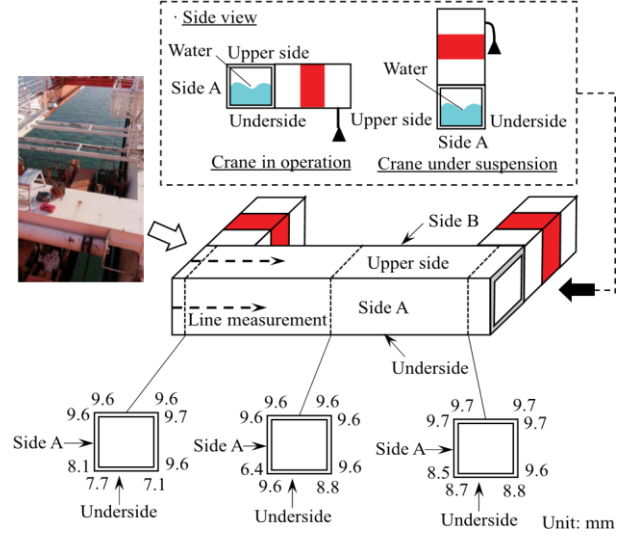
Fig. 3. Details regarding cargo crane, measured using automatic scanning system. Top schematic: mechanism of corrosion. Photograph and bottom schematic: measured area and reduction in thickness. Numerals: measured thickness of the steel plate.

For demonstrating the practical measurement using the developed system, we measured a tie beam of cargo crane. This tie beam consists of enclosed steel plates, and the back-side surface of the steel plates has corrosion owing to the rain infiltration (Fig. 3). As shown in Fig. 3 (top schematic), water remained inside the enclosed area, and the contact of water occurs frequently on the underside and side A, because the tie beam moves when it is operated and suspended. The corrosion and the thinning area of the steel plates have already been evaluated by the visual and ultrasonic inspection, and the thicknesses of the steel plate measured by the ultrasonic method are shown in Fig. 3 (bottom schematic). It was confirmed that remarkable reductions in thickness existed on the underside and side A. In this paper, the line measurement at four sides was performed by the developed automatic scanning system. The measured position and direction are shown in Fig. 3.

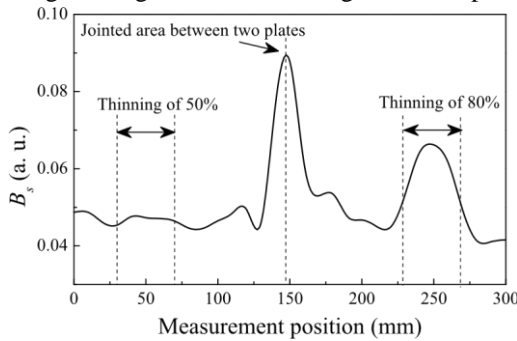
Fig. 4. Magnetic signal of  $B_s$  at the center line between the two jointed steel plates with back-side defects.

The magnetic signal  $B_s$  from the two jointed steel plates with artificial defects is shown in Fig. 4. A change in  $B_s$  was observed, and the position where  $B_s$  changed was correlated with the positions of the back-side defects and the joint line between the two plates. This magnetic signal change is due to the leaked magnetic field at the back-side defect and joint line. As seen in Fig. 4,  $B_s$  increased remarkably in the defect area of 80% thinning and at the joint line. A small increase in  $B_s$  in the defect area of 50% thinning was also observed. This suggests that the magnetic signal measured using the developed

automatic scanning system depended on the depth of the backside defects, and the effects of the environmental magnetic noise and the permanent magnet attached to the wheels were negligible. Therefore, by employing the automatic scanning system, the developed system can evaluate the back-side defects and the reduction in the thickness of the steel plates.

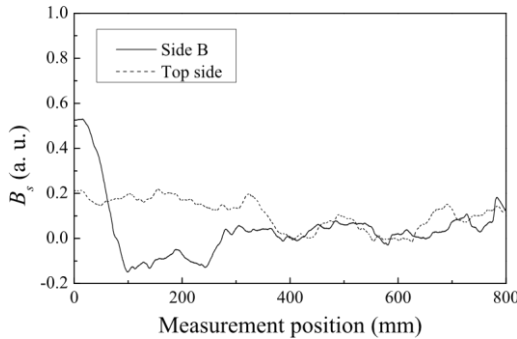
Fig. 5. Magnetic signal  $B_s$  of the cargo-crane tie beam in the area without corrosion.

The magnetic signals at the tie beam of the cargo crane were measured using the developed system. The signal change depended on whether the measurement area included the back-side corrosion of the steel plates (Figs. 5 and 6). The magnetic signal  $B_s$  measured in the corrosion areas (underside and side A) changed remarkably in the position range of 200 to 800 mm. On the other hand, the magnetic signal change in the areas without corrosion (upper side and side B) was small and almost constant between 300 and 800 mm. However, a drastic change in the magnetic signal of side B was observed between 0 and 150 mm.

We attributed this to the edge of the tie beam, which was located at the 0 mm measurement position on side B.

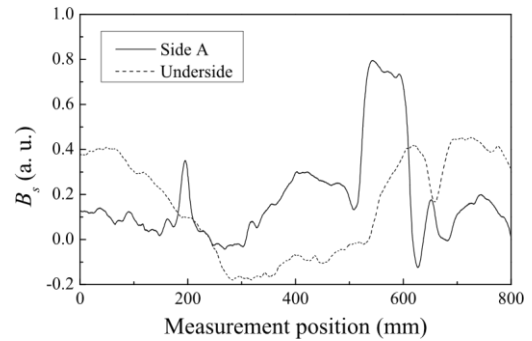
The difference in the magnetic signal change between the areas with and without corrosion is ascribed to the increase in the leaked magnetic signal due to the defects or the thinning caused by the corrosion of the steel plates. In particular, the value of  $B_s$  measured on side A changed markedly. We therefore consider that this area exhibited the largest reduction in the thickness of the steel plates, as shown in Fig. 3. This result indicates that the degree of corrosion can be estimated according to the magnetic signal change measured by the Fig. 6. Magnetic signal  $B_s$  of the cargo-crane tie beam in the area with

corrosion.
